ABSTRACT

This document describes the known exceptions to the functional specifications (advisories).

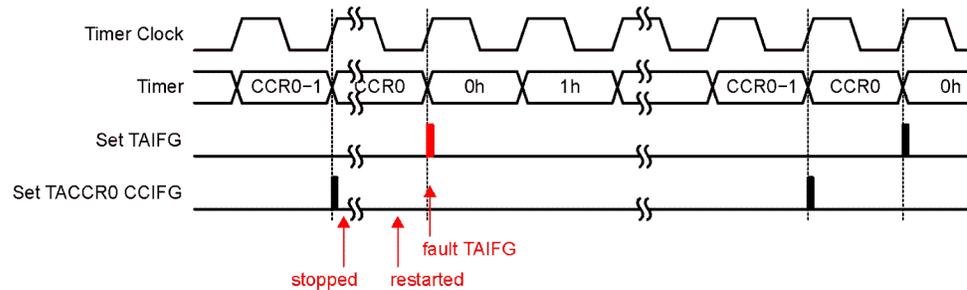
TA21 *TA Module*

Function TAIFG Flag is erroneously set after Timer A restarts in Up Mode

Description In Up Mode, the TAIFG flag should only be set when the timer counts from TACCR0 to zero. However, if the Timer A is stopped at TAR = TACCR0, then cleared (TAR=0) by setting the TACLr bit, and finally restarted in Up Mode, the next rising edge of the TACLK will erroneously set the TAIFG flag.

Workaround None.

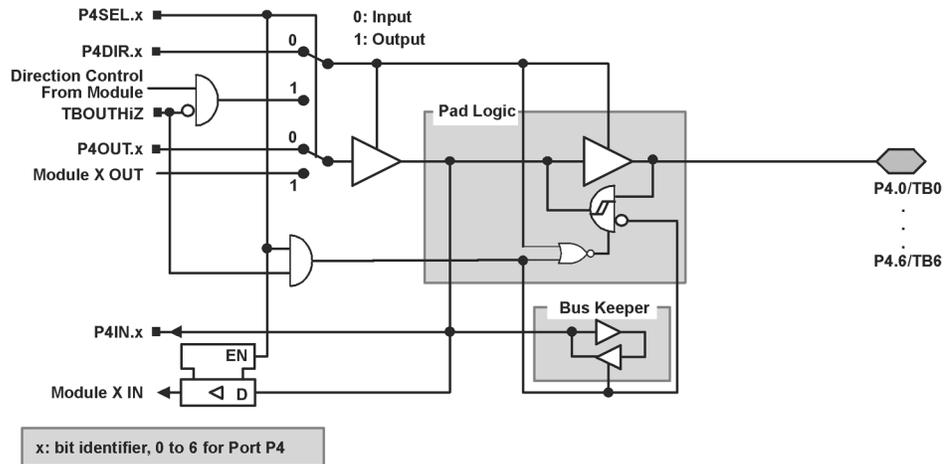
Port function as specified

Incorrect 3-state function of Ports P4.0/TB0 through P4.6/TB6 (TBoutHiZ control). If TBoutHiZ is set to high, all ports P4.0/TB0 through P4.6/TB6 are set to 3-state, independent of the P4SEL.x control signals. This means a port P4.x is switched to 3-state with TBoutHiZ, even if it is not selected for Timer_B function. In addition, the ports P4.0/TB0 through P4.6/TB6 are switched to 3-state with TBoutHiZ, even if the port direction (direction control from module) is set to input. This is in accordance with the specification description but, nevertheless, is an unexpected behavior.

No workaround.

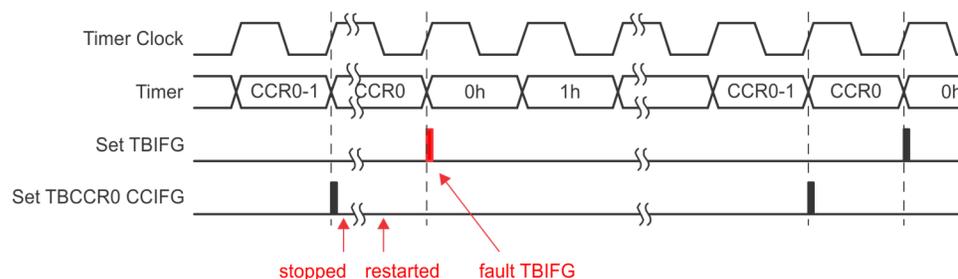
TB24 *TB Module*

Function TBIFG Flag is erroneously set after Timer B restarts in Up Mode

Description In Up Mode, the TBIFG flag should only be set when the timer resets from TBCCR0 to zero. However, if the Timer B is stopped at TBR = TBCCR0, then cleared (TBR=0) by setting the TBCLR bit, and finally restarted in Up Mode, the next rising edge of the TBCLK will erroneously set the TBIFG flag.

Workaround None.
