Errata  
**MSP430F2350 Microcontroller**

This document describes the known exceptions to the functional specifications (advisories).

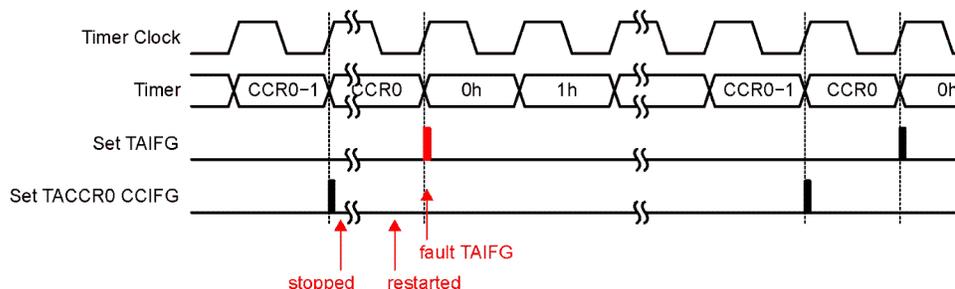
**Function** TAIFG Flag is erroneously set after Timer A restarts in Up Mode

**Description** In Up Mode, the TAIFG flag should only be set when the timer counts from TACCR0 to zero. However, if the Timer A is stopped at  $TAR = TACCR0$ , then cleared ( $TAR=0$ ) by setting the TACLr bit, and finally restarted in Up Mode, the next rising edge of the TACLK will erroneously set the TAIFG flag.

**Workaround** None.

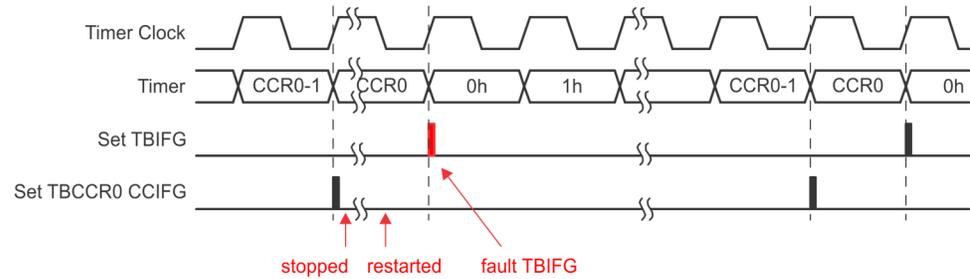
<b>Workaround</b>	None
<b>TB24</b>	<b><i>TB Module</i></b>
<b>Category</b>	Functional
<b>Function</b>	TBIFG Flag is erroneously set after Timer B restarts in Up Mode
<b>Description</b>	In Up Mode, the TBIFG flag should only be set when the timer resets from TBCCR0 to zero. However, if the Timer B is stopped at TBR = TBCCR0, then cleared (TBR=0) by setting the TBCLR bit, and finally restarted in Up Mode, the next rising edge of the TBCLK will erroneously set the TBIFG flag.

**Workaround** None.
