ABSTRACT

This document describes the known exceptions to the functional specifications (advisories).

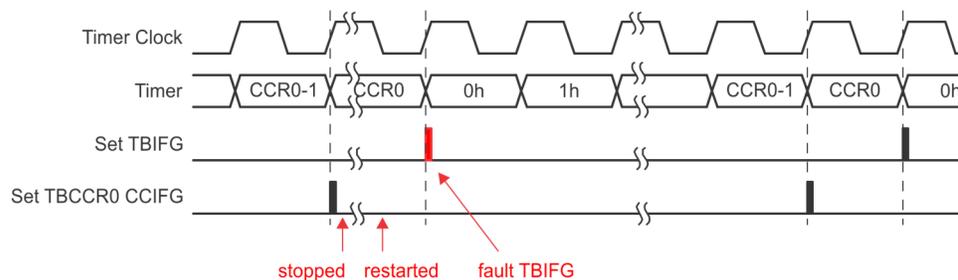
TB24 *TB Module*

Function TBIFG Flag is erroneously set after Timer B restarts in Up Mode

Description In Up Mode, the TBIFG flag should only be set when the timer resets from TBCCR0 to zero. However, if the Timer B is stopped at TBR = TBCCR0, then cleared (TBR=0) by setting the TBCLR bit, and finally restarted in Up Mode, the next rising edge of the TBCLK will erroneously set the TBIFG flag.

Workaround None.
