# Errata

## MSP430F5508 Microcontroller

This document describes the known exceptions to the functional specifications (advisories).

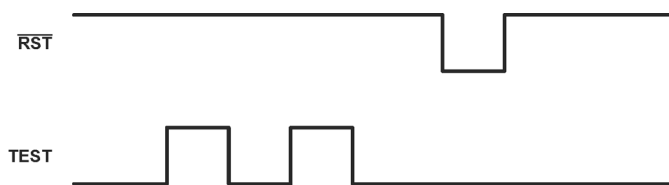
- Toggle the TEST pin twice when nRST is high and after 50us pull nRST low.

Note: This toggling of TEST pins is not subject to timing constraints. The appropriate level transitions on TEST pin, followed by a RST pulse after 50us, are sufficient to trigger an exit from BSL mode.
