Errata

MSP432E4 SimpleLink™ Microcontrollers

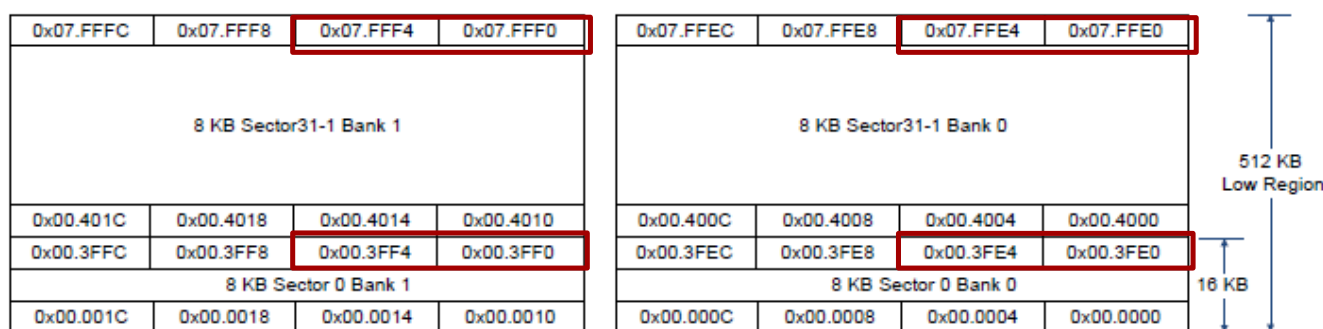
MEM#15
Specific flash locations in any sector do not get erased
Description

If only one or both of the first two words of the last line of a sector in a bank are programmed, an Erase of entire Sector, Mass Erase of device, or toggle mass erase does not erase the flash back to all 1's. The diagram below shows the affected words in Sector 0 and Sector 31 of the lower 512KB of Flash.

Program any other word in the Sector-Bank to allow Sector Erase to work.

Toggle Mass Erase or Mass Erase will still not work.
