**TMS320C6711, TMS320C6711B,
TMS320C6711C, TMS320C6711D**
Digital Signal Processors
Silicon Errata

SPRZ173P
May 2000
Revised August 2005

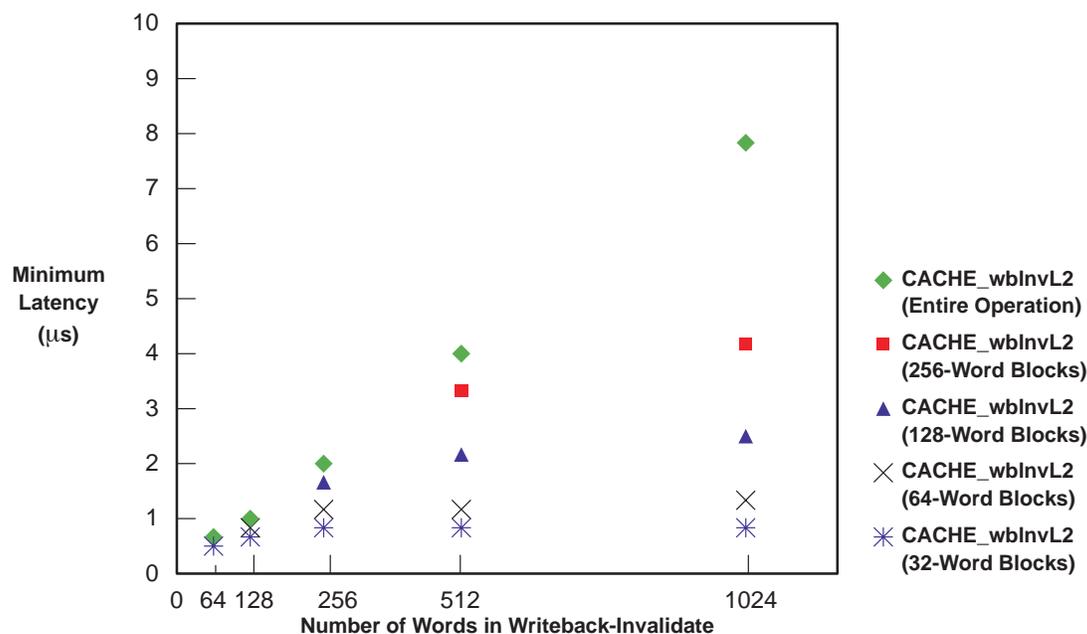
Figure 2. Minimum Required Latency Between McBSP Events for a Successful Transfer with Concurrent L2 Writeback-Invalidates at 200-MHz CPU and 50-MHz EMIF, Using Entire Operations and Block Breakdown

When using the L2 cache on the C671x/C621x devices, for a given EMIF-to-CPU frequency ratio, an L2 writeback or L2 writeback-invalidate operation may block other EDMA requests from accessing the EMIF until the operation completes. If the other EDMA requests to the EMIF have hard real-time deadlines, these deadlines may be missed if the deadline is shorter than the time required to complete the L2 writeback operation. The McBSP peripheral is most sensitive to this issue, as the buffering local to the McBSP peripheral can only hold data for at most one sample at a time before data loss occurs.

For example, if the CPU is running at 200 MHz with a 50-MHz EMIF and there is a McBSP hard real-time deadline of 5 µs, Figure 2 shows that a 1024-word L2 writeback-invalidate may cause data loss since back-to-back McBSP events can only be serviced at ~8 µs. By breaking down the L2 writeback-invalidate into 256-word blocks, the 5-µs McBSP deadline can then be met. In other words, when performing a 1024-word L2 writeback-invalidate operation with the CPU and EMIF conditions cited above, the McBSP events can be serviced in ~8 µs for the entire operation (one whole block), in ~4 µs when breaking it into 256-word blocks, in ~2.5 µs when breaking it into 128-word blocks, etc.

As the sample rate is system-dependent, the user must calculate the time between serial samples to determine the best approach to avoid data loss. The user may break large cache operations into smaller blocks, and transmit each of these blocks using the `CACHE_wbInvL2()` and `CACHE_wbL2()` CSL functions. By breaking the large cache operations into smaller blocks, other peripherals are then allowed to access the EDMA.

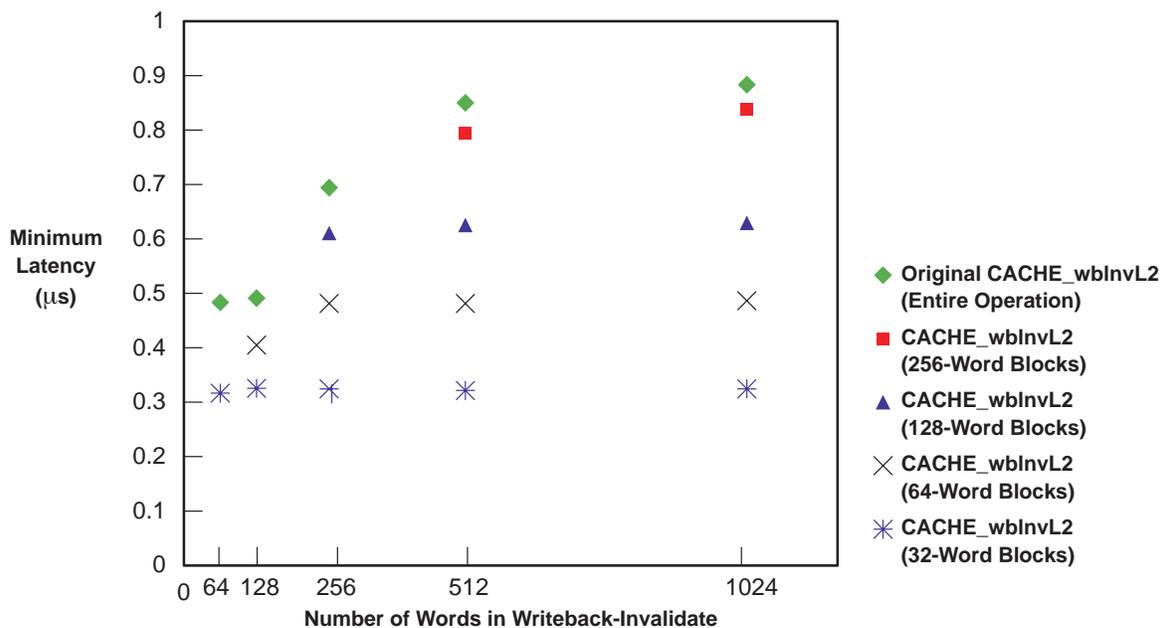
Figure 3. Minimum Required Latency Between McBSP Events for a Successful Transfer With Concurrent Writeback-Invalidates at 225-MHz CPU and 100-MHz EMIF, Using Entire Operations and Block Breakdown

When the CPU is set to 225 MHz and the EMIF is set to 100 MHz, breaking down the cache operations will still improve the block-out problem. Figure 3 shows the improvement in the McBSP's performance with this frequency ratio.

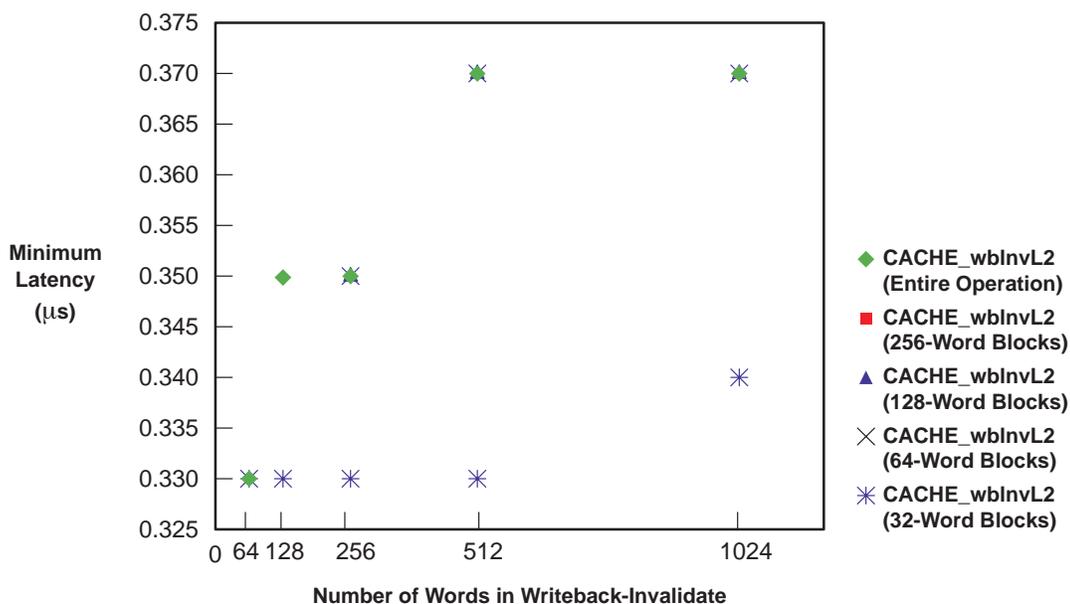
Figure 4. Minimum Required Latency Between McBSP Events for a Successful Transfer With Concurrent Writeback-Invalidates at 150-MHz CPU and 100-MHz EMIF, Using Entire Operations and Block Breakdown

When the CPU is set to 150 MHz and the EMIF is set to 100 MHz, there is virtually no benefit from breaking down the coherency cache operations. Figure 4 shows the McBSP's performance with this frequency ratio.

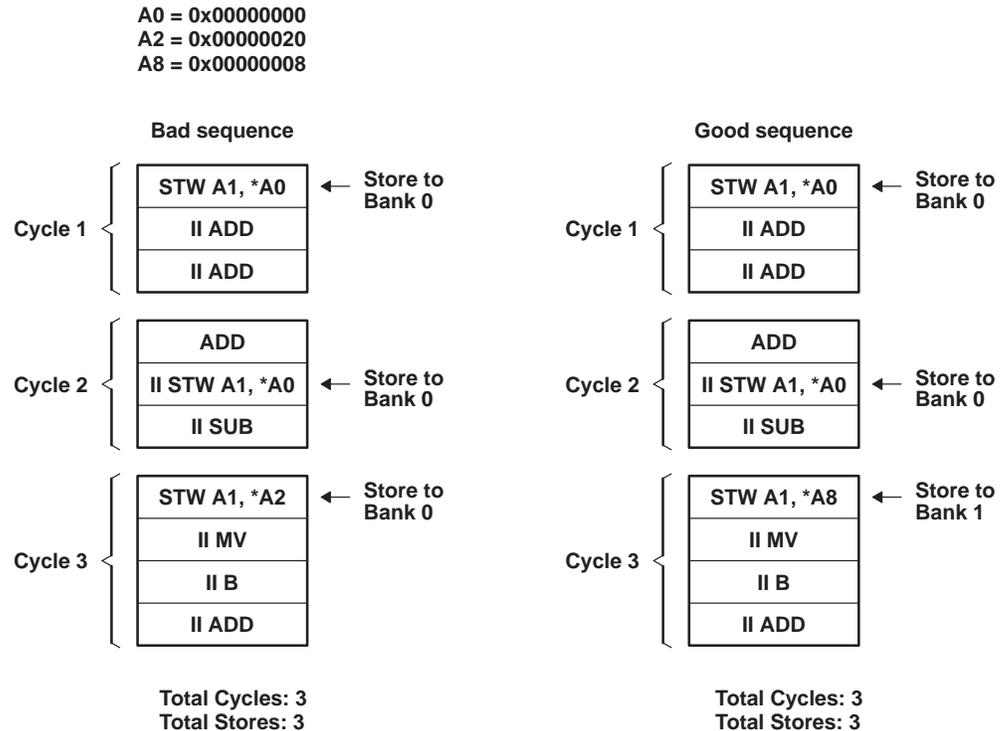
Figure 8. Pseudo Code Example Stores to Specified Banks (Criteria 3)

- All stores in the loop must be to the same bank of L2. If there are any stores to another bank, this will free the first bank long enough for the EDMA access to get in (see Figure 8).

In the case of two stores occurring on the same cycle, in parallel, the same rules apply. If both stores are to the same bank (and there are no other stores in the sequence to a different bank), then a problem may occur. If each of the parallel stores is to a different bank, then the problem cannot occur.

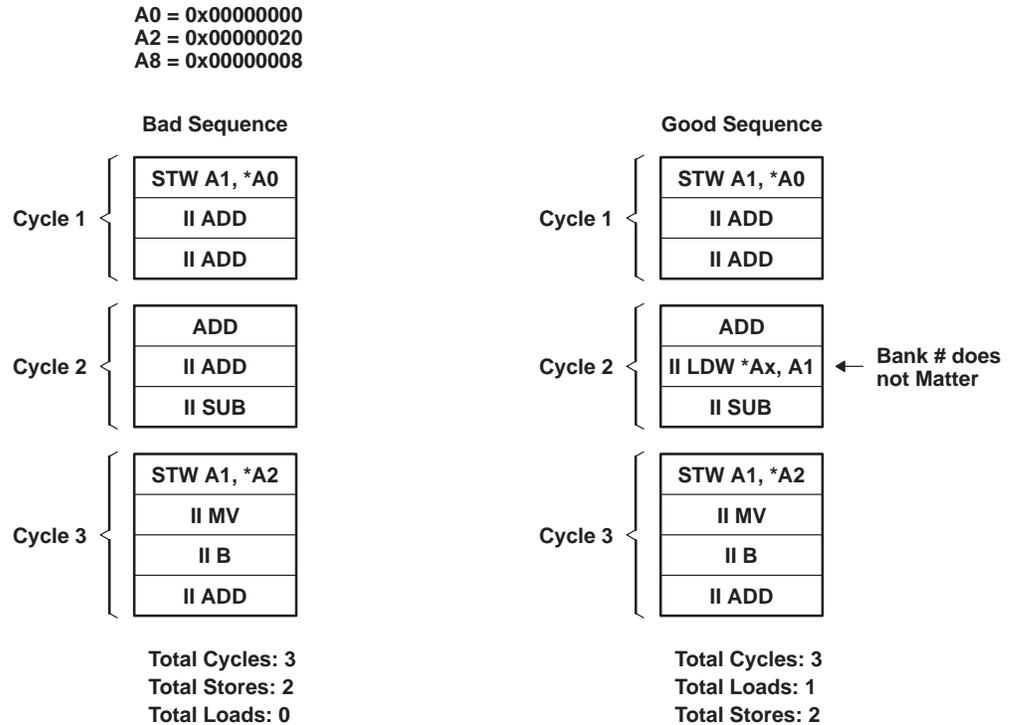
Figure 9. Pseudo Code Example Stores and Loads (Criteria 4)

A load from L2 provides enough of a gap to allow the EDMA to access L2. The good sequence would not cause a problem even if the load were executed in parallel with one of the stores, as long as the load occurred somewhere in the sequence. Notice that although the good sequence satisfies criteria 2 and 3, it would not cause a problem.

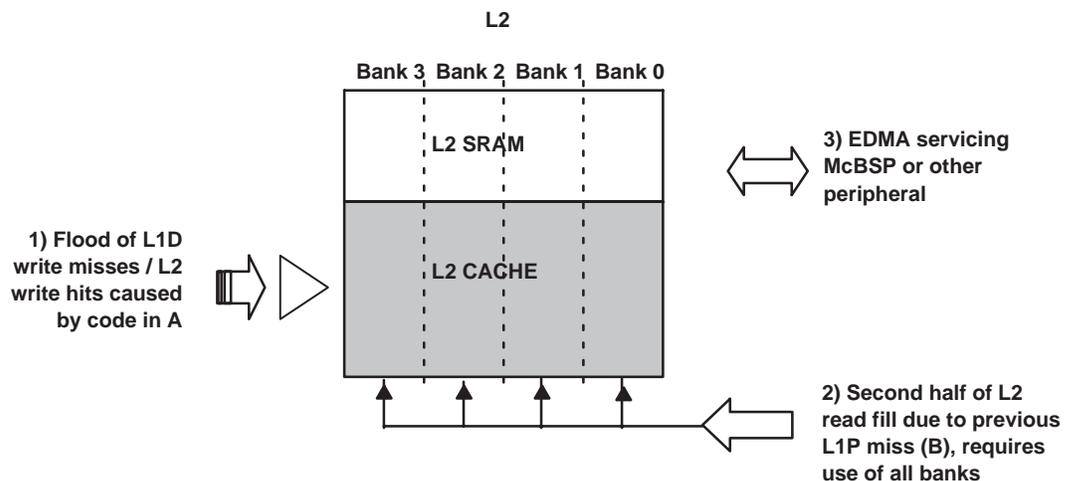
Figure 10. Problem Scenario

In this scenario, the next CPU fetch packet does not reside in either L1P or L2 cache; therefore, it causes an L1P and L2 miss. An L2 cache line (128 bytes, 4 fetch packets) must be fetched from external memory. The fetch from external memory is split into two requests (two halves) of 64 bytes, or two fetch packets each. In this document, the two halves are labeled A and B, respectively, as shown in Figure 10. The first half (A) to arrive in L2 is the half in which the missed fetch packet resides. This first half is immediately forwarded to L1P so that CPU can resume execution before the second half (B) is fetched from external memory. The second half of the L2 line (B) is to be fetched and written to L2 later.

The lockout condition occurs only when the second half (B) of the L2 cache line fill starts. When the B is ready, it attempts to write to L2. It will be unable to do so, however, because the line fill operation accesses all four banks of L2 whereas one bank is always busy servicing the higher priority L1D misses from the code in A. Thus, the line fill (B) cannot complete until the flood of writes from A has stopped. The line fill stays at the head of queue in the EDMA controller, so any other EDMA transfers that access L2 will also be blocked until the flood of stores has stopped *and* the L2 line fill (B) has completed.

The amount of time that an EDMA transfer is locked out of L2 is determined by the code running on the DSP (A), and ultimately by the amount of time that L1D write misses are happening in succession. When all of the conditions are met, the second half of the L2 line fill and the EDMA will be locked out of L2 as long as the flood of stores is sustained.

- Avoid the flood of L1D write misses. Pre-read all data locations prior to writing them. This will allocate them in L1D, preventing the L1D write misses from occurring. Recall that L1D read misses do not cause problems.
- Make sure that any algorithm or code segment that naturally produces a long string of writes inserts gaps in the write sequence such that writes occur at a frequency slower than 1 write miss every other cycle. The term "long" is based on the system requirements. Gaps in the L1D write misses means that the second half of the L2 read fill is given a chance to access L2.

- Run the algorithm or code segment that contains A from internal SRAM. There will not be L2 code read fill (A or B) coming into L2. The simulator can be used to detect such code segment. See simulator section below for details.
- Ensure the problematic segment of algorithm or code is in cache. This can be accomplished by issuing any CPU read/load instruction from the beginning of the problematic code segment in external memory, that will cause both L1D and L2 miss. Assuming the code segment is not yet in L1/L2 cache, Performing CPU load instruction generates an L1D request, and CPU stalls until the code missed and data is returned from L2. After the load instruction, code segment will reside in the L2 cache, and an L2 read fill due to L1P miss will not occur.

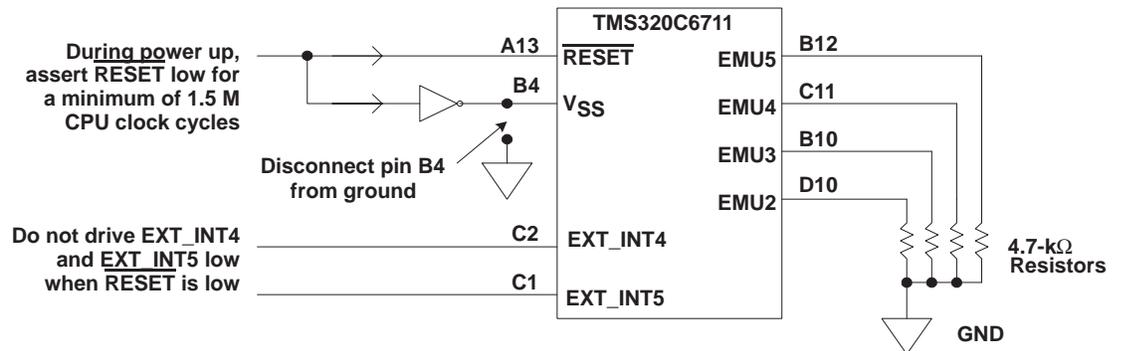
Figure 11. Board Modification

Details: On TMS320C6711 devices, certain test logic associated with the L1D controller may power up initialized to an incorrect state. In this case, any of the following conditions will cause data corruption:

The data at the address pointed to by the current load or store operation will be corrupted with the last value present on the associated store data bus. Although infrequent, stalls can have a variety of causes, such as: program-cache miss, data-cache miss, and data-cache store buffer stall. Thus, there is no viable software workaround.

- While $\overline{\text{RESET}}$ is active low, inputs EXT_INT4 and EXT_INT5 should be high to allow the test mode to run to completion. Both pins include internal pullups, so undriven inputs will meet this requirement.
