TMS320C6205
Digital Signal Processor
Silicon Errata

Silicon Revisions 1.0, 1.1, 1.2, 1.3, 1.4

SPRZ181J
September 2000
Revised February 2006

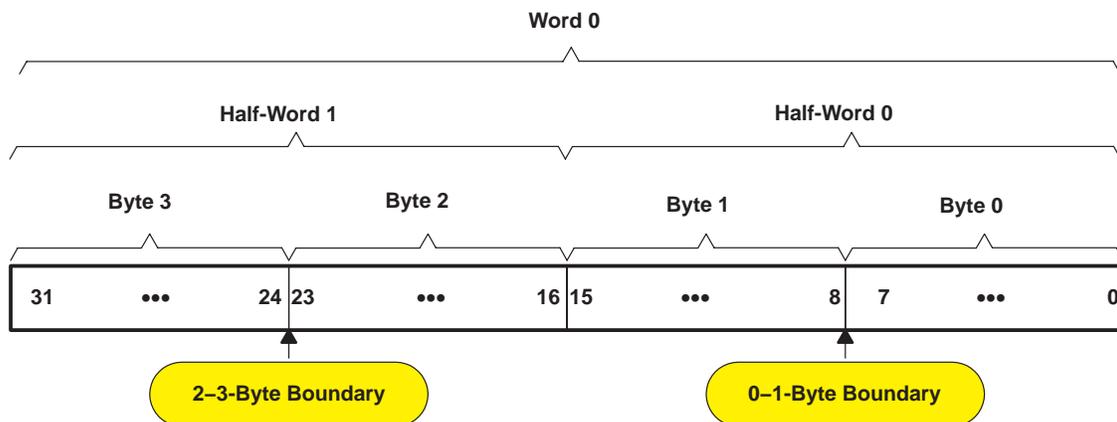
Figure 2. Diagram Showing the 0–1 and 2–3 Byte-Boundary From a Word in Data Memory

Data corruption occurs when a write to data memory is followed by an instruction that modifies the byte-enables on a 0–1 or a 2–3 byte boundary, as shown in Figure 2. Essentially, an STB instruction acts as an STH instruction. Data corruption occurs at the address referenced by the first instruction. Reads from data memory, as well as both read and write accesses to program memory and external memories do not exhibit this issue.

In these examples, the second execute packet contains an instruction that modifies a byte on either a 0–1 byte-boundary (Examples 1 and 2) or a 2–3 byte-boundary (Example 3).

Utilize half-word and word accesses instead of byte-wide accesses.

Avoid use of the char type from C.
