TMS320VC5503
Digital Signal Processor
Silicon Errata

SPRZ218C
April 2004 – Revised April 2008

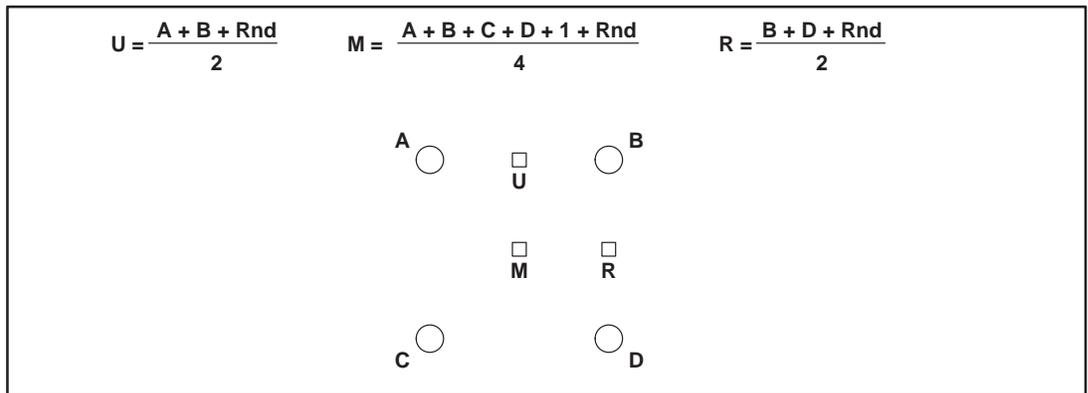
Details: The pixel interpolation computation is wrong by one pixel unit in “Decoder” mode, when “Rounding Mode” is set to zero and when half-pixel interpolation is performed in the middle of four full-resolution pixels (i.e., in the middle of two rows of pixels).

In “Decoder” mode, the Pixel Interpolator data path is configured to deliver two interpolated pixels per cycle. Each section of the data path implements the computations shown below, normalized according to video decoding standards:

U and R results are interpolated from lines and columns, respectively. M is computed from two following full-resolution pixels lines. Two U, R, or M results are computed during each cycle by the data path, according to the instruction being executed by the accelerator for the M results set (the results are denoted as M0 and M1). When “Rounding Mode” (Rnd in the above picture) is set to 1, the faulty data path section is implemented, $M0 = (A+B+C+D+2)/4$, which is the correct result; but when “Rounding Mode” is set to 0, the data path section implements $M0=(A+B+C+D)/4$. This is not correct and generates a bit exactness issue. The M1 result is always correct, regardless of the “Rounding Mode” state.

Workaround: Do not use the PI data path in the “Decoder” software when computing M type points and when software-rounding is needed. Instead, use a routine consisting of regular C55x instruction combinations. This routine must be called from the point where the one using PI HWA instructions is and should take the same parameters and data organization. Hence, the new routine should perform following steps:
