**66AK2E05/02**  
**Multicore DSP+ARM KeyStone II SOC**  
**Silicon Revision 1.0**

# Silicon Errata

Literature Number: SPRZ417B  
May 2014–Revised August 2015

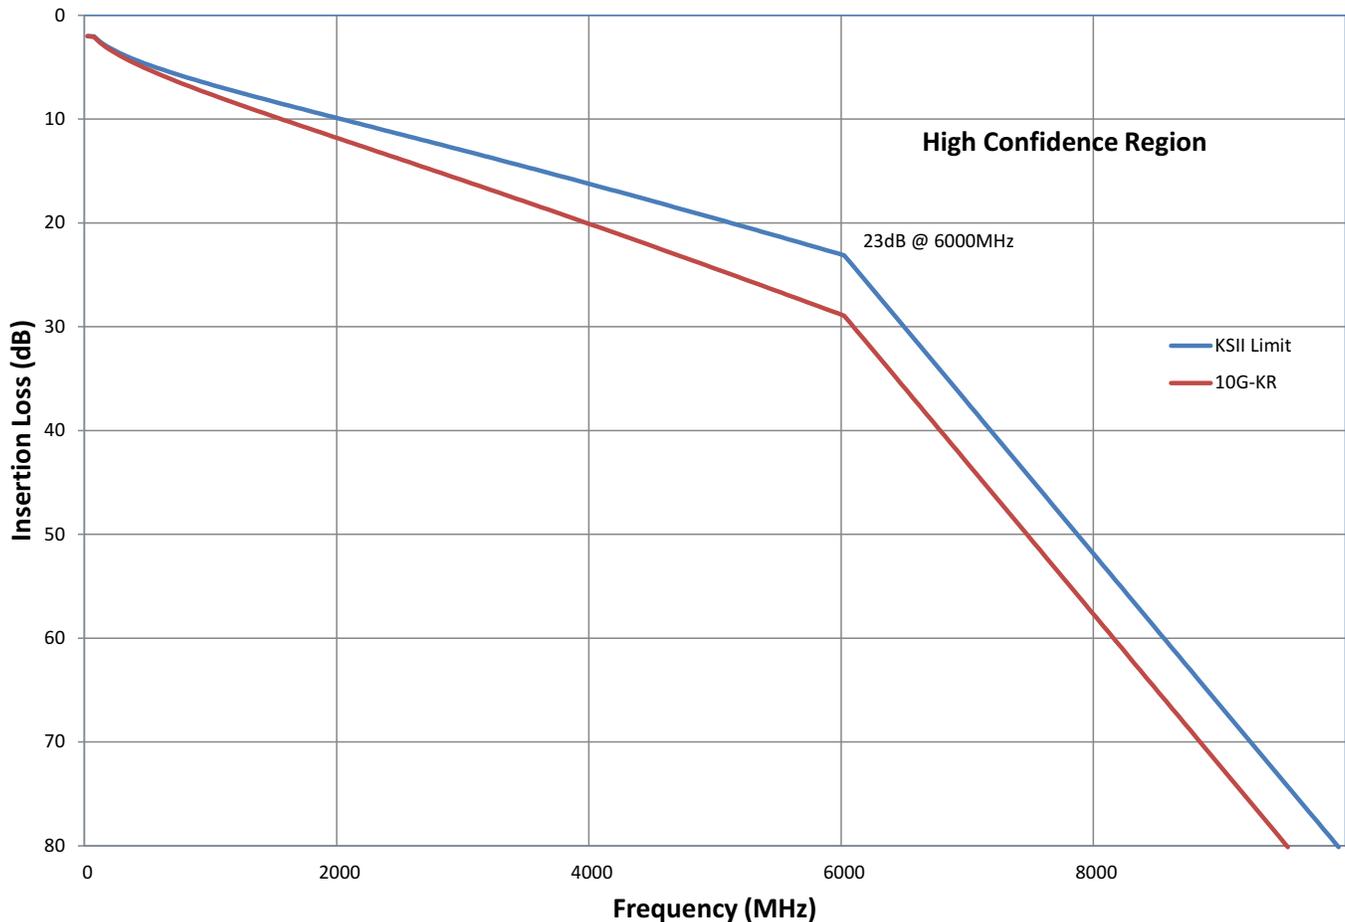
Device characterization has shown that bit error rate performance consistent with the 10GbE-KR standard as published in IEEE 802.3-2008 Annex 69B cannot be met across all device operating extremes. Production devices do operate at the required error rate across all rated operating conditions of voltage and temperature when the channel insertion loss is limited to 20dB at the Nyquist rate of 5.15625GHz. The figure below shows the Insertion Loss template from IEEE 802.3-2008 Annex 69B as well as the reduced Insertion Loss template.

**Workaround**      None.

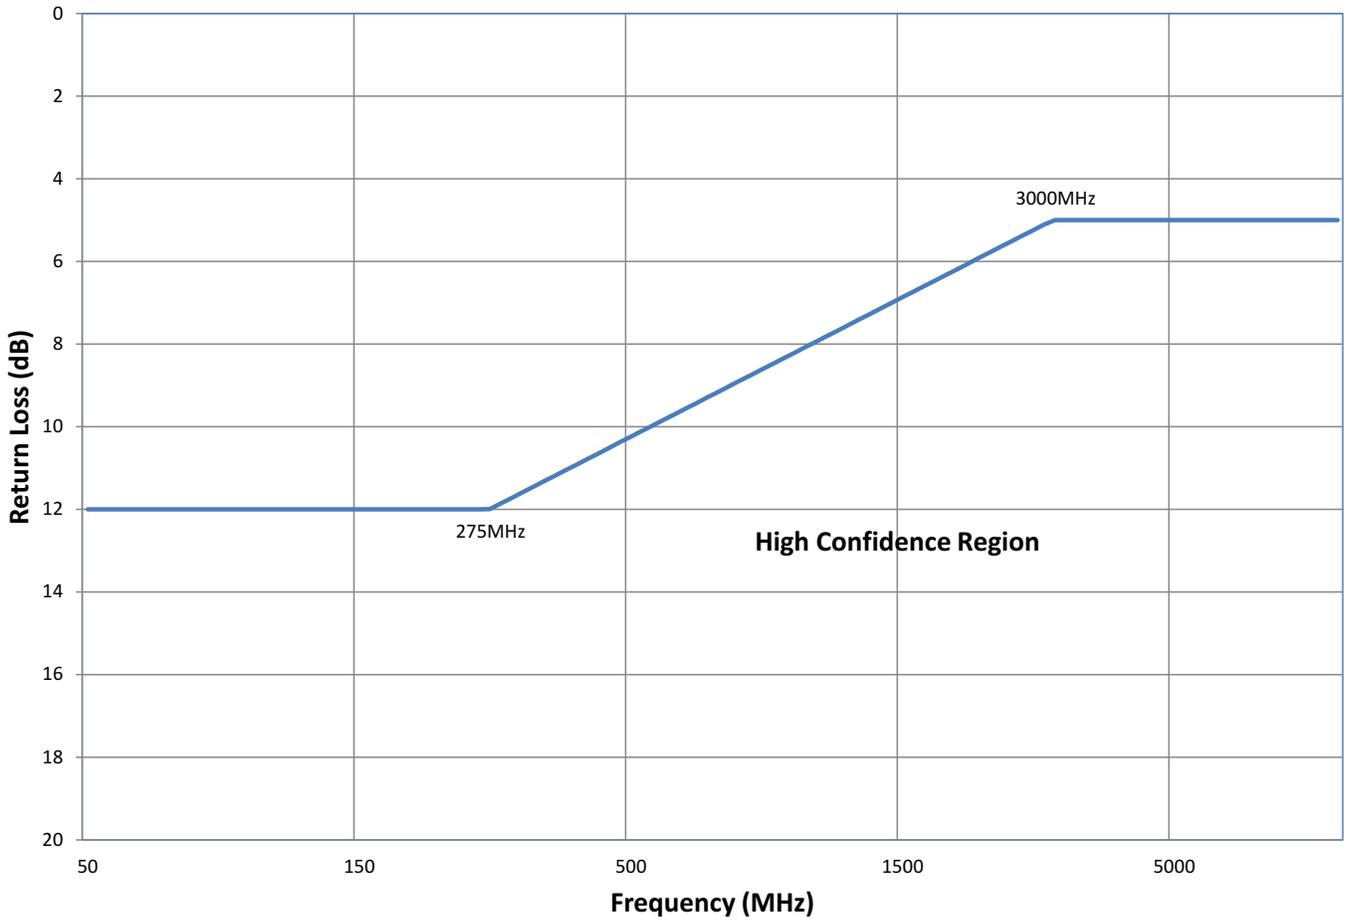
Characterization has shown that channels must also be compliant with the Return Loss template contained in the IEEE 802.3-2008 Annex 69B specification without modification. This is shown below for convenience.

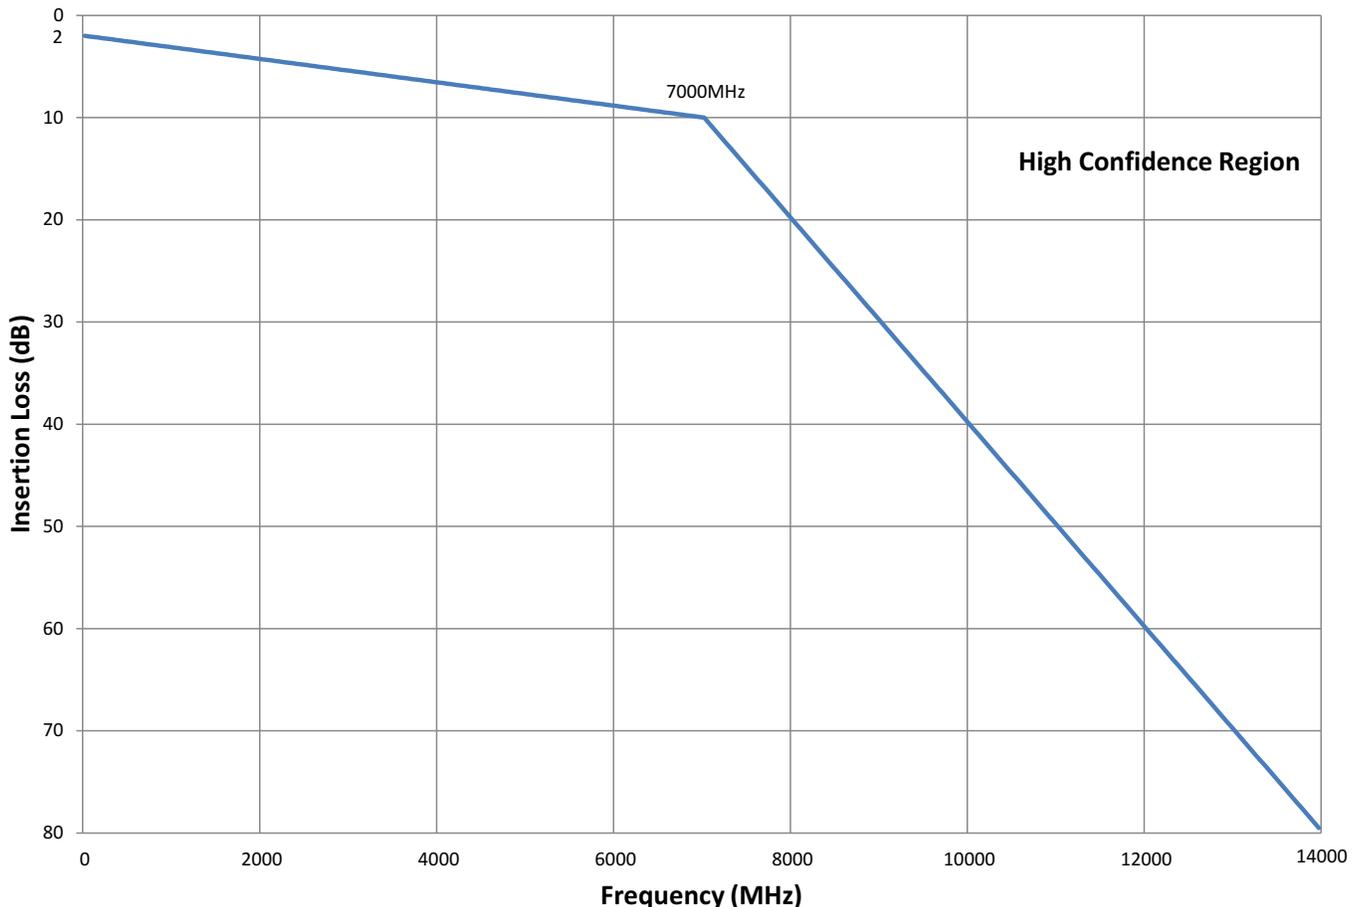
Device characterization has shown that expected bit error rate performance can only be met on layouts that meet constrained channel loss metrics. These can be examined by generating Insertion Loss and Return Loss graphs where loss is plotted versus frequency. Insertion Loss and Return Loss can be estimated during PCB layout using a 3D simulation tool. Insertion Loss and Return Loss should also be measured on early prototypes using a Vector Network Analyzer (VNA). Multiple PCB construction and layout enhancement techniques must be combined to achieve these channel performance requirements as stated in the KeyStone II SERDES User Guide.

An Insertion Loss measurement provides a composite view of the channel's loss versus frequency. Since HyperLink is a short-reach interface, channel loss is limited. Also, due to the high data rate, the Insertion Loss must be monotonic and without discontinuities that would degrade receiver operation. The template shown below provides Insertion Loss limits that will result in a robust channel. This template must be met for the entire channel from transmitter to receiver including the series capacitors.

**Workaround**      None.

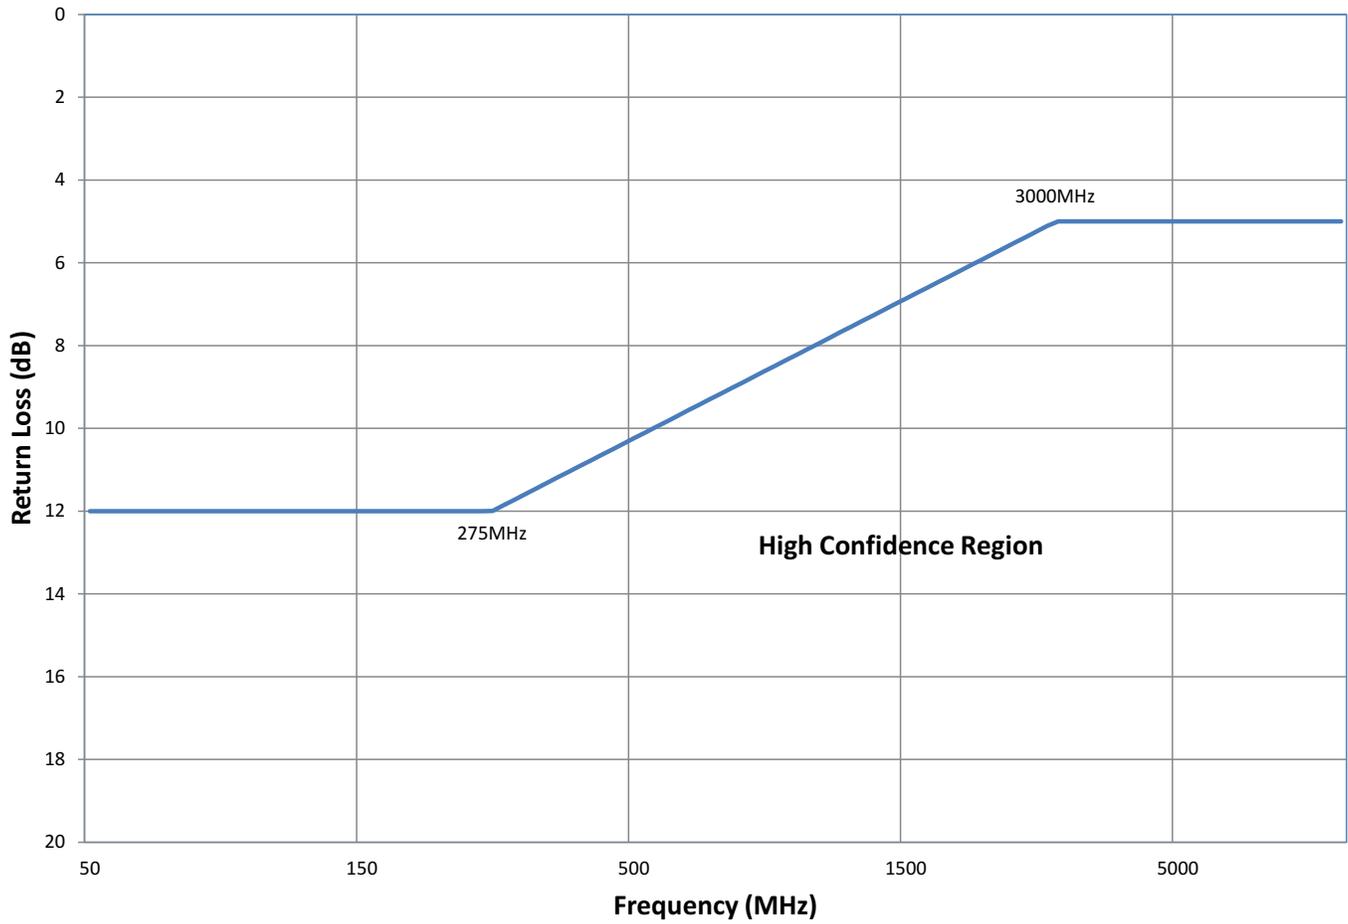
Device characterization has also shown that channels should be compliant with the Return Loss template shown below. The Return Loss measurement indicates the amount of energy reflected back to the source which is not available to the receiver. Impedance variation in the channel will cause reflected energy that can cause this template to be violated. Careful attention to PCB construction and layout must be followed to meet this requirement. This template must be met for the entire channel from transmitter to receiver including the series capacitors. Note that this is the same template

defined in IEEE 802.3-2008 Annex 69B specification for 10GbE.

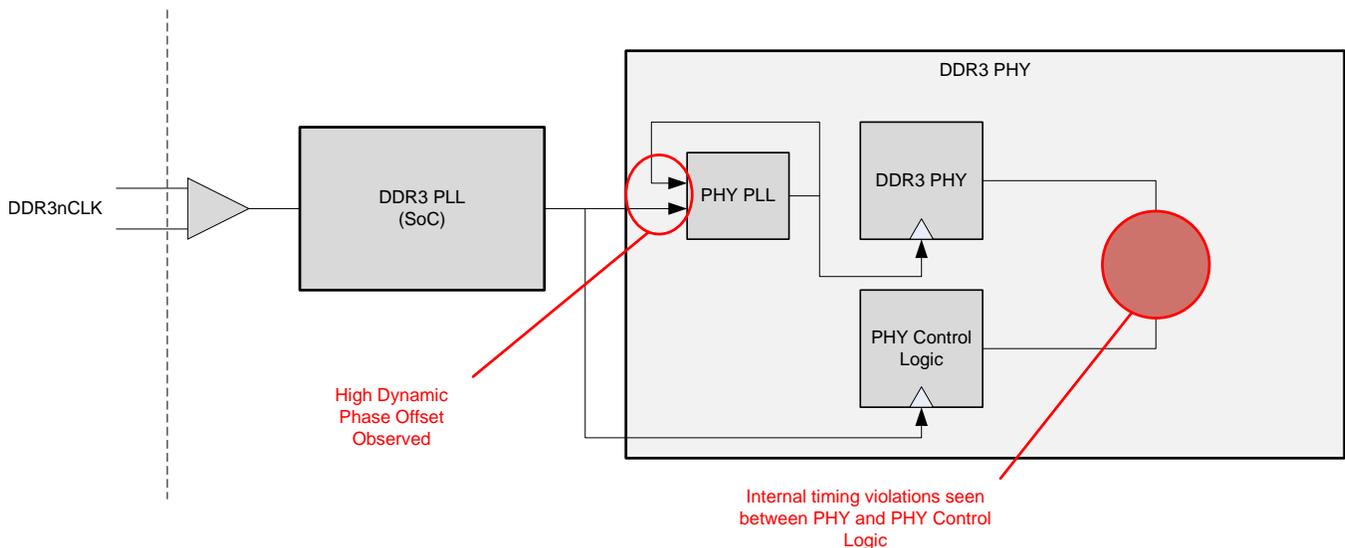
**Figure 2. DDR3 PHY**

DDR3 read operations may show errors due to increased levels of Dynamic Phase Offset (DPO) inside the DDR3 PHY. These errors are characterized by byte lane data corruption or intermittent bit errors. The byte lane data corruption can only be recovered using a device reset.

The DDR3 clocking architecture is illustrated in the figure below. The DDR3 reference clock input (DDR3nCLK) feeds the DDR3 SoC PLL, which outputs a clock to be used by the PHY Control Logic and provide an input to the PHY PLL.

The Dynamic Phase Offset (DPO) is a measure of the DDR3 PHY PLL’s ability to track rapid phase changes in the output of the DDR3 SoC PLL. High DPO can create internal timing violations between the DDR3 PHY and DDR3 PHY Control Logic and result in data errors during reads. As indicated by the shaded red circle in the figure above, the timing violations occur in the data transfer between the PHY and PHY control logic. It was determined that the root cause of the elevated DPO were SoC PLL and PHY PLL configurations that were non-optimized for the timing requirements of the system.

The workaround for this behavior is a change in the PLL configurations used for the DDR3 SoC PLL and the DDR3 PHY PLL. New configurations have been generated for DDR3-1600, DDR3-1333, DDR3-1066, and DDR3-800 operation and are presented in the tables below. Per field alert, "DDR3 Limited to Highest Data Rates Due to Possibility of PLL Instability During Temperature Changes after Startup", operation of DDR3-1066 and/or DDR3-800 is not recommended for affected Keystone2 devices in production systems

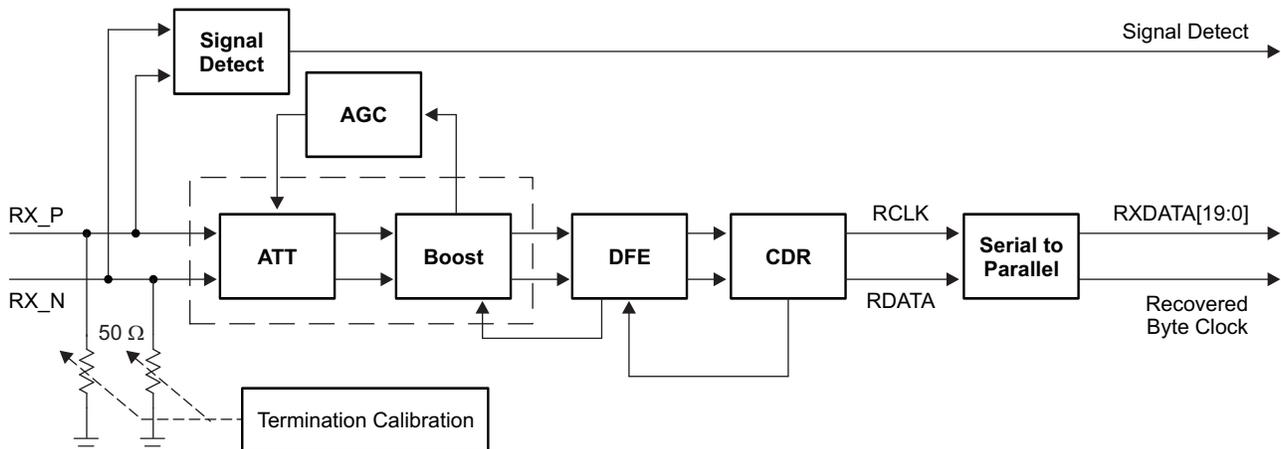
**Figure 3. RX Path Block Diagram**

**Details** The TI SerDes contains an adaptation algorithm that allows the RX equalization blocks to adapt their parameters to the SerDes data channel. The adaptation algorithm sets the optimal values for the ATT, BOOST, and DFE blocks in order to equalize the signal, maximize margin, and minimize channel distortion. For higher data rates (i.e. 5Gbps and greater), the high frequency gain provided by the BOOST block is generally considered necessary to compensate for the low-pass characteristics of data channels and widen the data eye.

The SerDes BOOST block was designed to require a specific set of patterns in order to best adapt its parameters to the channel. If these patterns are not found, the BOOST adaptation algorithm will not update the internal block settings and/or may incorrectly update these settings. The required data pattern is a series of six 0's followed by a 101 pattern. This pattern must occur numerous times on both odd and even bit alignments. This data pattern is not present in the 8b/10b coded symbols that are sent over many of the high speed peripheral links.

The recommended workaround is to not use the RX equalization auto-adaptation mechanism with the impacted interfaces at higher data rates. As an alternative, a user can hardcode the optimal ATT and BOOST values for their channel.

The optimal ATT and BOOST values found by one of the two above methods can be hardcoded into the SerDes upon initialization.
