TMS320F2838x Real-Time MCUs Silicon Errata

Silicon Revisions A, 0

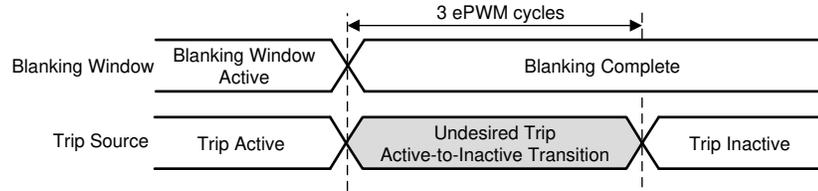
Figure 3-1. Undesired Trip Event and Blanking Window Expiration

The blanking window is typically used to mask any PWM trip events during transitions which would be false trips to the system. If an ePWM trip event remains active for less than three ePWM clocks after the end of the blanking window cycles, there can be an undesired glitch at the ePWM output.

Figure 3-1 illustrates the time period which could result in an undesired ePWM output.

Extend or reduce the blanking window to avoid any undesired trip action.
