**IWRL6432 Device Silicon Errata**

**Silicon Revisions 1.0 and 2.0**

**ABSTRACT**

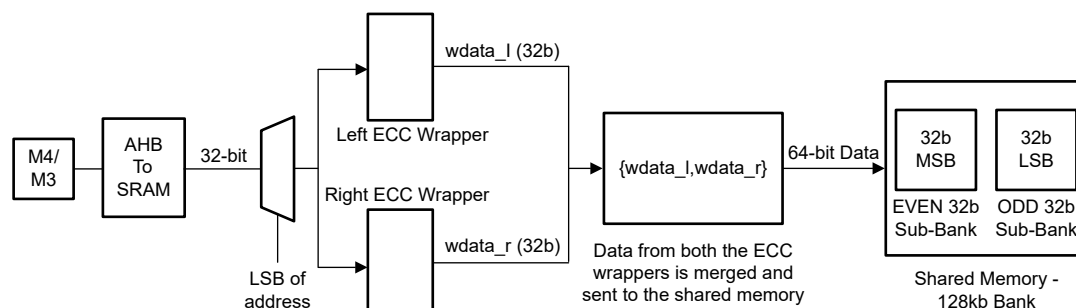
**Figure 5-1. Shared Memory Logic Diagram When Shared with M4/M3**

Internal shared memory has ODD and EVEN banking structure. For a particular address range, partial write (less than 32 bit) to EVEN bank corrupts same address of ODD bank with next data on the bus. When shared memory is allocated to M4/M3, back to back full word write access to location A followed by sub-word write access to location B corrupts data in location A.

When shared with M3/M4, the incoming data bit width is 32 bit as shown in the diagram. So, depending on LSB of address, signals are sent to either left or right ECC wrapper.

1. Use shared memories as code memory when shared with processor.
2. Disable ECC for non functional safety devices – ECC is disabled for shared memories in RBL for non functional safety devices.
