TMS570LC4x Microcontroller

Silicon Revision B

Silicon Errata

Literature Number: SPNZ232B
August 2015–Revised June 2018

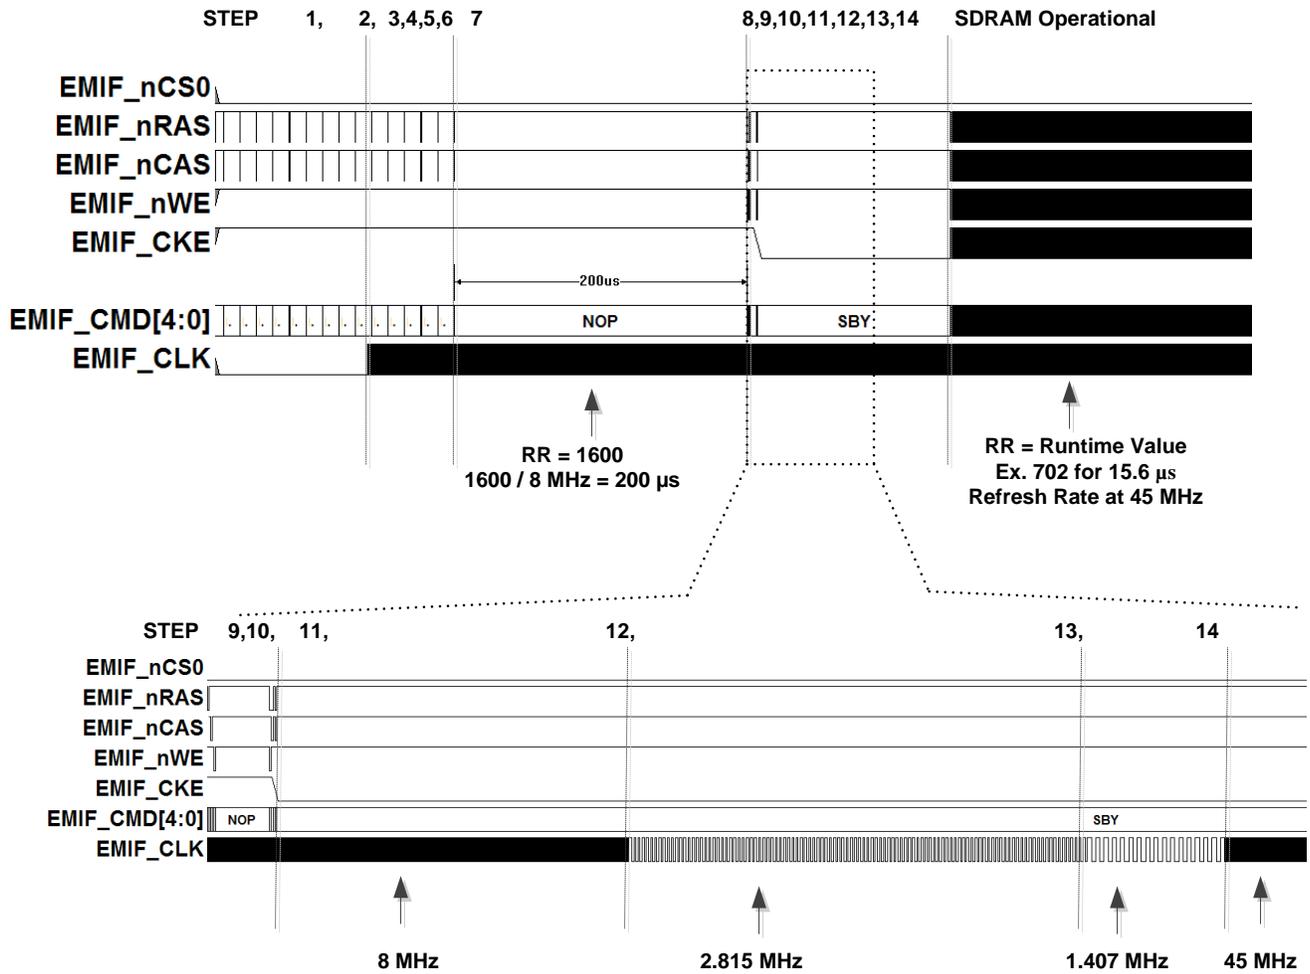
Figure 4. Correct SDRAM Initialization Procedure for Final EMIF Clock Frequency ≥ 40 MHz

Issue	Instead of issuing $8*RR$ NOP commands during initialization, the EMIF SDRAM controller only issues $1*RR$ NOP commands.
Conditions	This problem is a fundamental limitation in the EMIF module.
Implications	<p>The impact is dependent on the particular SDRAM device that is being used with the EMIF module. In many cases there will be no apparent issue even when the SDRAM specification is violated. Therefore, check and, if necessary, correct this problem even if no SDRAM-related issues have been observed.</p> <p>There are two possible implications to the delay of $1*RR$ instead of $8*RR$:</p> <ul style="list-style-type: none"> • For systems operating with an EMIF clock frequency < 40 MHz, the RR counter value computed by software may be too small if the calculation was originally based on an $8*RR$ EMIF clock cycle delay. • For systems operating with an EMIF clock frequency \geq 40 MHz, the RR counter value does not have the range necessary to create a 200-μs delay.

[Figure 4](#) shows EMIF activity as the preceding device initialization sequence is performed, assuming an OSCIN frequency of 16.0 MHz and a PLL frequency of 180 MHz.

This list consists of only the steps that are related to proper SDRAM initialization; it is not a comprehensive list of device initialization steps. Many other steps in the device initialization can be performed before [Step 1](#) and between [Step 1](#) and [Step 2](#). However, [Step 2](#) through [Step 14](#) should be performed as a sequence without introducing any other initialization steps between them. Following this recommendation reduces the risk of unrelated EMIF activity (including activity on the asynchronous chip selects) during the critical time when the SDRAM is in the self-refresh (SBY) state and the EMIF clock is being switched.

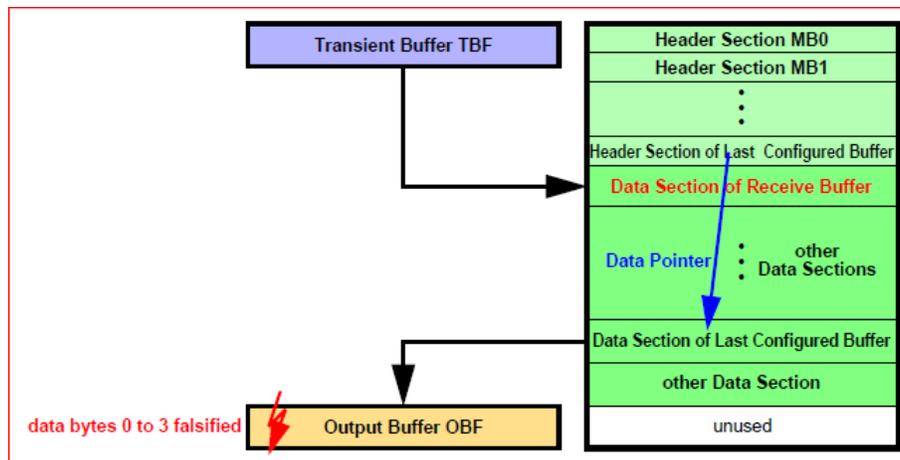
Figure 5. First Fail Mode

- 1) When a message is transferred from the Last Configured Buffer in the Message RAM to the OBF and PLC = 127 it may happen, that at the end of the transfer the OBF word on address 00h (payload data bytes 0 to 3) is overwritten with unexpected data (see Figure 5).

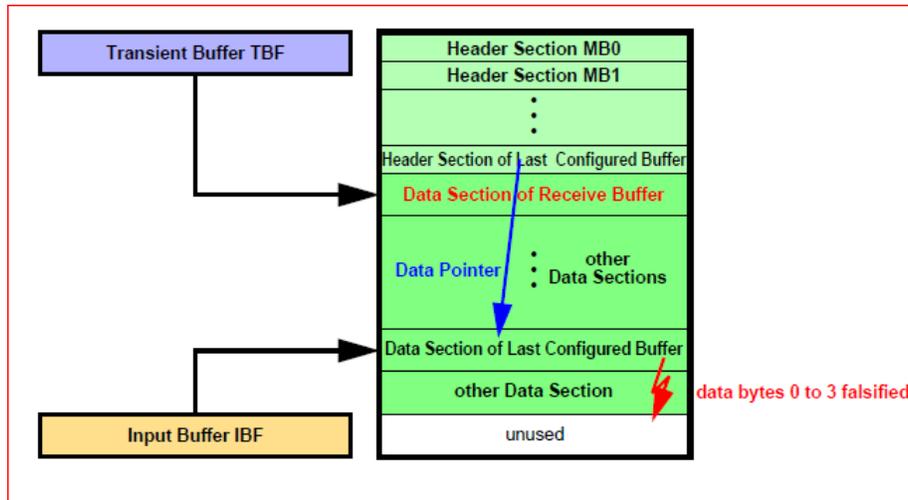
Figure 6. Second Fail Mode

- 2) When a message is transferred from IBF to the Last Configured Buffer in the Message RAM, it may happen, that at the end of the transfer of the Data Section one additional write access overwrites the following word, which may be the first word of another message's Data Section in the Message RAM (see Figure 6).
