**TMS320C6727, TMS320C6727B,
TMS320C6726, TMS320C6726B,
TMS320C6722, TMS320C6722B,
TMS320C6720
Digital Signal Processors
Silicon Errata**

Silicon Revisions 1.2, 1.1, 1.0

SPRZ232F
July 2005
Revised October 2008

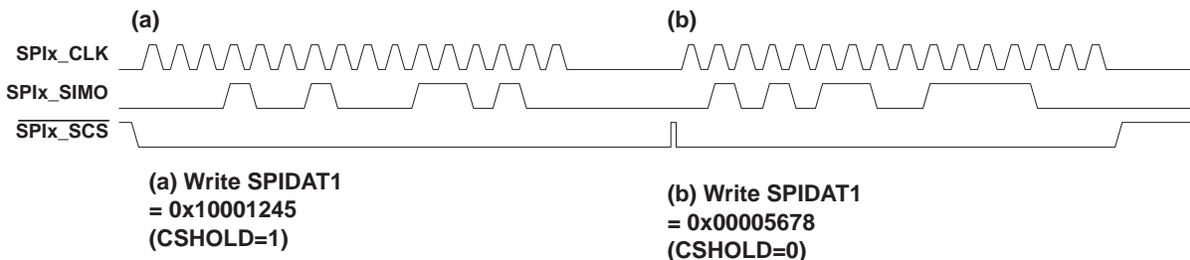
Figure 3. Actual CSHOLD Behavior—32-Bit Writes to SPIDAT1

Instead, what actually occurs is that $\overline{\text{SPIx_SCS}}$ is momentarily de-asserted at the beginning of the second write, as illustrated in Figure 3.

For each word in the sequence of words during which $\overline{\text{SPIx_SCS}}$ should be held low, write to the SPIDAT1 register with the CSHOLD bit set to '1'. Follow this by a write to only the CSHOLD field of SPIDAT1, setting CSHOLD = 0 to de-assert $\overline{\text{SPIx_SCS}}$. See Figure 5 for an illustration.

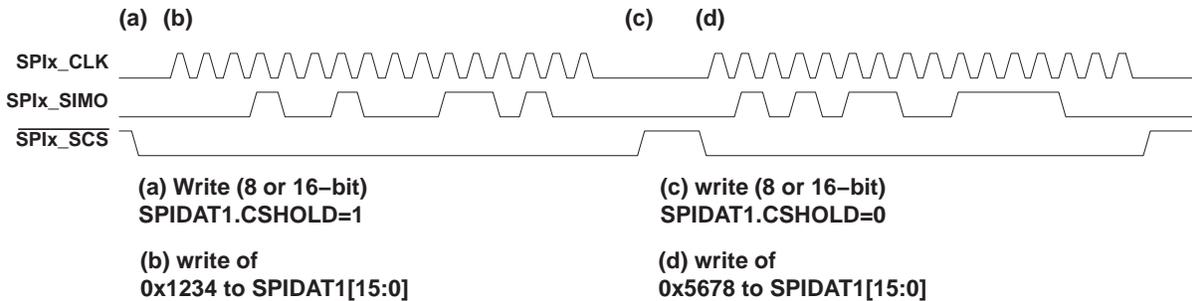
Figure 4. Actual CSHOLD Behavior—32-Bit Writes to SPIDAT1

Both Figure 2 and Figure 3 assume that SPIDAT1 is written using a single 32-bit write instruction. If SPIDAT1 is instead written using an 8-bit or 16-bit instruction to write to the CSHOLD field, followed by a 16-bit write to the transmit shift register field of SPIDAT1, then what actually occurs is illustrated in Figure 4. This is the same case as illustrated in Figure 3 except that the de-assertion of $\overline{\text{SPIx_SCS}}$ lasts for the duration between writing to a '0' to the CSHOLD field and writing new data to the transmit shift register.

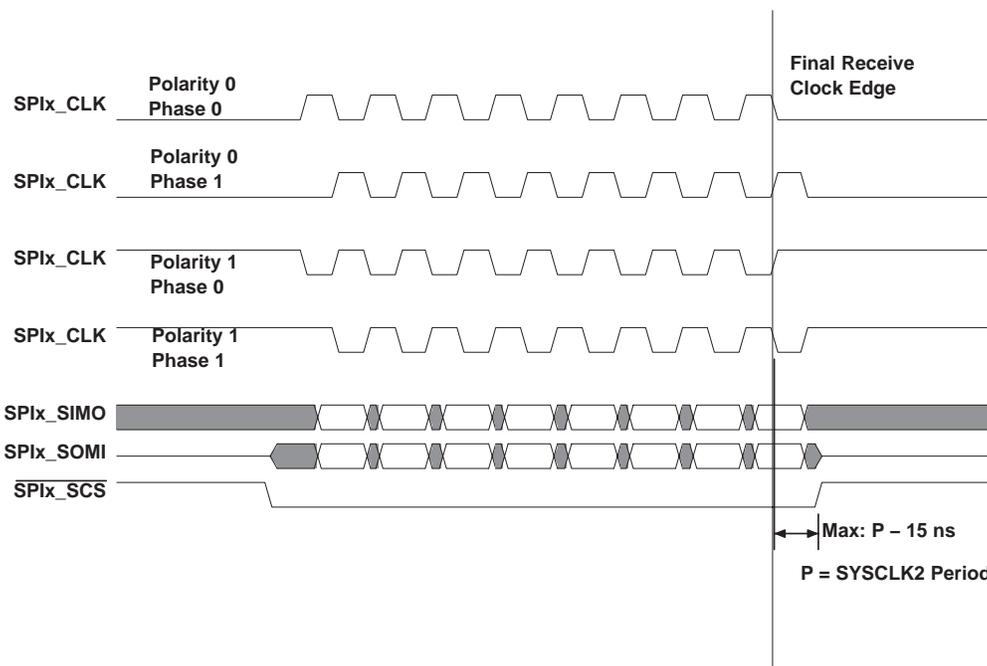
Figure 7. Timing Requirement of $\overline{\text{SPIx_SCS}}$ De-assertion in Four-Pin With Chip-Select Mode

Figure 7 illustrates the timing requirement on the de-assertion of the $\overline{\text{SPIx_SCS}}$ pin in the four-pin with chip-select mode. If the master does not meet this requirement, the slave will enter the transfer state again and receive the next word transferred on the SPI bus as well as consume any data already written to the transmit buffer.

Note that in most cases, the device system clock (P) is between 6 ns to 8 ns and the delay is negative. This means the master must actually de-assert the $\overline{\text{SPIx_SCS}}$ pin before the final receive clock edge. But the slave also 3-states its SPIx_SOMI output when $\overline{\text{SPIx_SCS}}$ is de-asserted, so the master may not be able to receive the final data bit correctly if it de-asserts $\overline{\text{SPIx_SCS}}$ early. (Timing requirements of SPI master devices vary; so, consult the data sheet of the particular master.)

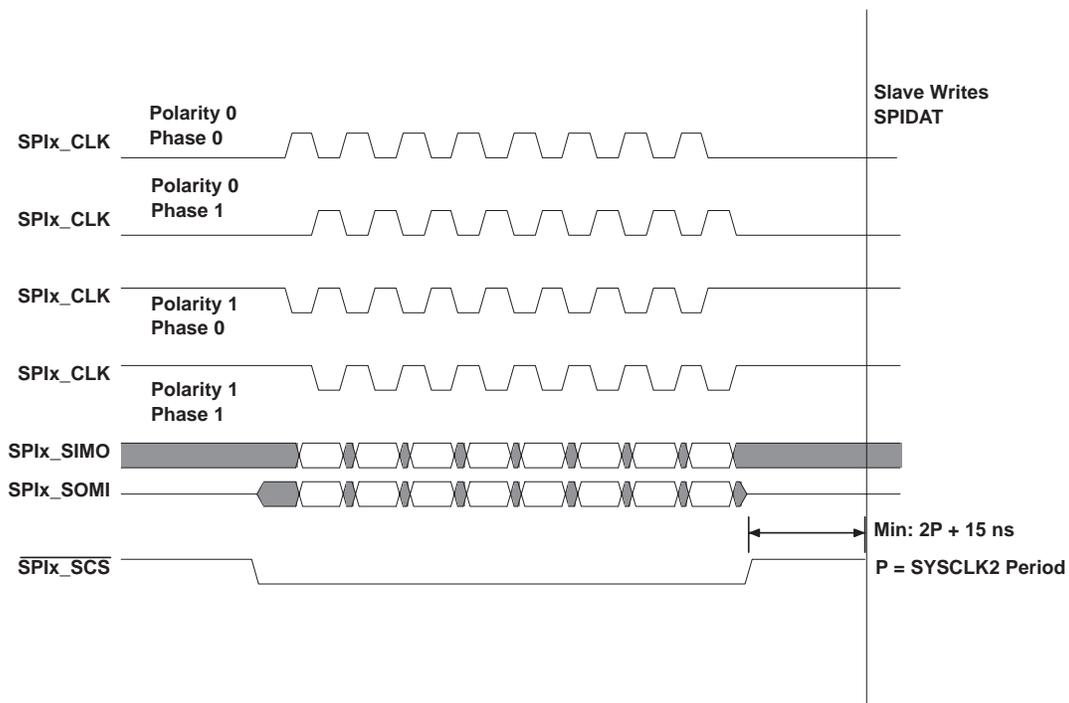
Figure 8. Timing Requirement of $\overline{\text{SPIx_SCS}}$ De-assertion in Five-Pin Mode

Figure 8 illustrates the timing requirement on the de-assertion of $\overline{\text{SPIx_SCS}}$ in five-pin mode. The timing requirements of this mode are looser than those in the four-pin with chip-select mode.

In five-pin mode, the slave delays entering the transfer state until $\overline{\text{SPIx_SCS}}$ is asserted and the transmit buffer (SPIDAT0 or SPIDAT1) has been written with data for the next transfer. This provides additional time for the master to de-assert $\overline{\text{SPIx_SCS}}$. As long as the master de-asserts $\overline{\text{SPIx_SCS}}$ $2P + 15 \text{ ns}$ before the slave writes to SPIDAT0 or SPIDAT1, the slave will not enter the transfer state until $\overline{\text{SPIx_SCS}}$ is asserted again, and the erroneous transfer may be avoided.

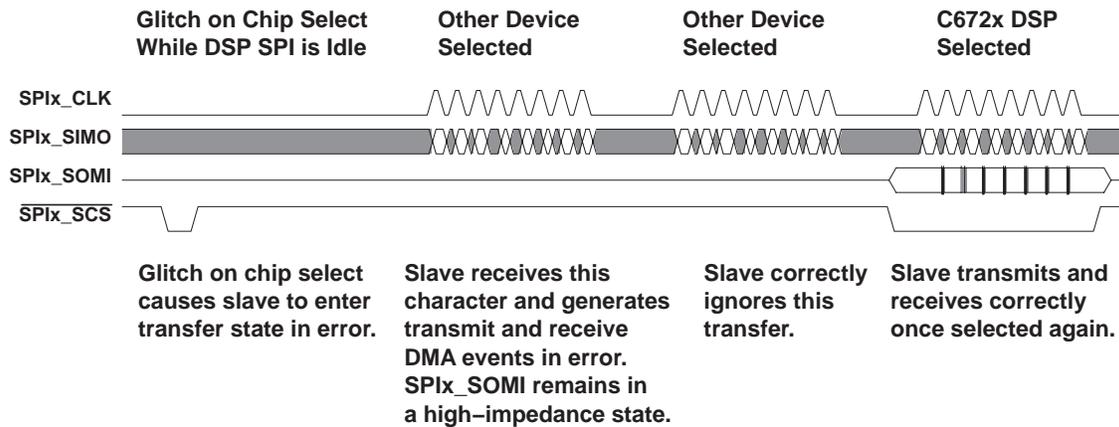
Figure 9. Glitch on Chip Select Causing Erroneous Transfer

The second most common reason for an erroneous transfer is a glitch on the $\overline{\text{SPIx_SCS}}$ pin while the slave SPI is idling between transfers. Since the slave SPI samples $\overline{\text{SPIx_SCS}}$ using SYSCLK2, any low-going glitch that lasts longer than a SYSCLK2 period will cause the SPI slave to enter the transfer state. Additionally, any glitch that is shorter than a SYSCLK2 period may still cause the SPI slave to enter the transfer state; but in this case, it depends upon whether or not the slave captures the glitch.

Figure 9 illustrates the case where the slave SPI captures a glitch on the chip-select line and enters the transfer state erroneously. If transfers to another slave device follow this event, then the C672x slave will erroneously receive the first character transmitted to the other selected slave device. Since $\overline{\text{SPIx_SCS}}$ is de-asserted, the C672x SPI holds its SPIx_SOMI pin in a high-impedance state and does not interfere with the data transmitted back to the SPI bus master by the selected slave device. After the erroneous transfer completes, the slave remains idle until the next assertion of SPIx_SCS . (See Figure 11 for the case where there are not enough clocks to complete the erroneous transfer.)

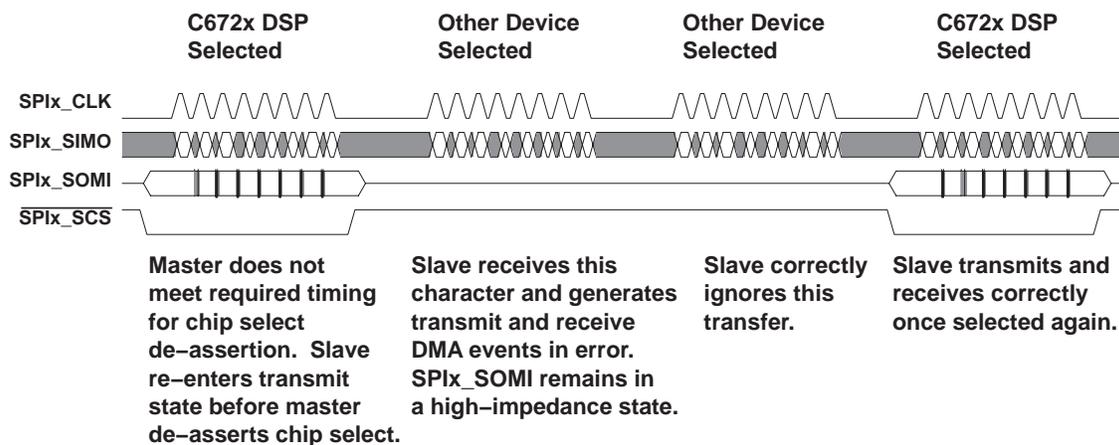
Figure 10. Erroneous Transfer Due to Master De-asserting Chip Select Late

Figure 10 illustrates almost the same case as Figure 9, except the slave device enters the transfer state due to the master failing to meet the timing requirements for de-assertion of the slave SPIx_SCS input following a valid transfer as illustrated in Figure 7 and Figure 8.

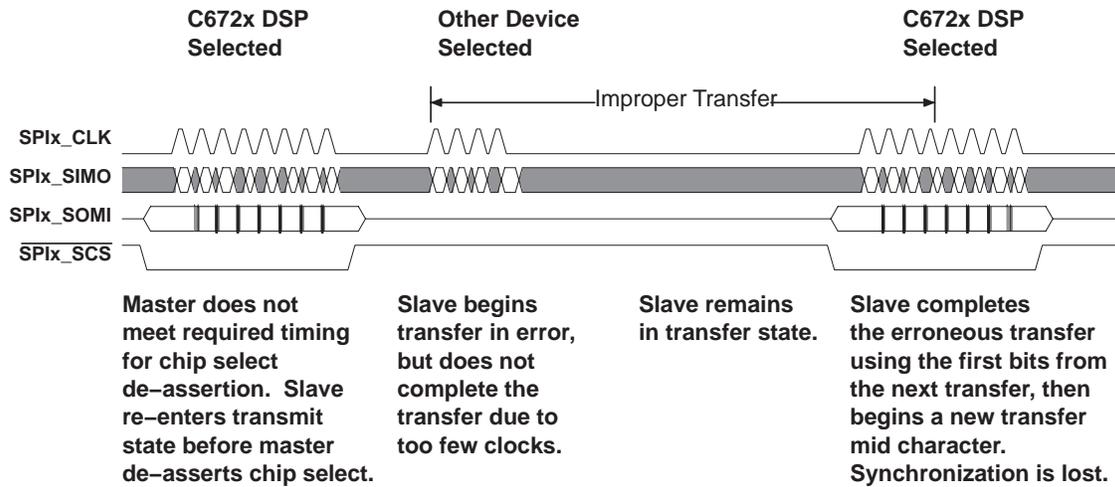
Figure 11. Loss of Synchronization to Character Boundary

Figure 11 illustrates the case where the slave enters the transfer state in error due to the master de-asserting $\overline{\text{SPI_SCS}}$ too late to meet the timing requirements. (Note: the same issue applies if the slave device enters the transfer state due to a glitch on SPIx_SCS .) If there are not enough clocks for the completion of the erroneous transfer while the slave is deselected, the slave will remain in the transfer state. When selected, the slave will first complete the erroneous transfer using the first bits from the valid transfer. The slave then begins another transfer in the middle of the valid transfer, and synchronization to the master is lost. Data received while synchronization is lost will be invalid.

The slave will regain synchronization only after $\overline{\text{SPIx_SCS}}$ is de-asserted and there is a sufficient number of clocks on to allow the slave to complete an invalid transfer and enter the idle state before the master asserts SPIx_SCS again.

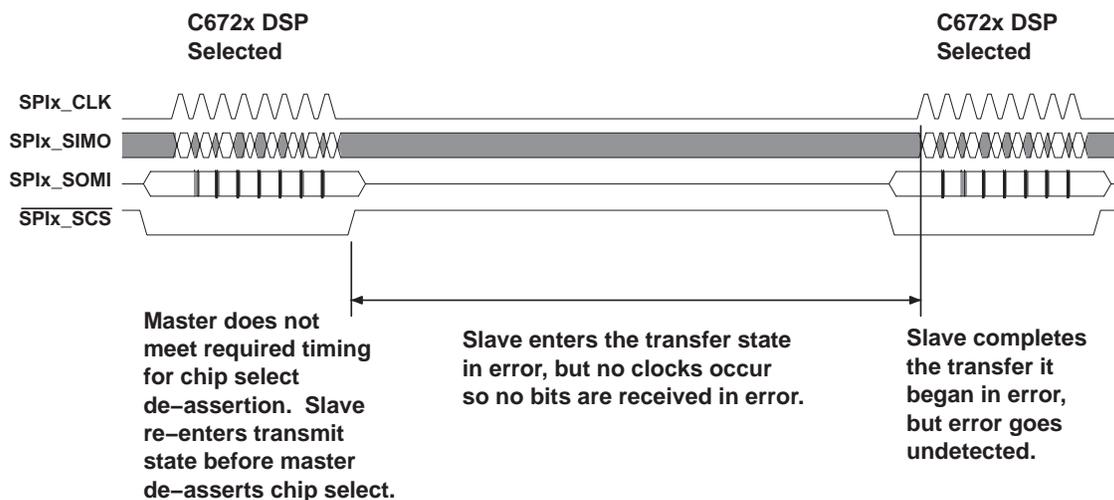
Figure 12. Slave Enters Transfer State in Error, but Error Goes Undetected

Figure 12 illustrates the case where the slave enters the transfer state in error due to the master de-asserting $\overline{\text{SPI_SCS}}$ too late to meet the timing requirements. (Note: the same issue applies if the slave device enters the transfer state due to a glitch on SPIx_SCS .)

If there are no clocks on the slave SPIx_CLK line while $\overline{\text{SPIx_SCS}}$ is de-asserted, then even though the slave is in the transfer state during this time period, no shifting occurs. This means that when the master selects the slave again for another transfer, this transfer will complete correctly. In four-pin mode, the error would go undetected. In five-pin mode, only SPIx_ENA remains a problem (see Figure 13).

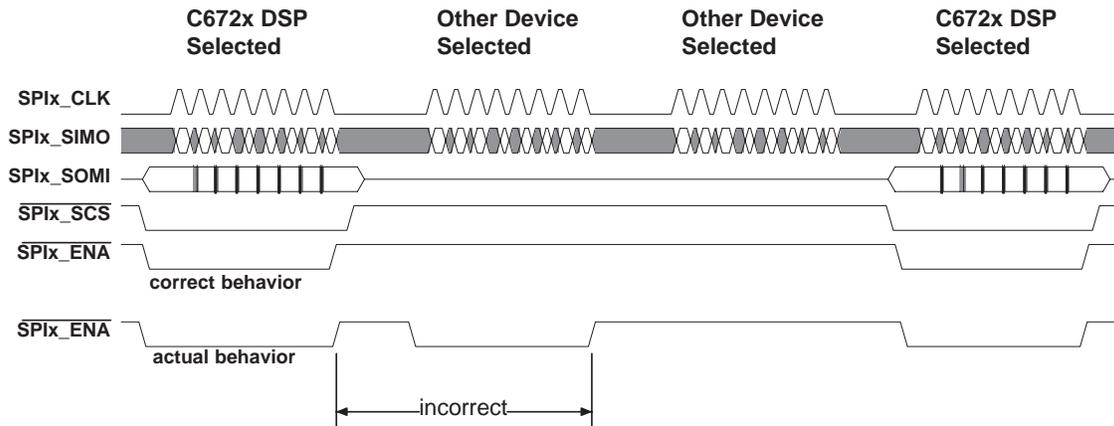
Figure 13. Slave Drives Enable Line Incorrectly During the Time it is in the Transfer State Erroneously

This will typically only cause a problem when sharing SPIx_ENA, since the de-selected slave may force the enable line to indicate ready even if the slave actually selected is not ready.

Note that Figure 13 illustrates the case where SPIINT0.ENABLEHIGHZ has been set to drive the SPIx_ENA pin in a push-pull mode. However, the same issue applies when configuring SPIINT0.ENABLEHIGHZ for open-drain mode, except instead of driving SPIx_ENA high as shown in Figure 13, the slave places the pin in a high-impedance state to de-assert SPIx_ENA.

The slave indicates its actual ready state while it is in the transfer state, even if it is in the transfer state in error due to the issues sampling chip select. This behavior is incorrect.

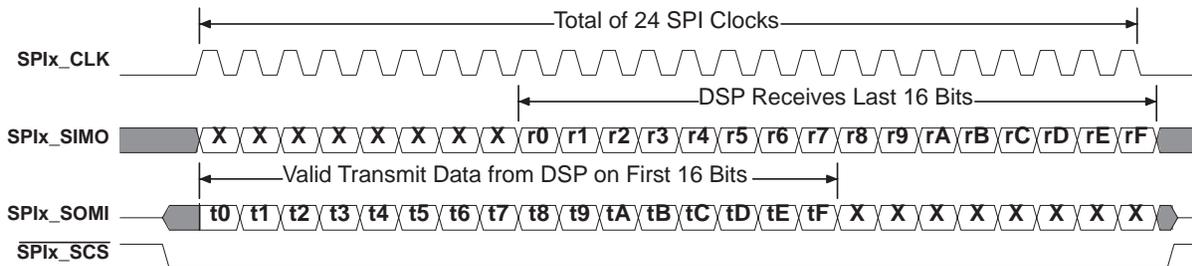
Figure 15. Slave SPI Operation With Character Length of 24 Bits

Figure 15 illustrates the operation of the SPI module in 3-pin mode with SPIFMT0.CHARLEN[4:0] programmed with a value greater than 0x10. In this case, the value of this field is 0x18 for a character length of 24 bits. This means that the slave SPI requires 24 clocks on SPIx_CLK to complete a single transfer. However, from an internal viewpoint, the slave only writes one 16-bit word to SPIDAT0/SPIDAT1 at the beginning of the transfer and only reads one 16-bit word from SPIBUF at the end of the transfer. As illustrated in Figure 15, the data written to SPIDAT0/SPIDAT1 will appear on the SPIx_SOMI pin during the first 16 SPI clock periods, followed by 8 indeterminate bits. Also, the data received in the SPIBUF register is the last 16 bits that appear on the SPIx_SIMO pin. The first 8 bits are shifted in but eventually discarded by the slave.

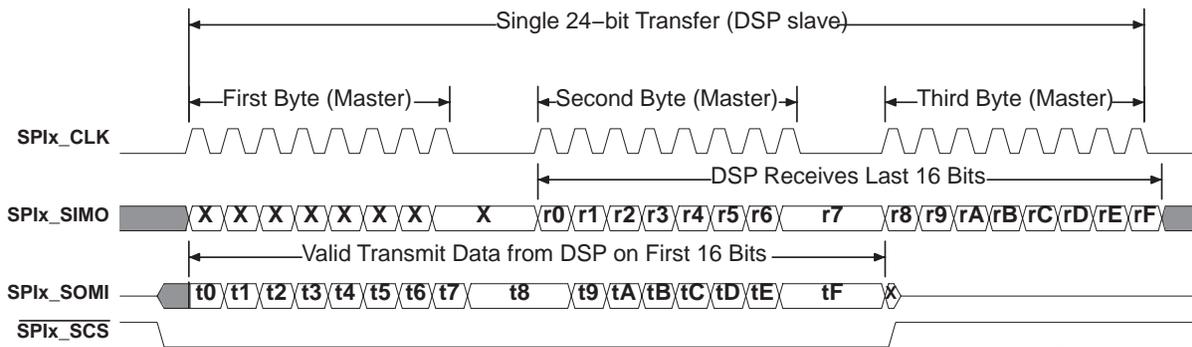
Master de-asserts chip select at the end of its second byte.

Advisory 1.1.2 issue now occurs at the end of the 24th bit. SPIx_SOMI is a don't care here.

Figure 16 illustrates the suggested workaround sequence, assuming that the SPI master is a microcontroller using an 8-bit character length.

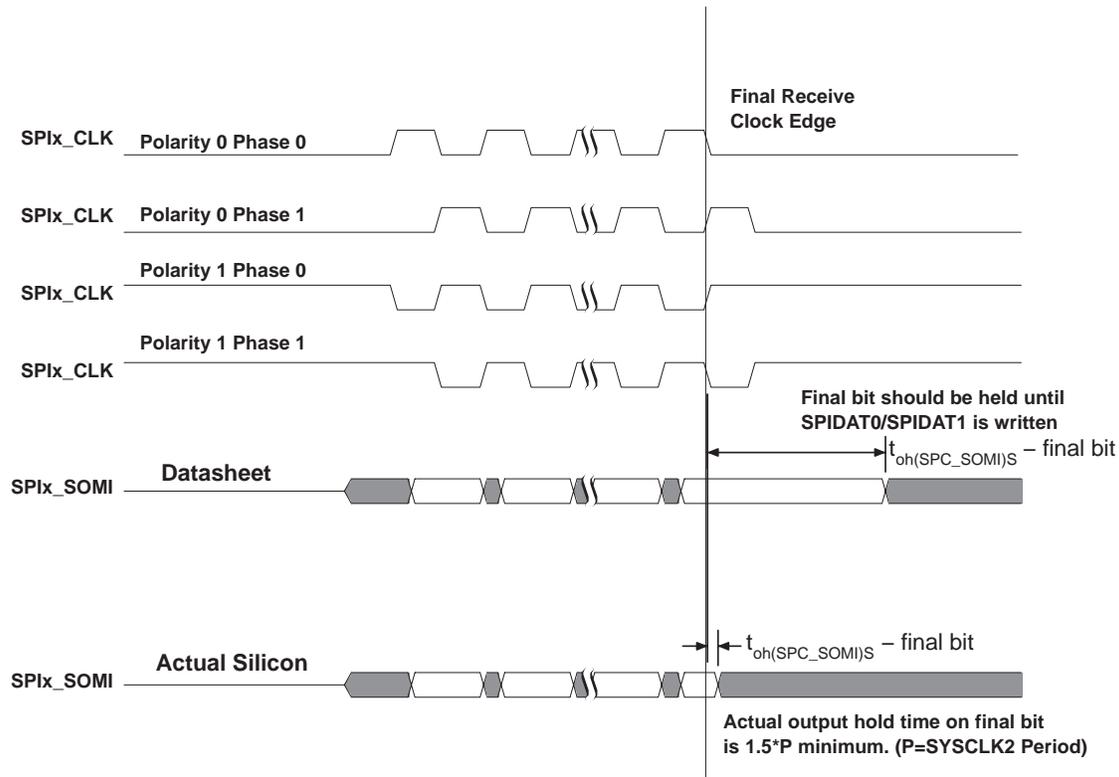
Figure 17. Actual Output Hold Time on Slave SPIx_SOMI Final Bit Versus Data Sheet

For the C672x device, this time is $1.5 \cdot \text{SYSCLK2}$ periods. With a typical SYSCLK2 period of 8 ns (based on 250-MHz SYSCLK1 and 125-MHz SYSCLK2), the resulting output hold time is only 12 ns.

Figure 17 illustrates the data sheet specification for the output hold time on the final bit (for the SPI in slave mode) versus the hold time on actual silicon.

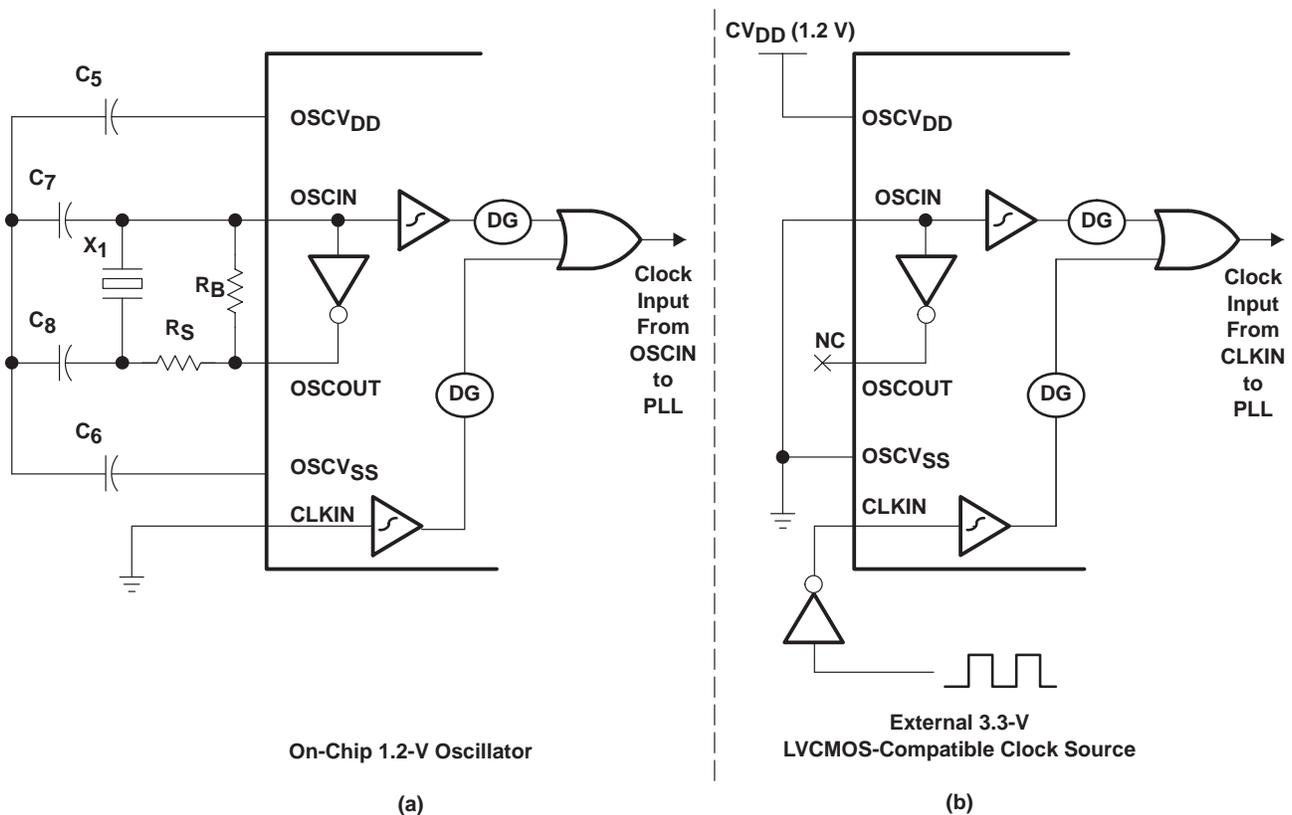
Figure 19. OSCIN and CLKIN Input Paths

The most noticeable indicator of this problem is the lack of any I/O activity after power up (except for the crystal oscillator which is not affected). Specifically, the EM_CLK output pin does not toggle when this problem occurs.

Both the OSCIN and CLKIN paths of the C672x include a special de-glitch cell (labeled “DG” in Figure 19). The de-glitch cell is designed to filter out short glitches that might occur due to system-level noise and to prevent these glitches from disturbing the PLL during normal operation, improving the robustness of the C672x devices.

However, the de-glitch cell on Revision 1.0 of the C672x devices has a defect that can leave its output in an uninitialized state until an edge appears on its input.

Note that the de-glitch circuit is not initialized by the C672x $\overline{\text{RESET}}$ pin, so that once the C672x powers up in a bad state, the only way to clear the state is to cycle power again. Even cycling power again may not clear the condition.
