66AK2Hxx
Multicore DSP+ARM KeyStone II SOC
Silicon Revisions 1.0, 1.1, 2.0, 3.0, 3.1

Silicon Errata

Literature Number: SPRZ402F
June 2013–Revised June 2018

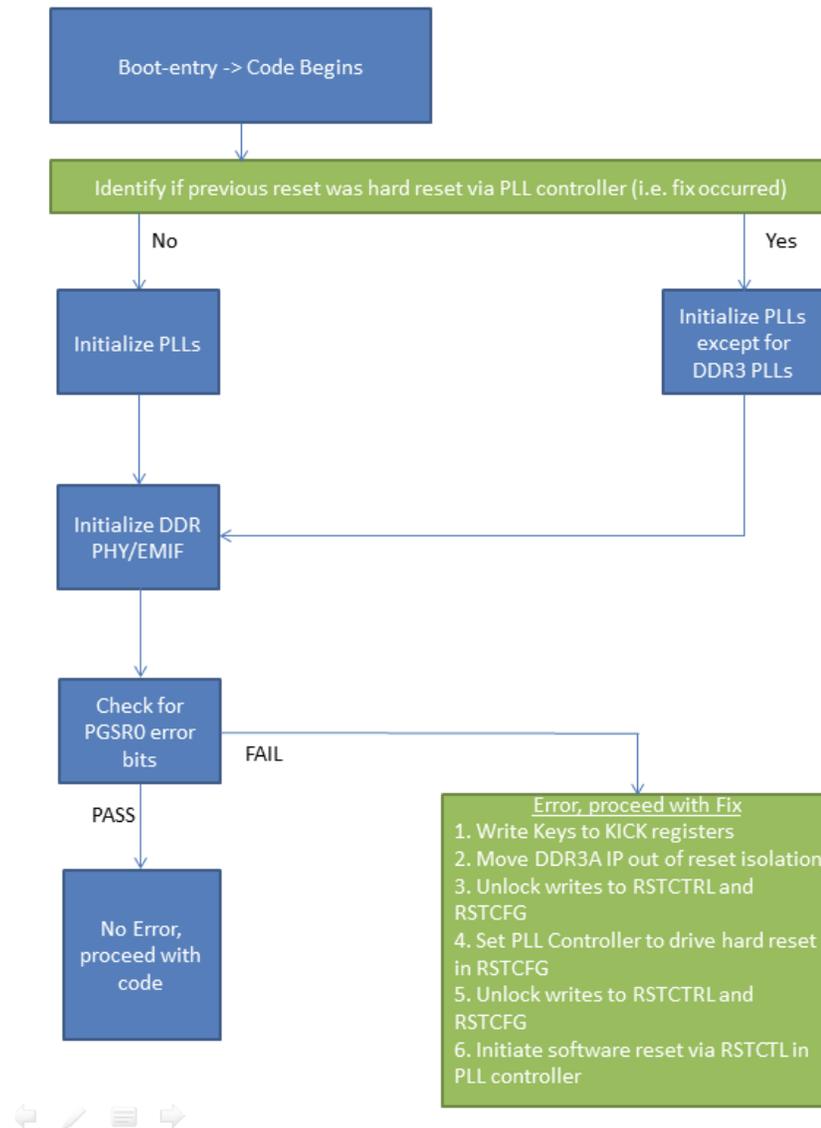
Figure 3. Software Reset Using the RSTCTRL Register

DDR Read/Write errors are reported after DDR initialization for <1% of power-on resets. When executing UBOOT from the MCSDK, this results in DDR POST (Power On Self Test) failure.

Sometimes DDR initialization fails with leveling errors (reported in DDR PHY status registers). Once the leveling errors are reported, DDR read/write operations fail. This issue happens only during initialization time and cannot occur during runtime. This issue occurs irrespective of the operating frequency of the device and is also independent of the operating frequency of the DDR. This issue is applicable for both DDR3A and DDR3B. ROM Boot modes supporting initialization of, and booting to DDR can fail due to this issue. Below is the list of boot modes for which ROM Bootloader performs DDR configuration (only if boot image is required to be stored in DDR):

The root cause is identified to an issue that happens after the very first DDR3 PHY initialization, this first initialization happens directly from Power-on reset. The issue occurs because the clocking requirements of the DDR3 PHY are not met on the first initialization, this happens because the DDR3A and DDR3B SoC PLLs are not yet programmed to provide the requisite clock. There is a ratio requirement between the DDR3A/B PHY clocks and the core configuration clock, such that the core configuration clock must be less than or equal to the PHY clock. These clocks are asynchronous and the PHY support an asynchronous FIFO scheme with limited depth on the PHY clock domain. If the ratio requirement is not met then FIFO can overflow. This would mean that the configuration data for the PHY may be lost during the initialization sequence. Experiments have proven that if we apply Hard Reset once the clocking has been set up correctly, the issue is resolved.

DDR read/write failures can be avoided by checking the DDR PHY status register for any Leveling errors at the end of DDR PHY Initialization. For boot modes using DDR, the workarounds below can be used as a part of second-stage boot only. Once the leveling errors are detected, one of the following workarounds can be used.

- *Software Reset using RSTCTRL register in PLL Controller*

BLUE colored blocks show the normal execution while the GREEN colored blocks show the changes. The “Error, proceed with Fix” block is the block which explains the steps that need to be followed to apply the Software Reset using RSTCTRL register. The steps are mentioned for DDR3A. The same steps need to be used for DDR3B also.

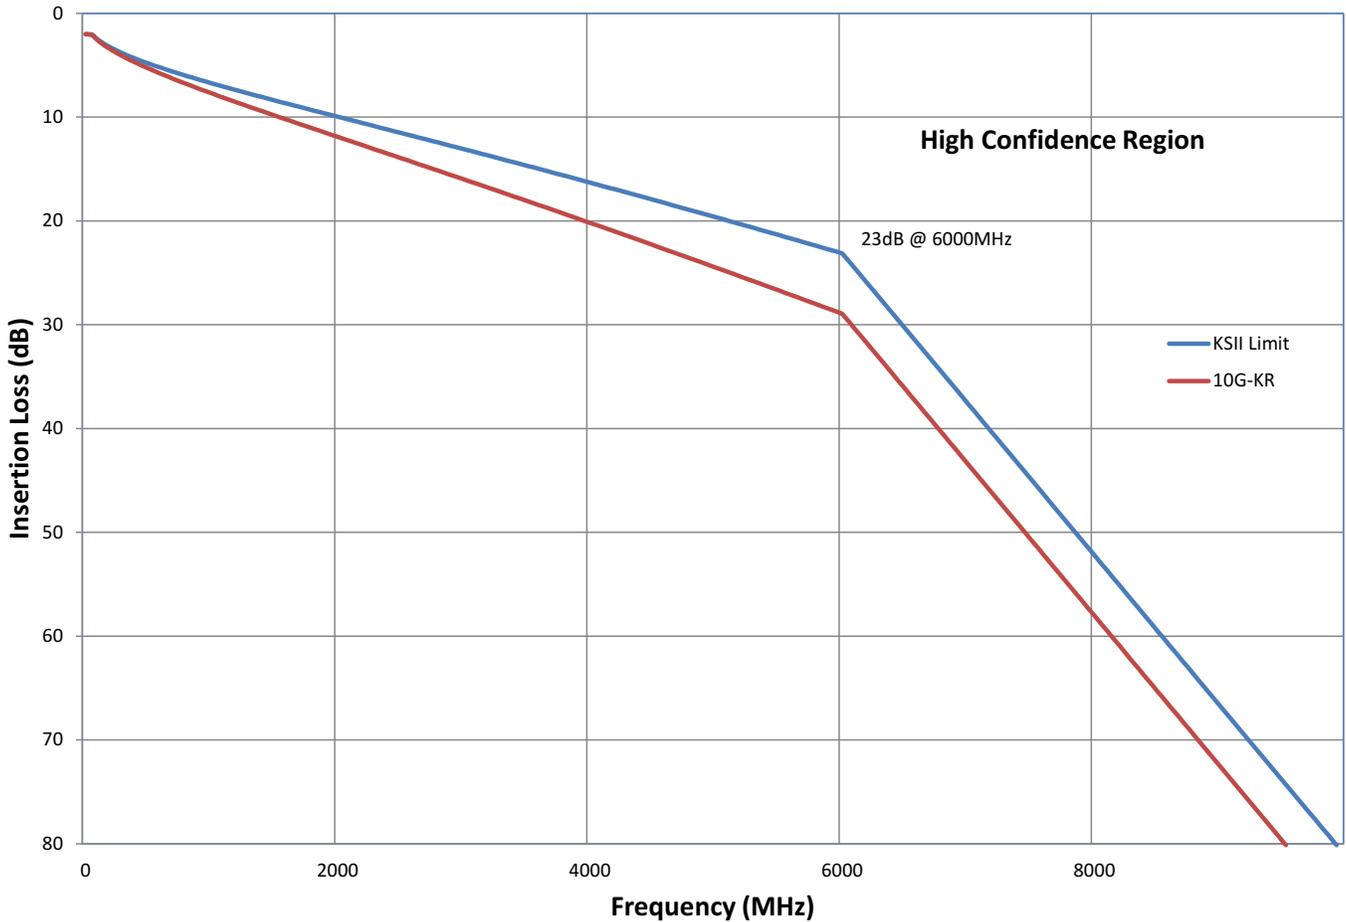
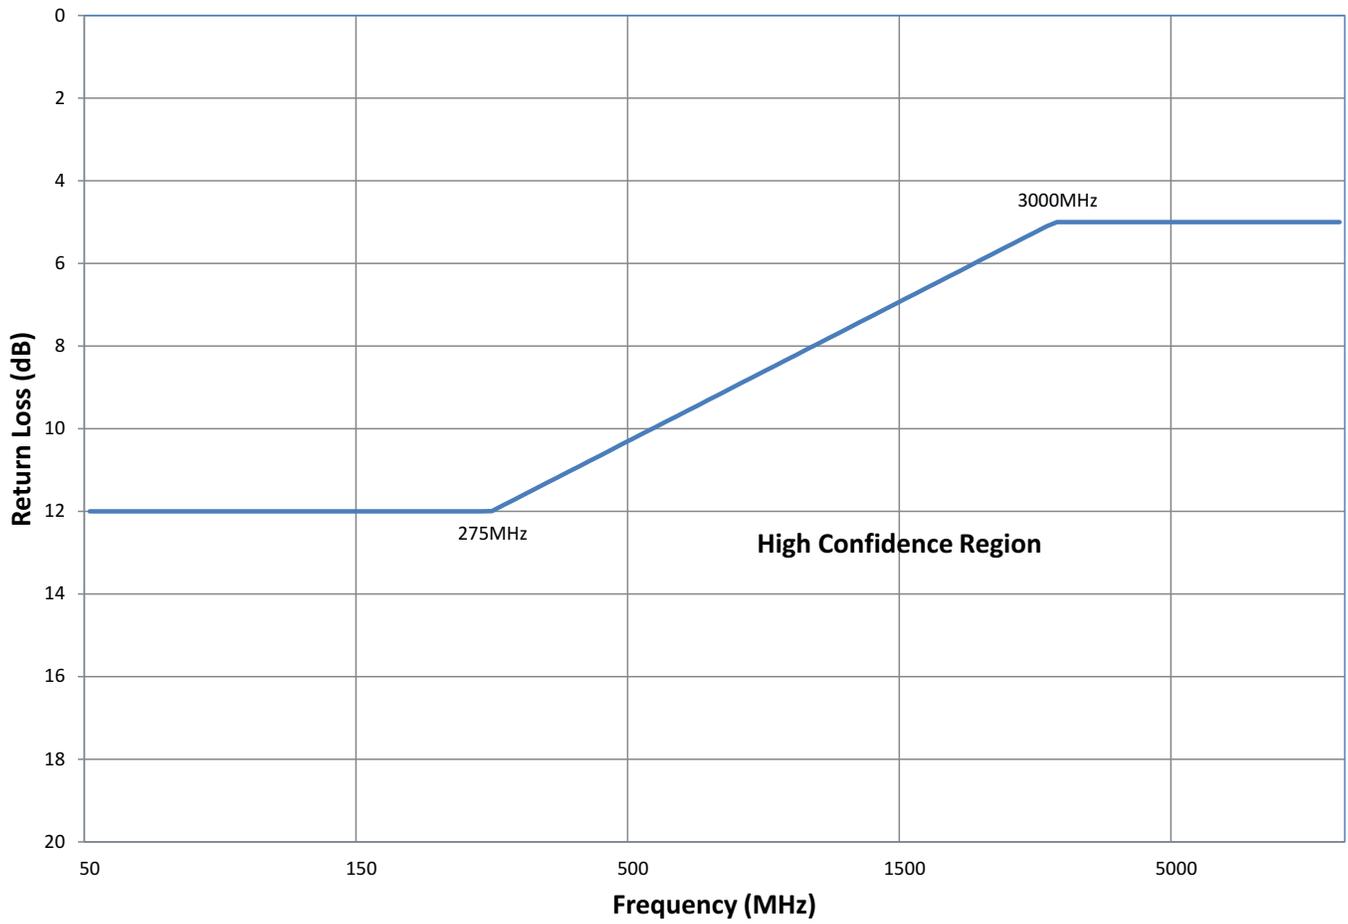
Device characterization has shown that bit error rate performance consistent with the 10GbE-KR standard as published in IEEE 802.3-2008 Annex 69B cannot be met across all device operating extremes. Production devices do operate at the required error rate across all rated operating conditions of voltage and temperature when the channel insertion loss is limited to 20dB at the Nyquist rate of 5.15625GHz. The figure below shows the Insertion Loss template from IEEE 802.3-2008 Annex 69B as well as the reduced Insertion Loss template.

Characterization has shown that channels must also be compliant with the Return Loss template contained in the IEEE 802.3-2008 Annex 69B specification without modification. This is shown below for convenience.

Workaround None.

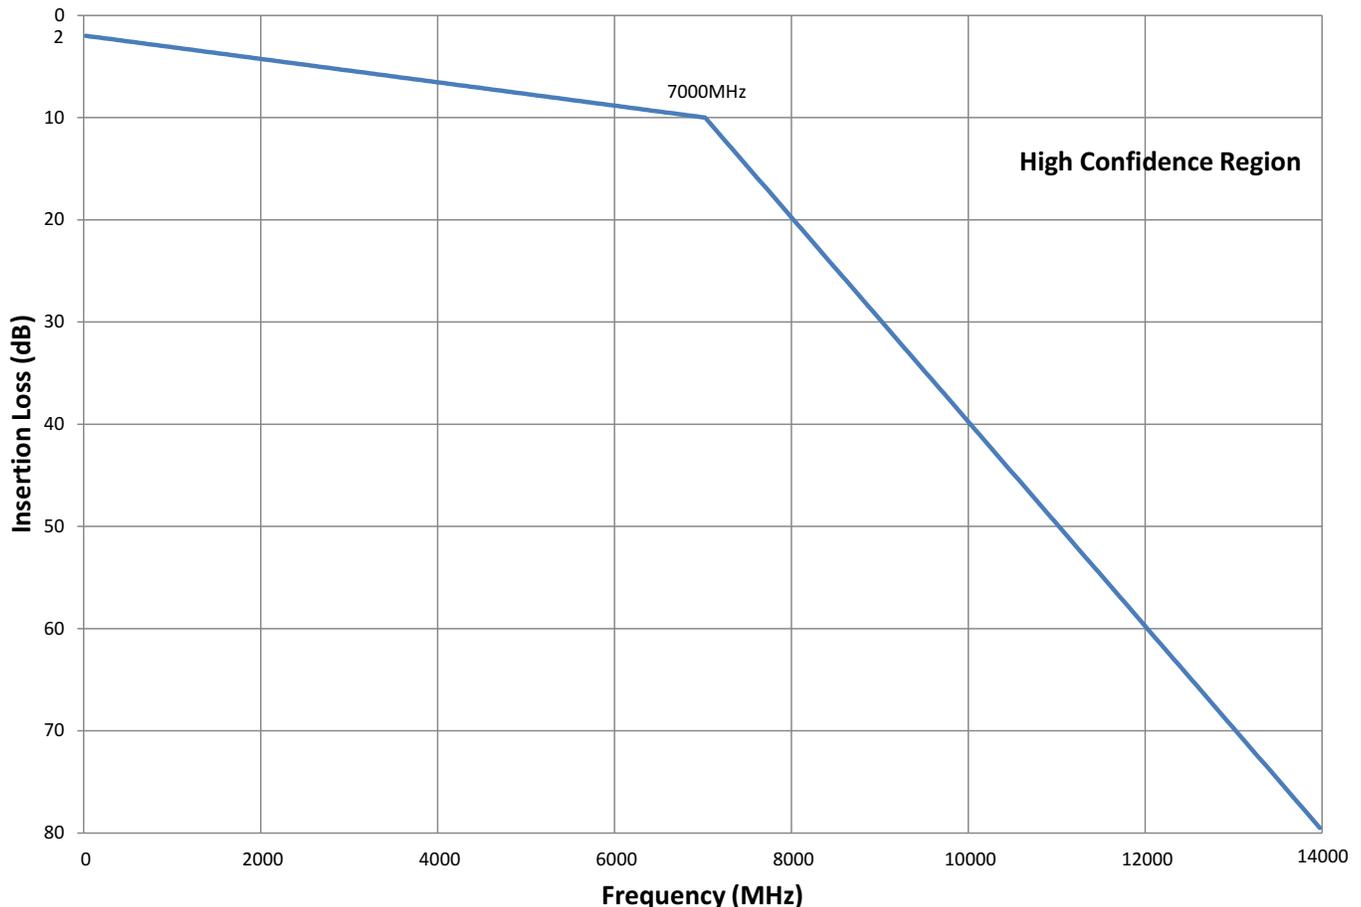
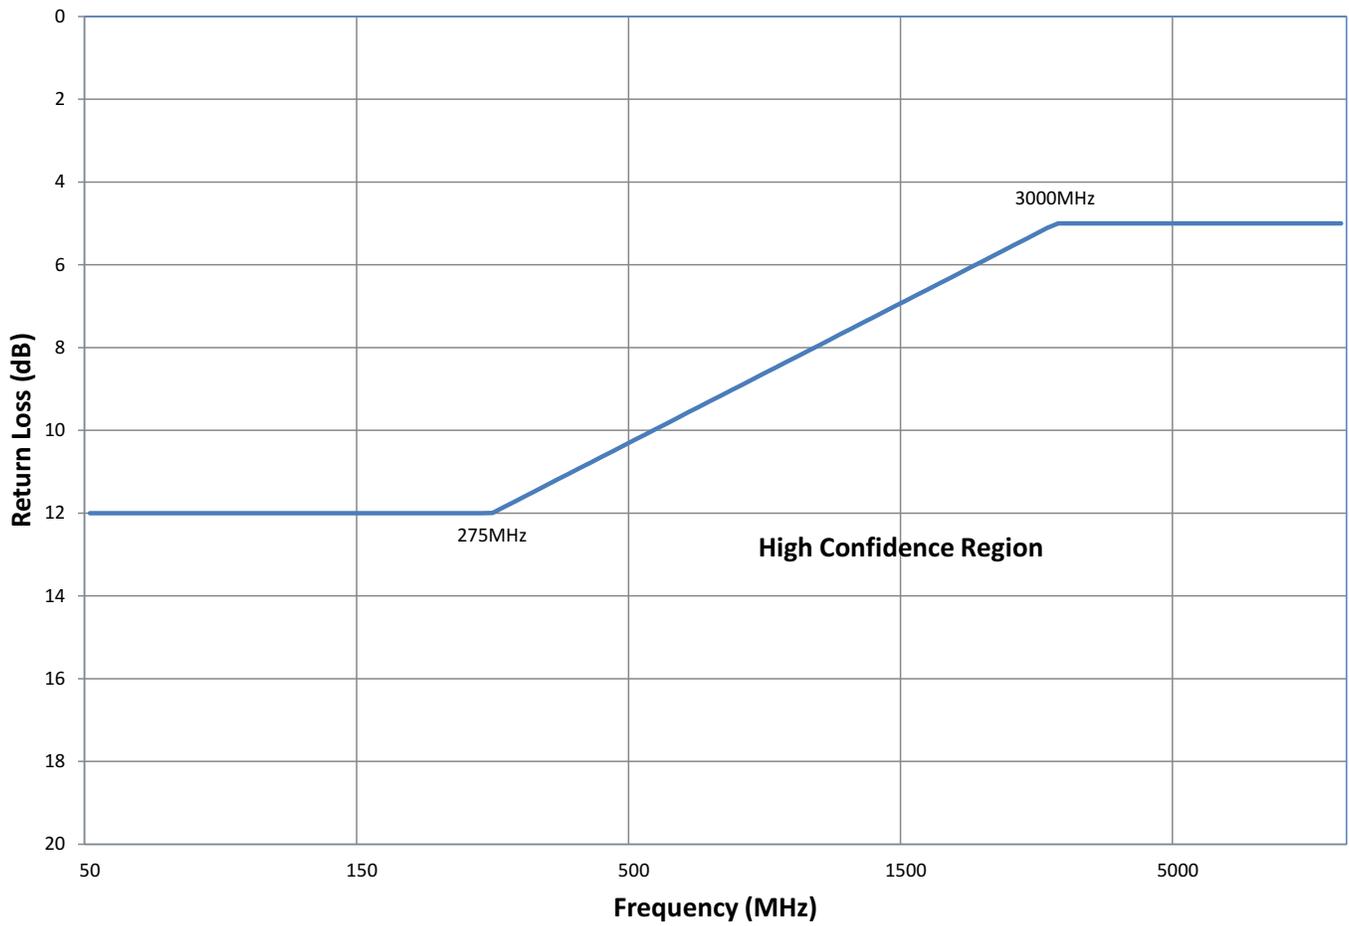
Device characterization has shown that expected bit error rate performance can only be met on layouts that meet constrained channel loss metrics. These can be examined by generating Insertion Loss and Return Loss graphs where loss is plotted versus frequency. Insertion Loss and Return Loss can be estimated during PCB layout using a 3D simulation tool. Insertion Loss and Return Loss should also be measured on early prototypes using a Vector Network Analyzer (VNA). Multiple PCB construction and layout enhancement techniques must be combined to achieve these channel performance requirements as stated in the KeyStone II SERDES User Guide.

An Insertion Loss measurement provides a composite view of the channel's loss versus frequency. Since HyperLink is a short-reach interface, channel loss is limited. Also, due to the high data rate, the Insertion Loss must be monotonic and without discontinuities that would degrade receiver operation. The template shown below provides Insertion Loss limits that will result in a robust channel. This template must be met for the entire channel from transmitter to receiver including the series capacitors.

Device characterization has also shown that channels should be compliant with the Return Loss template shown below. The Return Loss measurement indicates the amount of energy reflected back to the source which is not available to the receiver. Impedance variation in the channel will cause reflected energy that can cause this template to be violated. Careful attention to PCB construction and layout must be followed to meet this requirement. This template must be met for the entire channel from transmitter to receiver including the series capacitors. Note that this is the same template

defined in IEEE 802.3-2008 Annex 69B specification for 10GbE.

Workaround None.

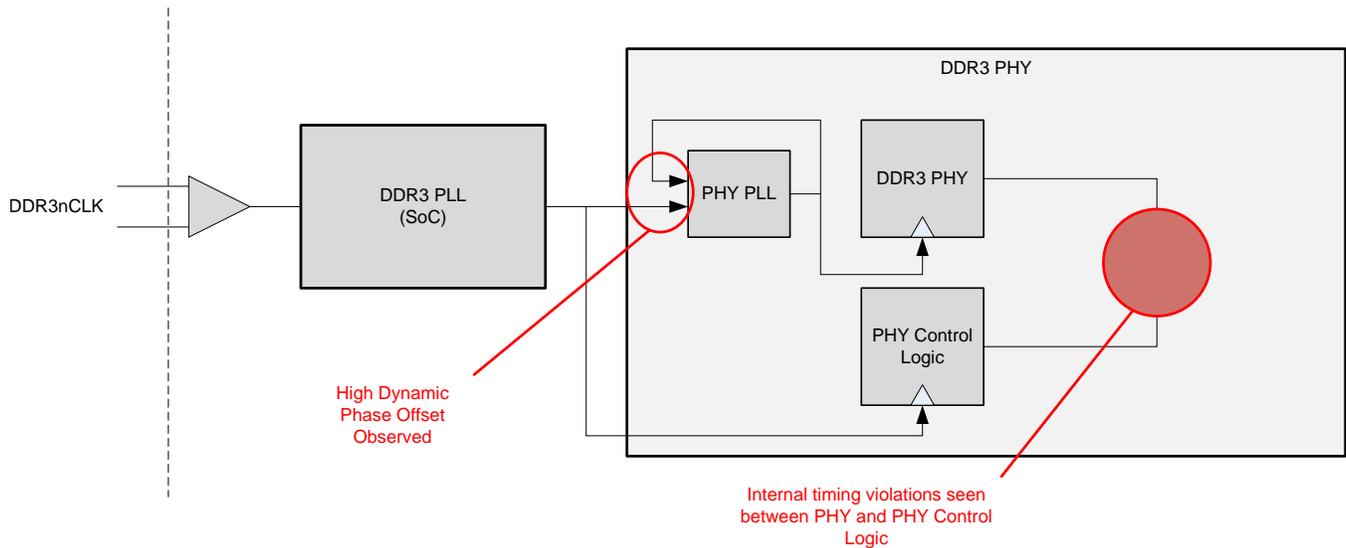
Figure 5. DDR3 PHY

Details: DDR3 read operations may show errors due to increased levels of Dynamic Phase Offset (DPO) inside the DDR3 PHY. These errors are characterized by byte lane data corruption or intermittent bit errors. The byte lane data corruption can only be recovered using a device reset.

The DDR3 clocking architecture is illustrated in the figure below. The DDR3 reference clock input (DDR3nCLK) feeds the DDR3 SoC PLL, which outputs a clock to be used by the PHY Control Logic and provide an input to the PHY PLL.

The Dynamic Phase Offset (DPO) is a measure of the DDR3 PHY PLL’s ability to track rapid phase changes in the output of the DDR3 SoC PLL. High DPO can create internal timing violations between the DDR3 PHY and DDR3 PHY Control Logic and result in data errors during reads. As indicated by the shaded red circle in the figure above, the timing violations occur in the data transfer between the PHY and PHY control logic. It was determined that the root cause of the elevated DPO were SoC PLL and PHY PLL configurations that were non-optimized for the timing requirements of the system.

The workaround for this behavior is a change in the PLL configurations used for the DDR3 SoC PLL and the DDR3 PHY PLL. New configurations have been generated for DDR3-1600, DDR3-1333, DDR3-1066, and DDR3-800 operation and are presented in the tables below. Per field alert, "DDR3 Limited to Highest Data Rates Due to Possibility of PLL Instability During Temperature Changes after Startup", operation of DDR3-1066 and/or DDR3-800 is not recommended for affected Keystone2 devices in production systems

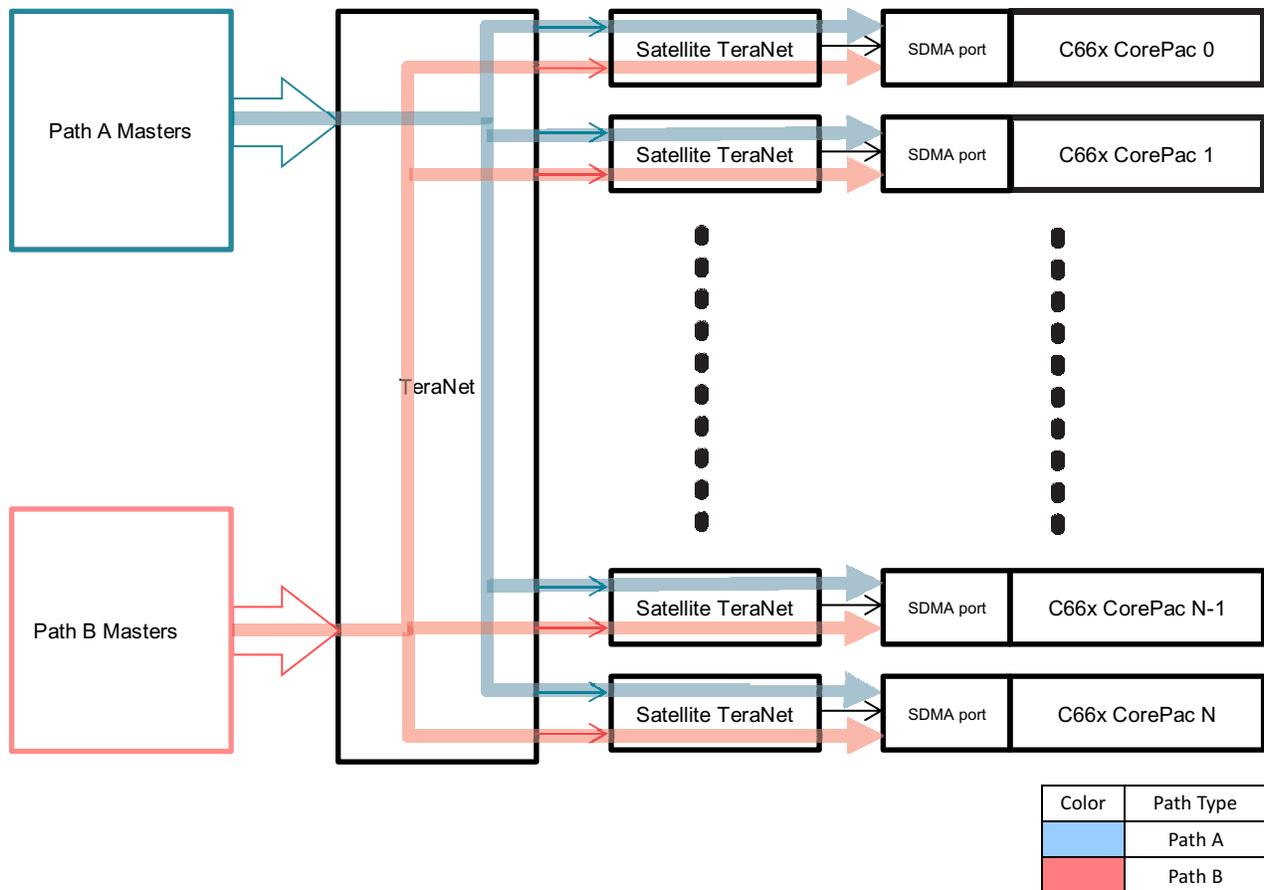
Figure 6. Satellite TeraNet Paths

When two masters send out write transactions to two C66x CorePac's L2 slave end points, a hang can occur when the C66x CorePacs are busy and stalling the incoming write transactions.

Each C66x CorePac has a TeraNet component in front of its slave (SDMA) port, which serves as a satellite TeraNet for C66x CorePac's SDMA port. Device masters communicate with the C66x CorePac's L2 memory through these satellite TeraNets. These satellite TeraNets have two input paths, path A and path B, and each path can be accessed by distinct set of masters. Thus, each write transaction appearing at the SDMA ports of C66x Corepac L2 memory can take one of the two possible paths, depending on the master that sent out that transaction.

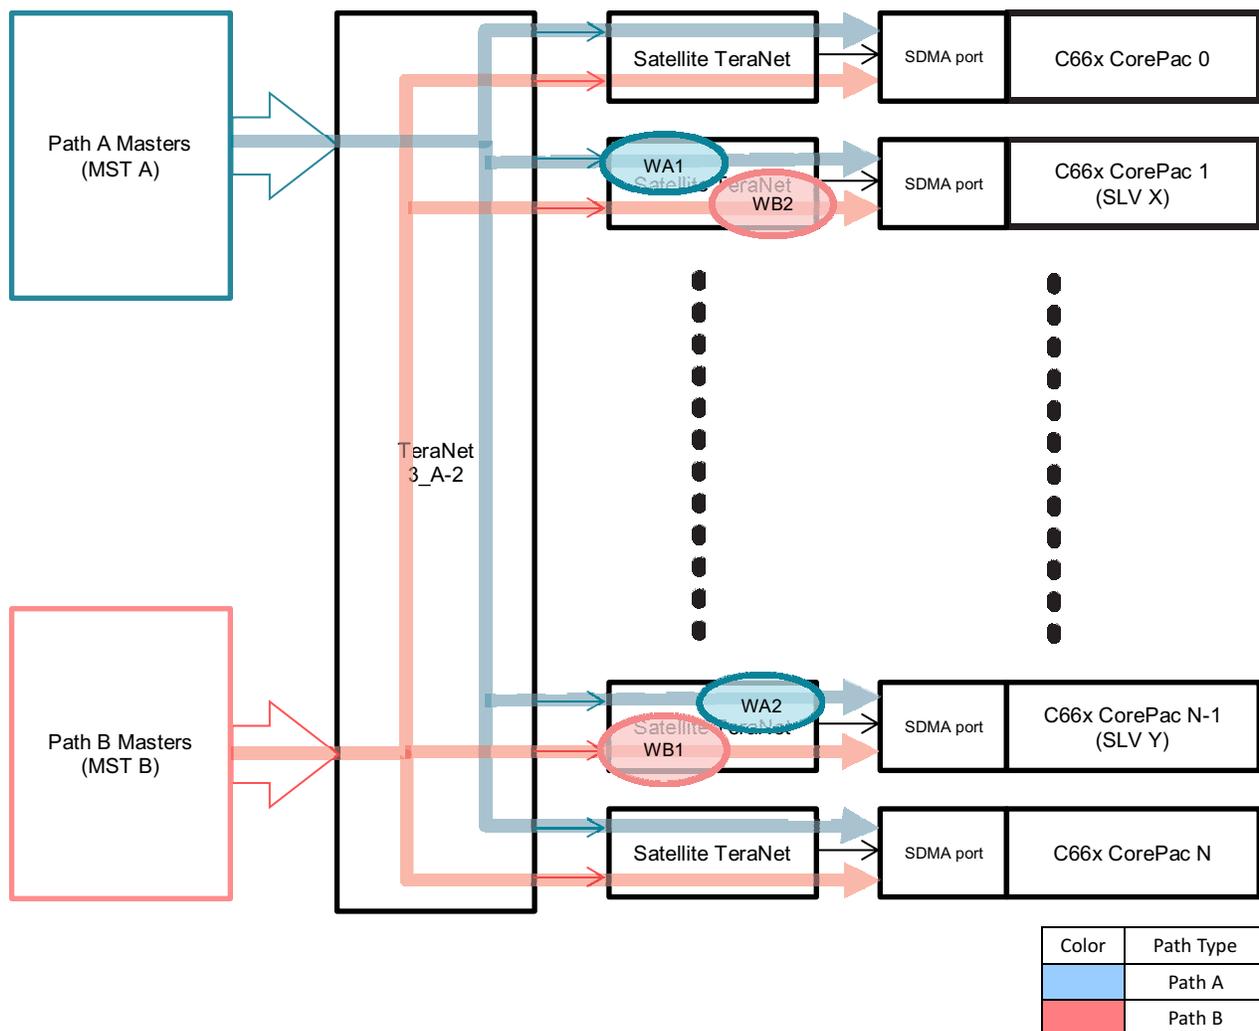
Figure 7. Hang Scenario

Hang Scenario: When a master (MST A) that uses path A and another master (MST B) that uses path B send out two writes each (WA1, WA2 and WB1, WB2) to two C66x CorePac slave end points (SLV X, SLV Y), a hang can occur if the following conditions occur:

- Both masters send one write to each of the two slave end points in opposite order:
 - MST A sends two writes: first write WA1 to SLV X, and second write WA2 to SLV Y
 - MST B sends two writes: first write WB1 to SLV Y, and second write WB2 to SLV X
- Writes from two masters arrive on separate paths at slave endpoint:
 - MST A writes arrive on path A
 - MST B writes arrive on path B
- Both slaves are busy, so they stall the incoming write transactions.
- Both slaves select second writes when they are ready:
 - SLV X selects WB2
 - SLV Y selects WA2

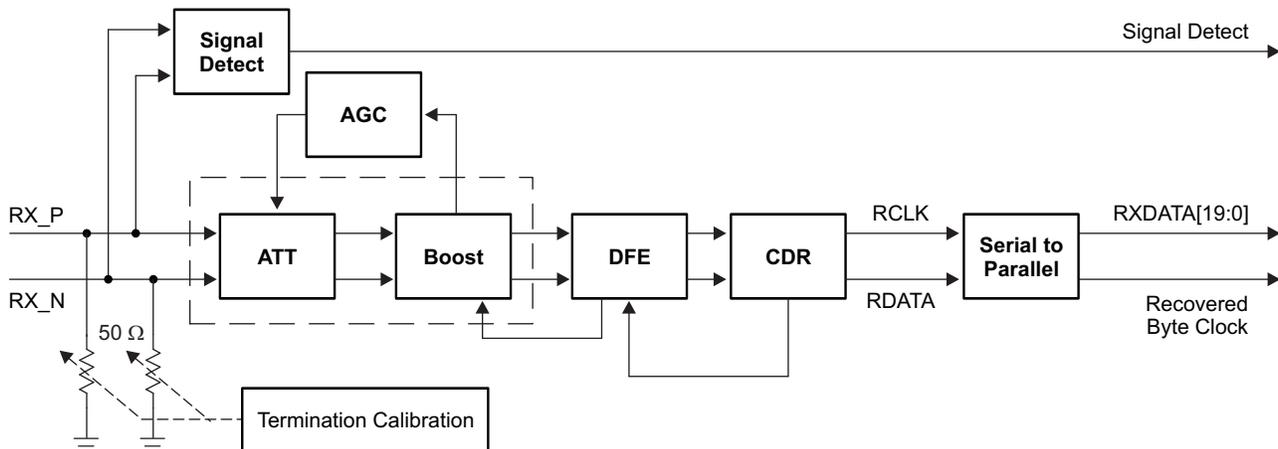
Figure 10. RX Path Block Diagram

Problem Summary: The SerDes on some peripherals will not automatically adapt its RX equalization when provided with certain data encodings common to that peripheral’s electrical standard.

Details The TI SerDes contains an adaptation algorithm that allows the RX equalization blocks to adapt their parameters to the SerDes data channel. The adaptation algorithm sets the optimal values for the ATT, BOOST, and DFE blocks in order to equalize the signal, maximize margin, and minimize channel distortion. For higher data rates (i.e. 5Gbps and greater), the high frequency gain provided by the BOOST block is generally considered necessary to compensate for the low-pass characteristics of data channels and widen the data eye.

The SerDes BOOST block was designed to require a specific set of patterns in order to best adapt its parameters to the channel. If these patterns are not found, the BOOST adaptation algorithm will not update the internal block settings and/or may incorrectly update these settings. The required data pattern is a series of six 0's followed by a 101 pattern. This pattern must occur numerous times on both odd and even bit alignments. This data pattern is not present in the 8b/10b coded symbols that are sent over many of the high speed peripheral links.
