Errata

F29H85x, F29P58x, and F29P32x Real-Time MCUs Silicon Errata (Silicon Revisions B, A, 0)

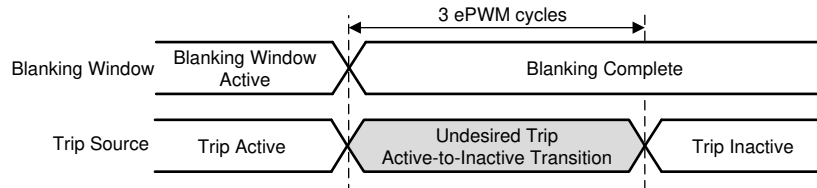
Figure 3-1. Undesired Trip Event and Blanking Window Expiration

The blanking window is typically used to mask any PWM trip events during transitions which would be false trips to the system. If an ePWM trip event remains active for less than three ePWM clocks after the end of the blanking window cycles, there can be an undesired glitch at the ePWM output.

Figure 3-1 illustrates the time period which could result in an undesired ePWM output.

Extend or reduce the blanking window to avoid any undesired trip action.

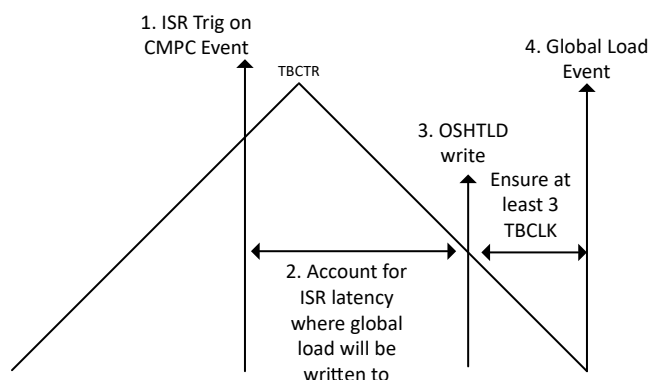
Figure 3-3. Example of Synchronous ISR Loading Method

Details When a write to the GLDCTL2.OSHTLD register bit occurs within 3 TBCLKs of the global load event (configured by GLDCTL.GLDMODE), the global load of registers (configured by GLDCFG) may get delayed, which can create unintended waveforms.

Workaround 1 (Recommended): Synchronous ISR to PWMs

1. Generate an ISR on a known Event Trigger Interrupt event (that is, CMPC, CMPD event, and so forth).
2. Ensure a minimum of 3 TBCTR cycles are kept between the global load event and when the ISR writes to GLDCTL2.OSHTLD.
 - a. When writing to the OSHTLD bit, ensure this is non-interruptible code by disabling the interrupts.
