## ABSTRACT

This document describes the known exceptions to the functional specifications (advisories).

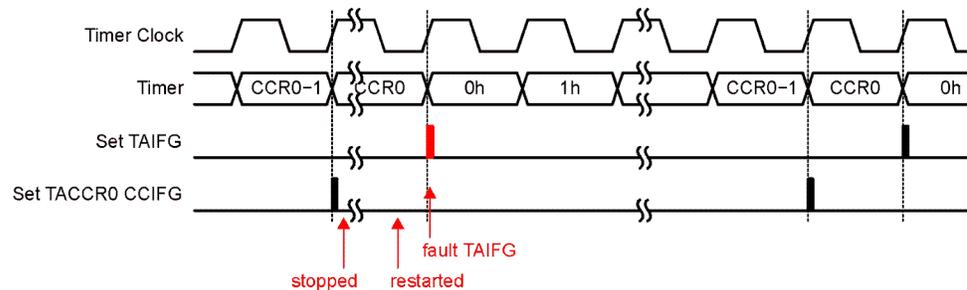
## TA21 *TA Module*

<b>Category</b>	Functional
<b>Function</b>	TAIFG Flag is erroneously set after Timer A restarts in Up Mode
<b>Description</b>	In Up Mode, the TAIFG flag should only be set when the timer counts from TACCR0 to zero. However, if the Timer A is stopped at TAR = TACCR0, then cleared (TAR=0) by setting the TACLK bit, and finally restarted in Up Mode, the next rising edge of the TACLK will erroneously set the TAIFG flag.

<b>Workaround</b>	None.
<b>TAB22</b>	<b><i>TAB Module</i></b>
<b>Category</b>	Functional
<b>Function</b>	Timer_A/Timer_B register modification after Watchdog Timer PUC
<b>Description</b>	Unwanted modification of the Timer_A/Timer_B registers TACTL/TBCTL and TAIV/TBIV can occur when a PUC is generated by the Watchdog Timer(WDT) in Watchdog mode and any Timer_A/Timer_B counter register TACCRx/TBCCRx is incremented/ decremented (Timer_A/Timer_B does not need to be running).
<b>Workaround</b>	Initialize TACTL/TBCTL register after the reset occurs using a MOV instruction (BIS/BIC may not fully initialize the register). TAIV/TBIV is automatically cleared following this initialization.  Example code:  MOV.W #VAL, &TACTL or MOV.W #VAL, &TBCTL  Where, VAL=0, if Timer is not used in application otherwise, user defined per desired function.
<b>WDG2</b>	<b><i>WDG Module</i></b>
<b>Category</b>	Functional
<b>Function</b>	Incorrectly accessing a flash control register
