# MSP430FG4250 Device Erratasheet

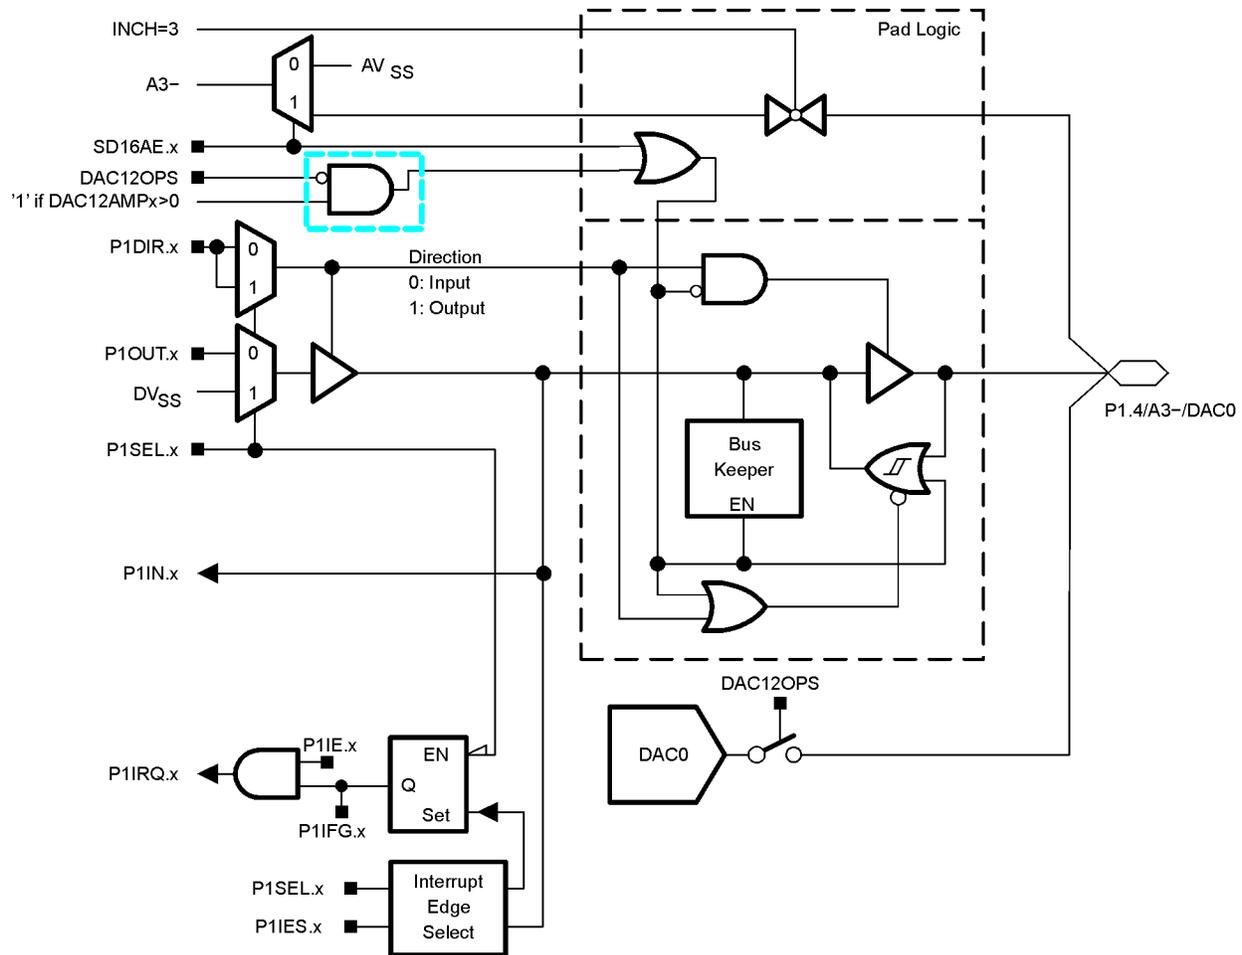
**Description** The DAC12OPS control bit used to automatically disable the P1.4 I/O logic is inverted as shown in the figure below. When DAC12 is enabled (DAC12AMPx > 0) and DAC12OPS=0, the port I/O for P1.4 will be disabled. Setting DAC12OPS = 1 to connect the DAC12 output to P1.4 will erroneously enable the port GPIO logic.

**Workaround** The P1.4 I/O logic should be disabled when the DAC12 is enabled using the SD16AE.4 analog enable bit. SD16AE.4=1 will disable the P1.4 I/O logic. The A3 SD16\_A analog input cannot be used under this condition.

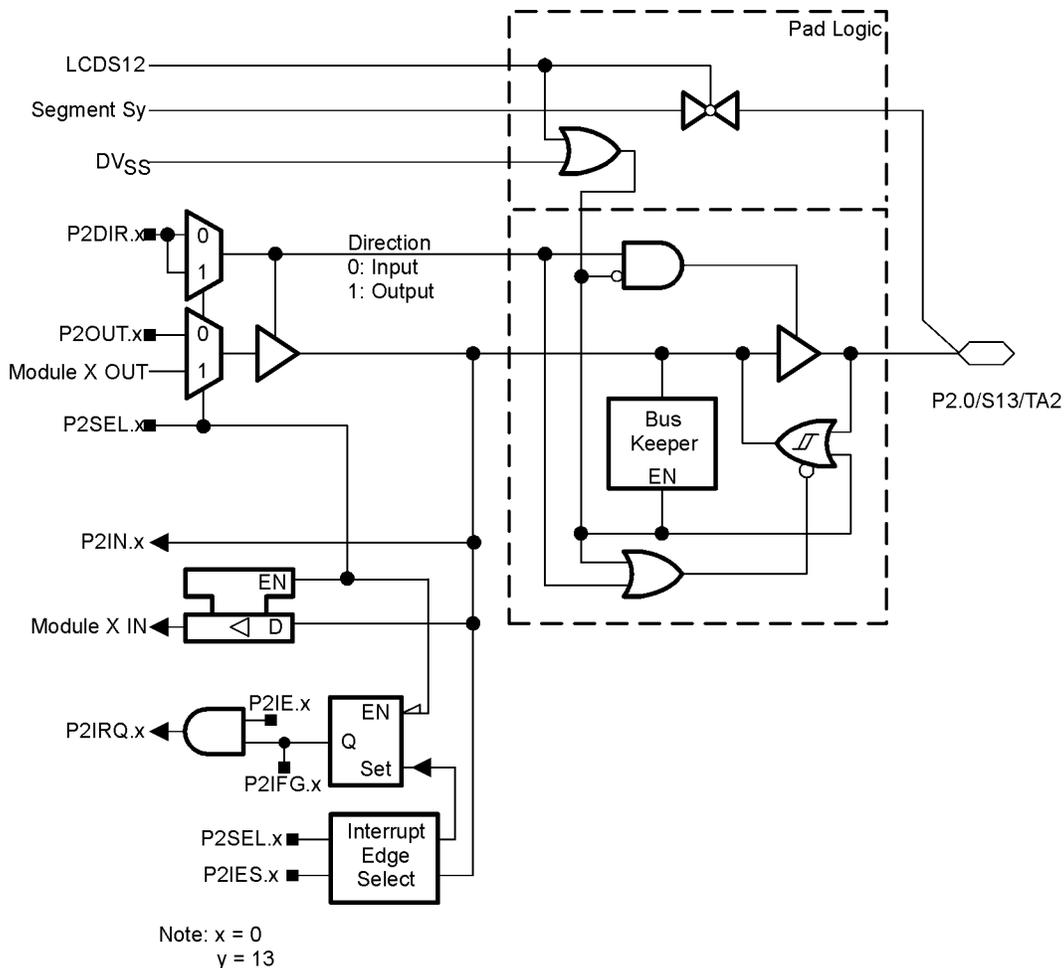
**Description** In addition to GPIO and LCD functionality, P2.0 also has Timer\_A3 module output capability. When  $\text{P2SEL.0} = 1$  and  $\text{P2DIR.0} = 1$ , P2.0 becomes a TA2 output.

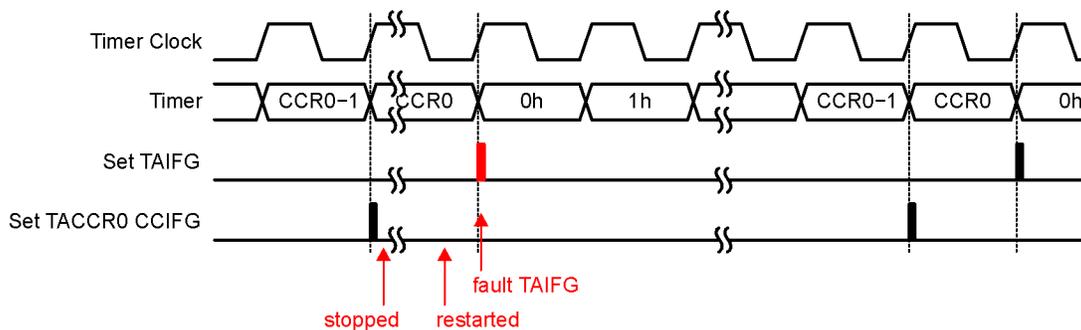
<b>Category</b>	Functional
<b>Function</b>	TAIFG Flag is erroneously set after Timer A restarts in Up Mode
<b>Description</b>	In Up Mode, the TAIFG flag should only be set when the timer counts from TACCR0 to zero. However, if the Timer A is stopped at TAR = TACCR0, then cleared (TAR=0) by setting the TACLK bit, and finally restarted in Up Mode, the next rising edge of the TACLK will erroneously set the TAIFG flag.

<b>Workaround</b>	None.
-------------------	-------
