Tiva™ C Series TM4C123x Microcontrollers Silicon Revisions 6 and 7

Silicon Errata

Literature Number: SPMZ849F
August 2013–Revised April 2016

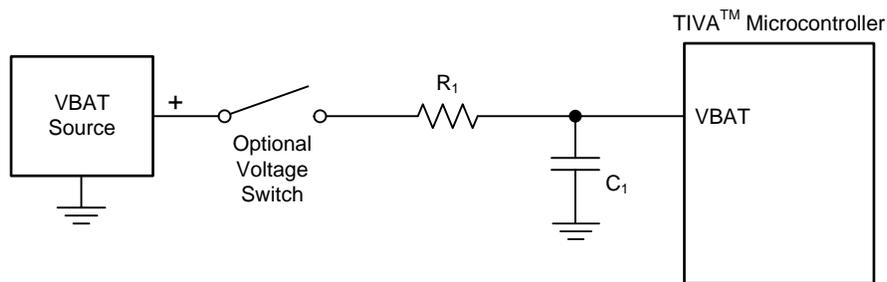
Figure 2. RC Circuit

ELEC#02 **V_{BAT} Supply pin may be Damaged if the pin Voltage Ramps Faster Than 0.7 V/ μ s**

Description The V_{BAT} supply pin may be damaged if the pin voltage ramps faster than 0.7 V/ μ s. Fast V_{BAT} ramps are a concern when a battery is being connected or the V_{BAT} supply is hard switched.

Workaround(s) An RC circuit as shown should be added to the V_{BAT} pin to prevent the damage. The R_1 and C_1 should be placed close to the microcontroller for best protection. In systems that do not require Hibernate when the VDD supply is off, the V_{BAT} pin should be tied to the VDD supply, which typically ramps at a rate slower than 0.7 V/ μ s. The R_1 and C_1 components are not required for a V_{BAT} supply ramp less than 0.7 V/ μ s.

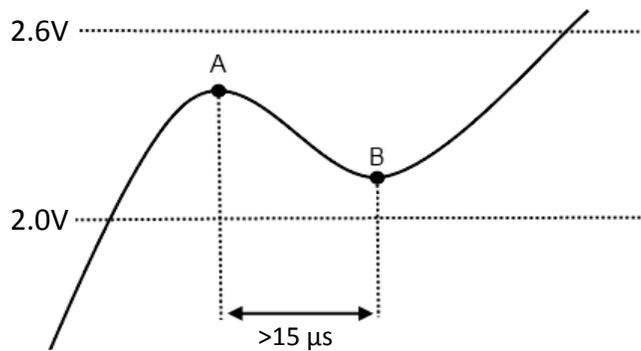
Figure 3. VDDA Waveform to Avoid Between V_{POR} min and V_{POR} max

Description: In very rare cases, a non-monotonic voltage rise of VDDA between the minimum and maximum Power-On Reset Threshold (V_{POR}) voltage range, 2.0 V and 2.6 V, can cause the on-chip LDO to not start up. Because the LDO controls the core voltage (VDDC), the device cannot start up correctly in this situation. If the LDO fails to start, power cycle the device until a successful power up occurs. A software or hardware reset cannot restart the LDO.

Workaround(s): A monotonic voltage rise of VDDA prevents this issue from occurring; however, a perfect monotonic ramp is difficult to achieve, particularly during LDO inrush. The risk of encountering this issue can be minimized by performing one of the following:

- If the VDD and VDDA pins are connected directly to the same power source, at every possible point A and point B along the VDDA waveform between 2.0 V and 2.6 V, point B must never fall below point A after 15 μ s, as shown in [Figure 3](#).
- Use a separate power supply for VDDA to reduce noise and isolate it from the effects of LDO inrush. At every possible point A and point B along the VDDA waveform between 2.0 V and 2.6 V, point B must never fall below point A after 15 μ s, as shown in [Figure 3](#). The separate power supply will make it easier to avoid this condition.
