TMS320VC5510/5510A
Digital Signal Processors
Silicon Errata

SPRZ08O
September 2001 – Revised April 2008

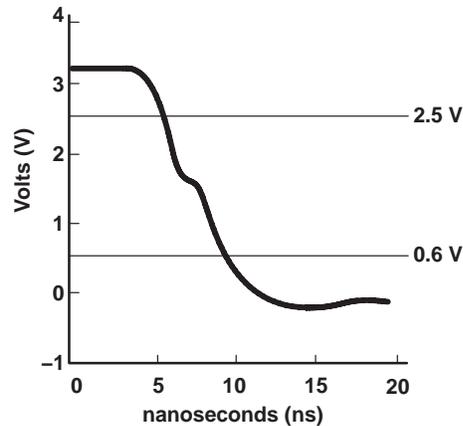
**Figure 2. Bad TCK Transition**

This phenomenon is observed when an erroneous clock edge is generated from the TCK signal inside the C55x™ DSP. This can be caused by several factors, acting independently or cumulatively:

- TCK transition times (as measured between 2.4 V and 0.8 V) in excess of 3 ns.
- Operating the C55x DSP in a socket, which can aggravate noise or glitches on the TCK input.
- Poor signal integrity on the TCK line from reflections or other layout issues.

A TCK edge that can cause this problem might look similar to the one shown in Figure 2. A TCK edge that does not cause the problem looks similar to the one shown in Figure 3. The key difference between the two figures is that Figure 3 has a clean and sharp transition whereas Figure 2 has a “knee” in the transition zone. Problematic TCK signals may not have a knee that is as pronounced as the one in Figure 2. Due to the TCK signal amplification inside the chip, any perturbation of the signal can create erroneous clock edges.

As the problem may be caused by one or more of the above factors, one or more of the steps outlined below may be necessary to fix it:

- Avoid using a socket
- Ensure the board design achieves rise times and fall times of less than 3 ns with clean monotonic edges for the TCK signal.
- For designs where TCK is supplied by the emulation pod, use a C55x Emulation Adapter Board, part number DSP8102U. To order a C55x Emulation Adapter Board, please contact the TI Product Information Center (PIC).

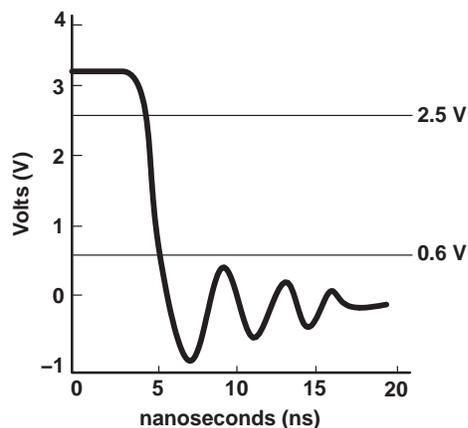
**Figure 3. Good TCK Transition****Workaround:**

As a result of the faster edge transition, there is increased ringing in Figure 3. As long as the ringing does not cross logic input thresholds (0.8 V for falling edges, and 2.4 V for rising edges), this ringing is acceptable.
