**TMS320C6414, TMS320C6415,
and TMS320C6416
Digital Signal Processors
Silicon Errata**

Silicon Revisions 1.0, 1.01, 1.02, 1.03, 1.1, 2.0

SPRZ011T
October 2001
Revised August 2007

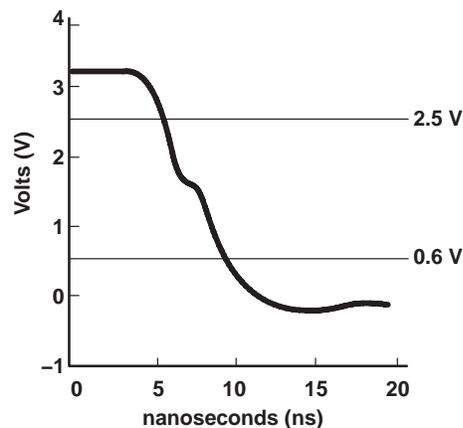
Figure 2. Bad TCK Transition

This phenomenon is observed when an erroneous clock edge is generated from the TCK signal inside the C64x DSP. This can be caused by several factors, acting independently or cumulatively:

A TCK edge that can cause this problem might look similar to the one shown in Figure 2. A TCK edge that does not cause the problem will look similar to the one shown in Figure 3. The key difference between the two figures is that Figure 3 has a clean and sharp transition whereas Figure 2 has a “knee” in the transition zone. Problematic TCK signals may not have a knee that is as pronounced as the one in Figure 2. Due to the TCK signal amplification inside the chip, any perturbation of the signal can create erroneous clock edges.

As the problem may be caused by one or more of the above factors, one or more of the steps outlined below may be necessary to fix it:

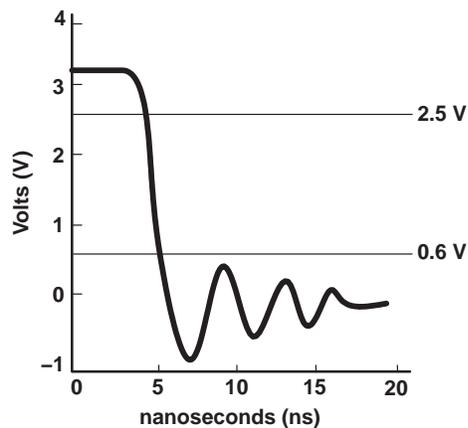
Figure 3. Good TCK Transition

As a result of the faster edge transition, there is increased ringing in Figure 3. As long as the ringing does not cross logic input thresholds (0.6 V for falling edges, and 2.5 V for rising edges), this ringing is acceptable.

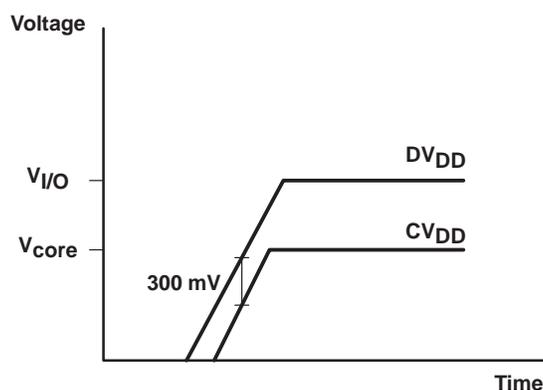
**Figure 5. Core and I/O Power-On Ramps**

Details: The TMS320C64x device uses electronically blowable fuses for certain memory and device configuration purposes, which may be damaged if the device is not held in reset during and after the power-on ramp. In addition, since the reset signal must propagate through the I/O buffers to the core logic, the I/O supply must be powered on enough to allow the reset signal to propagate through before the core supply reaches a voltage where fuse damage can occur (1.0 V). However, if the I/O supply reaches a voltage where the I/O buffers are operational before the core is powered on enough to force all outputs to the high-impedance state, board-level bus contention may result.

Workaround: To protect the fuses and prevent bus contention, a reset supervisor must be used in conjunction with a controlled power-on ramp sequence. A reset supervisor such as the Texas Instruments' TPS3110 ensures that $\overline{\text{RESET}}$ is asserted low or put in a high-impedance mode so that it may be pulled down for the entire power-on ramp. The I/O rail must start to ramp before or at the same time as the core rail, and the core rail must be no more than 300 mV behind at any time until the core rail has reached its operating voltage. Ramping the power in this manner ensures that the device's input buffers allow the $\overline{\text{RESET}}$ signal to propagate to the core (which is necessary to prevent fuse damage) while providing a valid signal to the device's output buffers before they can drive (which is necessary to prevent bus contention). Power supplies such as the Power Trends™ PT6932 sequence the power ramp in this manner. See Figure 5 and Figure 6 for the core and I/O power-on ramps and a recommended reset supervisor circuit example.

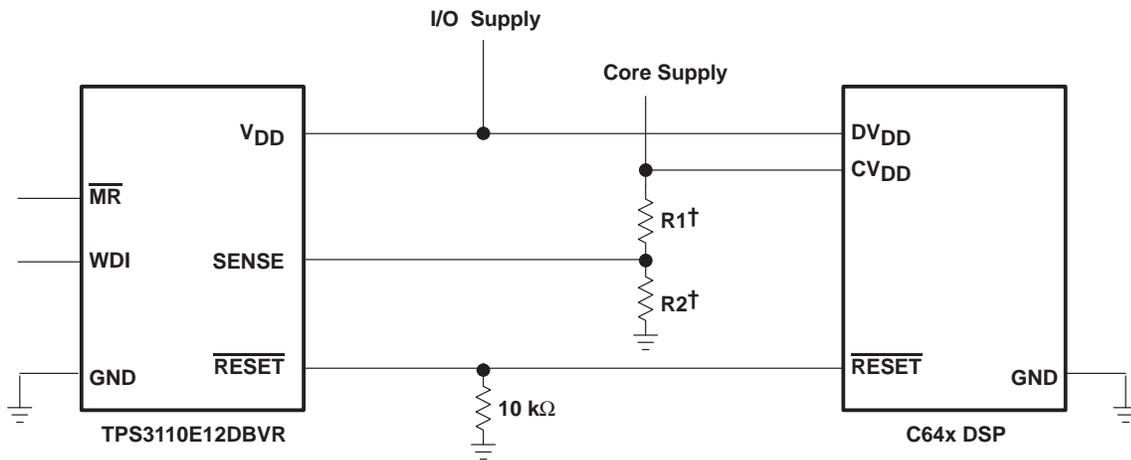
$$V_{(SENSE-TH)} = 0.551V \times \frac{R1 + R2}{R2}$$

† R1 and R2 should be chosen such that $V_{(SENSE-TH)}$ is set below the data sheet recommended operating conditions voltage for CV_{DD} .
