TMS320C6211/TMS320C6211B
Digital Signal Processors
Silicon Errata

Silicon Revisions 1.0, 1.1, 2.1, 2.2, 3.0, and 3.1

SPRZ154L
October 1999
Revised May 2004

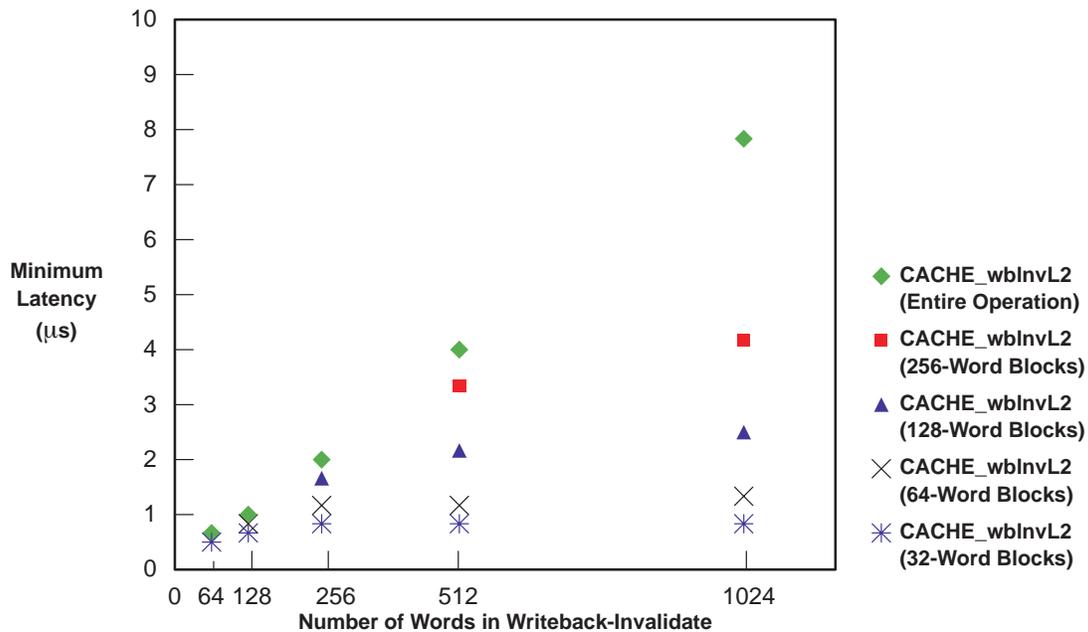
Figure 2. Minimum Required Latency Between McBSP Events for a Successful Transfer with Concurrent L2 Writeback-Invalidates at 200-MHz CPU and 50-MHz EMIF, Using Entire Operations and Block Breakdown

For example, if the CPU is running at 200 MHz with a 50-MHz EMIF and you have a McBSP hard real-time deadline of 5 μ s, Figure 2 shows that a 1024-word L2 writeback-invalidate may cause data loss since back-to-back McBSP events can only be serviced at $\sim 8 \mu$ s. By breaking down the L2 writeback-invalidate into 256-word blocks, you can then meet the 5- μ s McBSP deadline. In other words, when performing a 1024-word L2 writeback-invalidate operation with the CPU and EMIF conditions cited above, the McBSP events can be serviced in $\sim 8 \mu$ s for the entire operation (one whole block), in $\sim 4 \mu$ s when breaking it into 256-word blocks, in $\sim 2.5 \mu$ s when breaking it into 128-word blocks, etc.

To avoid cache operations blocking other time-sensitive EDMA accesses, observe the following guidelines:

1. Avoid placing real-time data in EMIF address range. Instead, real-time data should be placed in the L2 address range.
2. If data must be placed in the EMIF address range:
 - Avoid global cache operations in favor of block-based cache operations.
 - Block-based cache operations should be submitted in small blocks, such that the total amount of time that the EMIF is blocked is less than the amount of time between serial samples.

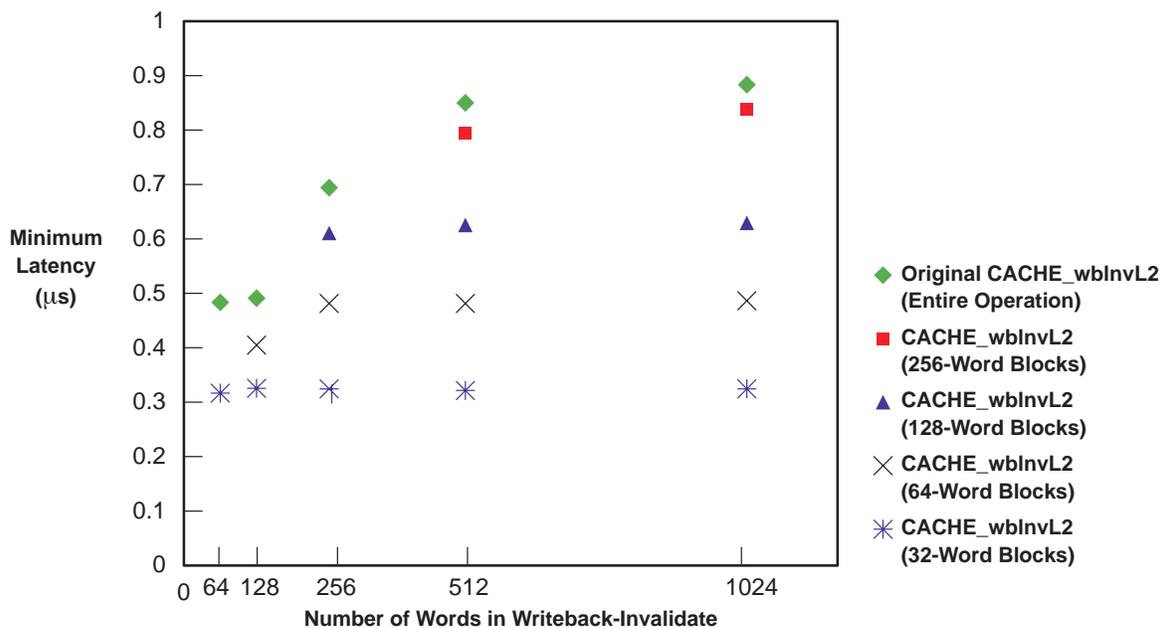
Figure 3. Minimum Required Latency Between McBSP Events for a Successful Transfer With Concurrent Writeback-Invalidates at 225-MHz CPU and 100-MHz EMIF, Using Entire Operations and Block Breakdown

When the CPU is set to 225 MHz and the EMIF is set to 100 MHz, breaking down the cache operations will still improve the block-out problem. Figure 3 shows the improvement in the McBSP's performance with this frequency ratio.

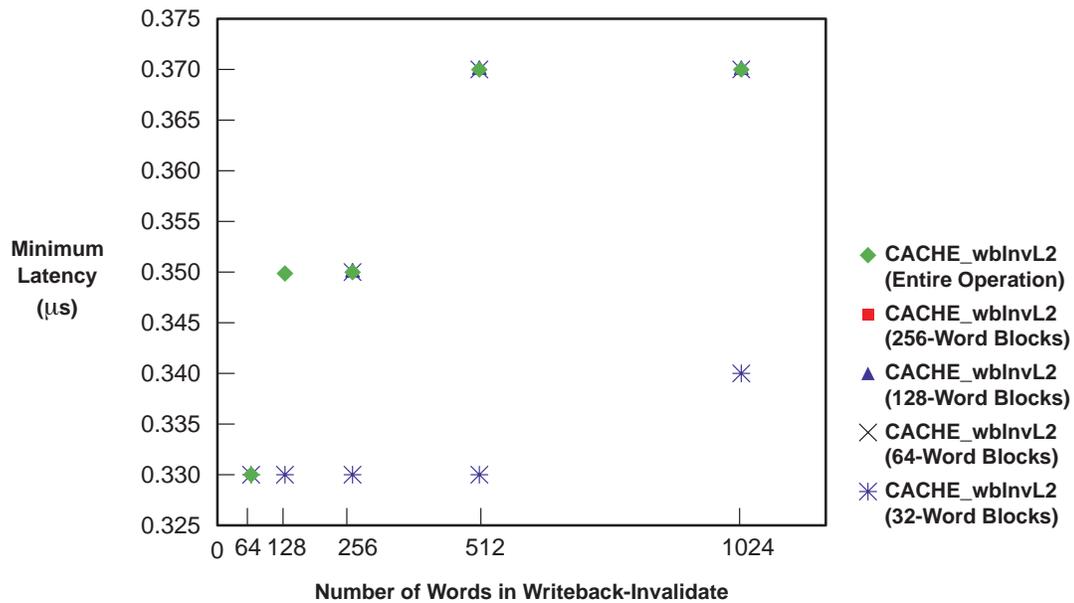
Figure 4. Minimum Required Latency Between McBSP Events for a Successful Transfer With Concurrent Writeback-Invalidates at 150-MHz CPU and 100-MHz EMIF, Using Entire Operations and Block Breakdown

When the CPU is set to 150 MHz and the EMIF is set to 100 MHz, there is virtually no benefit from breaking down the coherency cache operations. Figure 4 shows the McBSP’s performance with this frequency ratio.

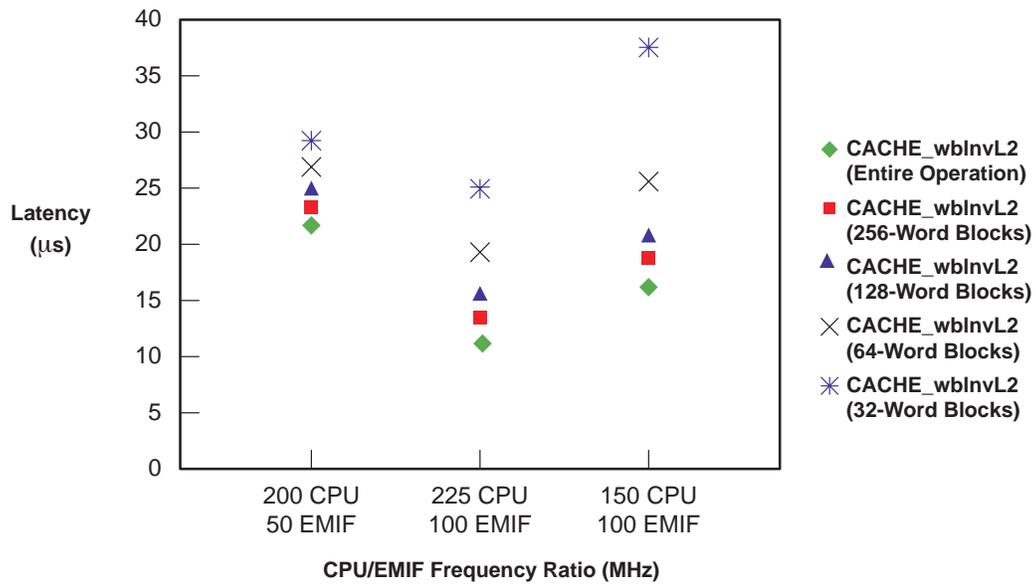
Figure 5. 1024-Word L2 Writeback-Invalidate Performance at Various Frequency Ratios With Old and New CACHE-wbInvL2()

Breaking down the cache operations into smaller blocks takes longer to complete than performing the entire cache function as one large block. Figure 5 shows how much extra overhead is incurred by breaking down an L2 writeback-invalidate operation to transfer 1024 words with different sized blocks and at various frequency ratios. Notice that for the 200-MHz CPU and the 50-MHz EMIF frequency ratio, where the new functions are most critical for peripherals such as the McBSP, the least overhead is incurred.

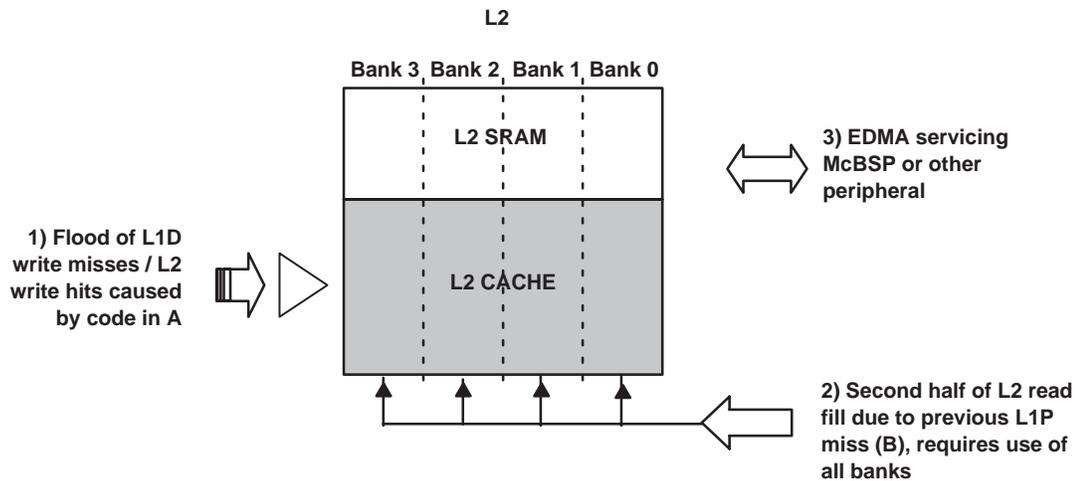
Figure 6. Problem Scenario

In this scenario, the next CPU fetch packet does not reside in either L1P or L2 cache; therefore, it causes an L1P and L2 miss. An L2 cache line (128 bytes, 4 fetch packets) must be fetched from external memory. The fetch from external memory is split into two requests (two halves) of 64 bytes, or two fetch packets each. In this document, the two halves are labeled A and B, respectively, as shown in Figure 6. The first half (A) to arrive in L2 is the half in which the missed fetch packet resides. This first half is immediately forwarded to L1P so that CPU can resume execution before the second half (B) is fetched from external memory. The second half of the L2 line (B) is to be fetched and written to L2 later.

The lockout condition occurs only when the second half (B) of the L2 cache line fill starts. When the B is ready, it attempts to write to L2. It will be unable to do so, however, because the line fill operation accesses all four banks of L2 whereas one bank is always busy servicing the higher priority L1D misses from the code in A. Thus, the line fill (B) cannot complete until the flood of writes from A has stopped. The line fill stays at the head of queue in the EDMA controller, so any other EDMA transfers that access L2 will also be blocked until the flood of stores has stopped *and* the L2 line fill (B) has completed.

The amount of time that an EDMA transfer is locked out of L2 is determined by the code running on the DSP (A), and ultimately by the amount of time that L1D write misses are happening in succession. When all of the conditions are met, the second half of the L2 line fill and the EDMA will be locked out of L2 as long as the flood of stores is sustained.

- Avoid the flood of L1D write misses. Pre-read all data locations prior to writing them. This will allocate them in L1D, preventing the L1D write misses from occurring. Recall that L1D read misses do not cause problems.
- Make sure that any algorithm or code segment that naturally produces a long string of writes inserts gaps in the write sequence such that writes occur at a frequency slower than 1 write miss every other cycle. The term "long" is based on the system requirements. Gaps in the L1D write misses means that the second half of the L2 read fill is given a chance to access L2.

- Run the algorithm or code segment that contains A from internal SRAM. There will not be L2 code read fill (A or B) coming into L2. The simulator can be used to detect such code segment. See simulator section below for details.
- Ensure the problematic segment of algorithm or code is in cache. This can be accomplished by issuing any CPU read/load instruction from the beginning of the problematic code segment in external memory, that will cause both L1D and L2 miss. Assuming the code segment is not yet in L1/L2 cache, Performing CPU load instruction generates an L1D request, and CPU stalls until the code missed and data is returned from L2. After the load instruction, code segment will reside in the L2 cache, and an L2 read fill due to L1P miss will not occur.

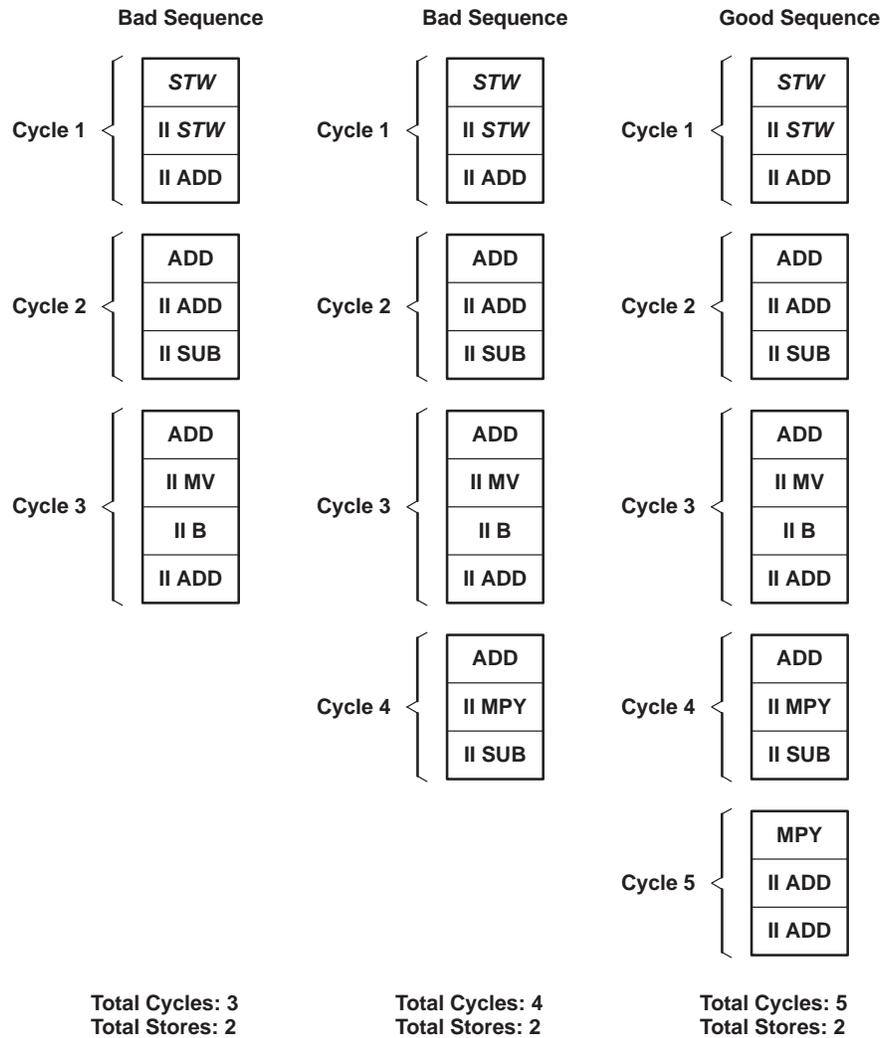
Figure 8. Pseudo Code Example With Parallel Stores (Criteria 2)

Figure 8 outlines this scenario. Note that the STW instruction represents a store of any word size (32-, 16-, or 8-bit).

In most looped code, more than one instruction would likely be executed on each cycle, i.e., instructions would be executed in parallel. In this case, as long as a store is one of the instructions being executed in parallel on a particular cycle, that cycle counts as a cycle on which a store occurs. Instructions with parallel bars (||) at the beginning of the line of assembly execute in parallel with instructions on the preceding line.

- A. Reduce the duration of the loop by breaking into smaller loops. If a particular problem loop has a length of 4 cycles (determined by looking at the software pipeline kernel in the assembly file), and the loop runs 200 times, then the total loop duration is ~800 cycles. If the deadline is 586 cycles, then loop could cause a problem (assuming the loop meets all the other criteria). The workaround is to break the loop into four smaller loops of 50 iterations each. Then any one loop will only run for 200 cycles allowing the EDMA transfer to complete between the smaller loops.

- B. Try to break criteria 2. The quickest way to do this is to turn off optimization for the file containing the problem loop (this is done in the File Specific Options for the file). Instead of using the compiler switch `-o3`, use the compiler switch `-o1` for the particular problem file. This will cause the problem loop to not be software pipelined and less likely to meet criteria 2. The downside to this fix is that all the loops in the particular file will be un-optimized, not just the problem loop.

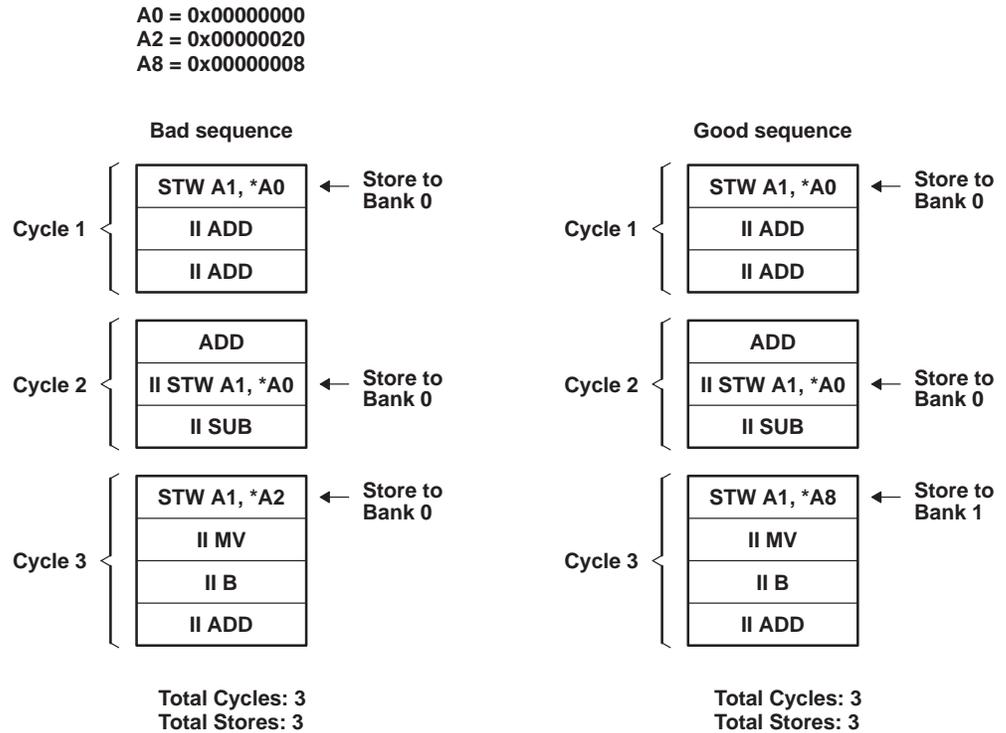
Figure 9. Pseudo Code Example Stores to Specified Banks (Criteria 3)

- All stores in the loop must be to the same bank of L2. If there are any stores to another bank, this will free the first bank long enough for the EDMA access to get in (see Figure 9).

In the case of two stores occurring on the same cycle, in parallel, the same rules apply. If both stores are to the same bank (and there are no other stores in the sequence to a different bank), then a problem may occur. If each of the parallel stores is to a different bank, then the problem cannot occur.

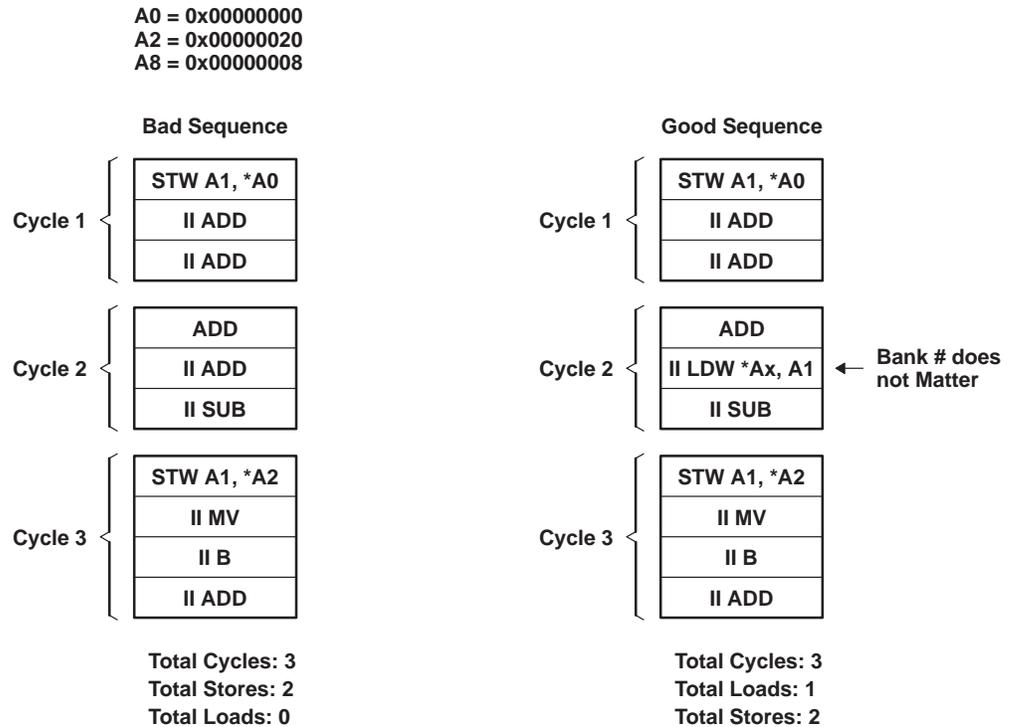
Figure 10. Pseudo Code Example Stores and Loads (Criteria 4)

A load from L2 provides enough of a gap to allow the EDMA to access L2. The good sequence would not cause a problem even if the load were executed in parallel with one of the stores, as long as the load occurred somewhere in the sequence. Notice that although the good sequence satisfies criteria 2 and 3, it would not cause a problem.
