TMS320C6713, TMS320C6713B
Digital Signal Processors
Silicon Errata

C6713 Silicon Revision 1.1

C6713B Silicon Revision 2.0

SPRZ191J
December 2002
Revised August 2005

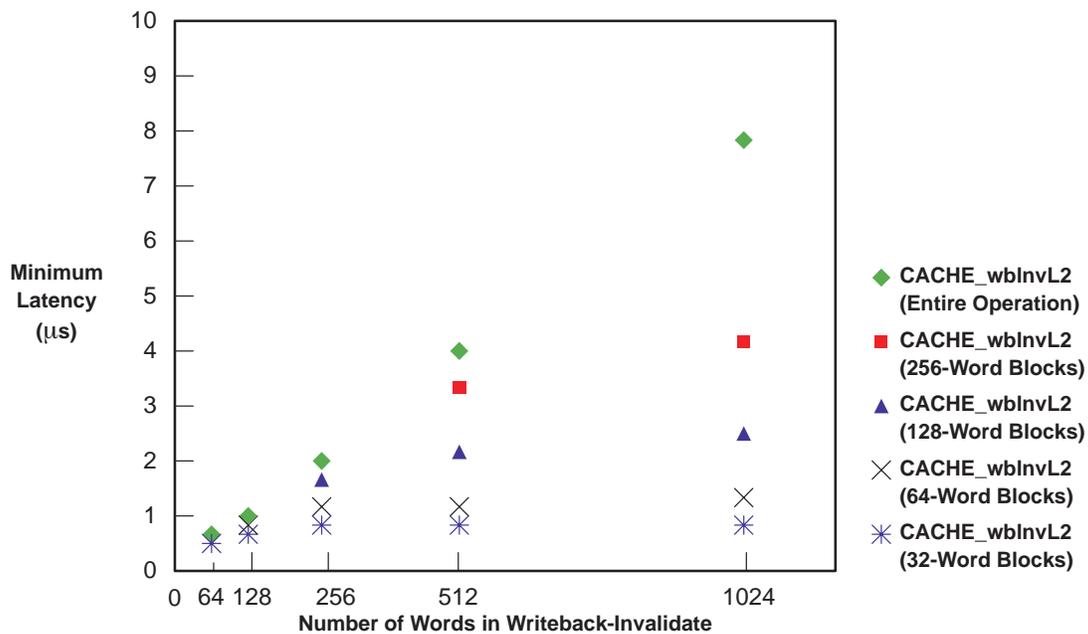
Figure 2. Minimum Required Latency Between McBSP Events for a Successful Transfer with Concurrent L2 Writeback-Invalidates at 200-MHz CPU and 50-MHz EMIF, Using Entire Operations and Block Breakdown

For example, if the CPU is running at 200 MHz with a 50-MHz EMIF and you have a McBSP hard real-time deadline of 5 μ s, Figure 2 shows that a 1024-word L2 writeback-invalidate may cause data loss since back-to-back McBSP events can only be serviced at \sim 8 μ s. By breaking down the L2 writeback-invalidate into 256-word blocks, you can then meet the 5- μ s McBSP deadline. In other words, when performing a 1024-word L2 writeback-invalidate operation with the CPU and EMIF conditions cited above, the McBSP events can be serviced in \sim 8 μ s for the entire operation (one whole block), in \sim 4 μ s when breaking it into 256-word blocks, in \sim 2.5 μ s when breaking it into 128-word blocks, etc.

To avoid cache operations blocking other time-sensitive EDMA accesses, observe the following guidelines:

1. Avoid placing real-time data in EMIF address range. Instead, real-time data should be placed in the L2 address range.
2. If data must be placed in the EMIF address range:
 - Avoid global cache operations in favor of block-based cache operations.
 - Block-based cache operations should be submitted in small blocks, such that the total amount of time that the EMIF is blocked is less than the amount of time between serial samples.

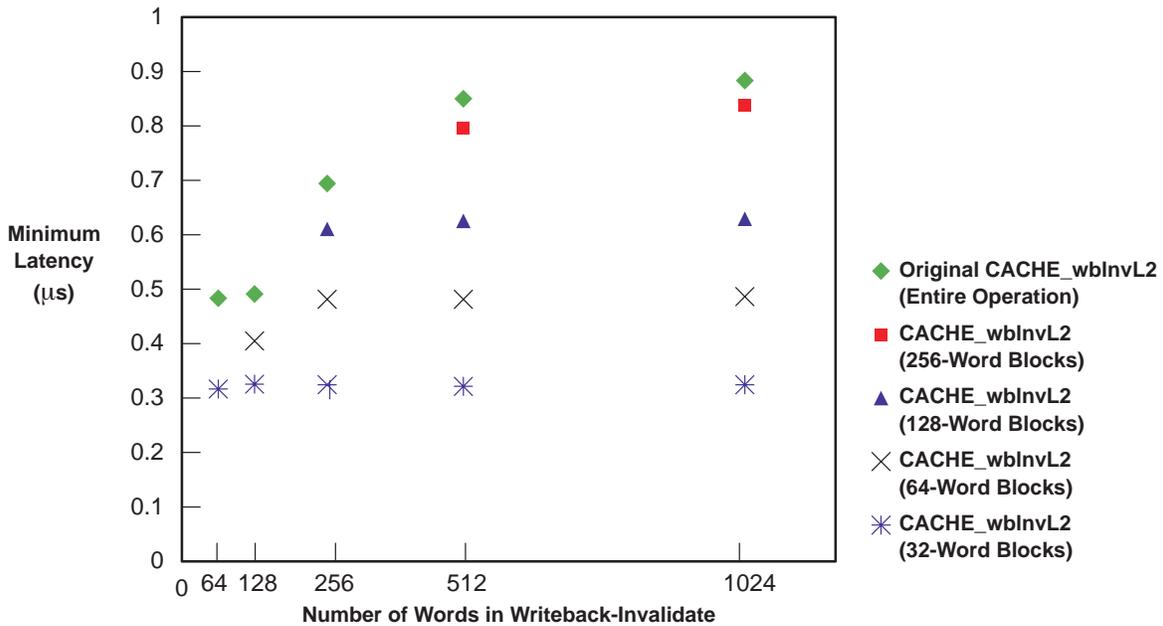
Figure 3. Minimum Required Latency Between McBSP Events for a Successful Transfer With Concurrent Writeback-Invalidates at 225-MHz CPU and 100-MHz EMIF, Using Entire Operations and Block Breakdown

When the CPU is set to 225 MHz and the EMIF is set to 100 MHz, breaking down the cache operations will still improve the block-out problem. Figure 3 shows the improvement in the McBSP’s performance with this frequency ratio.

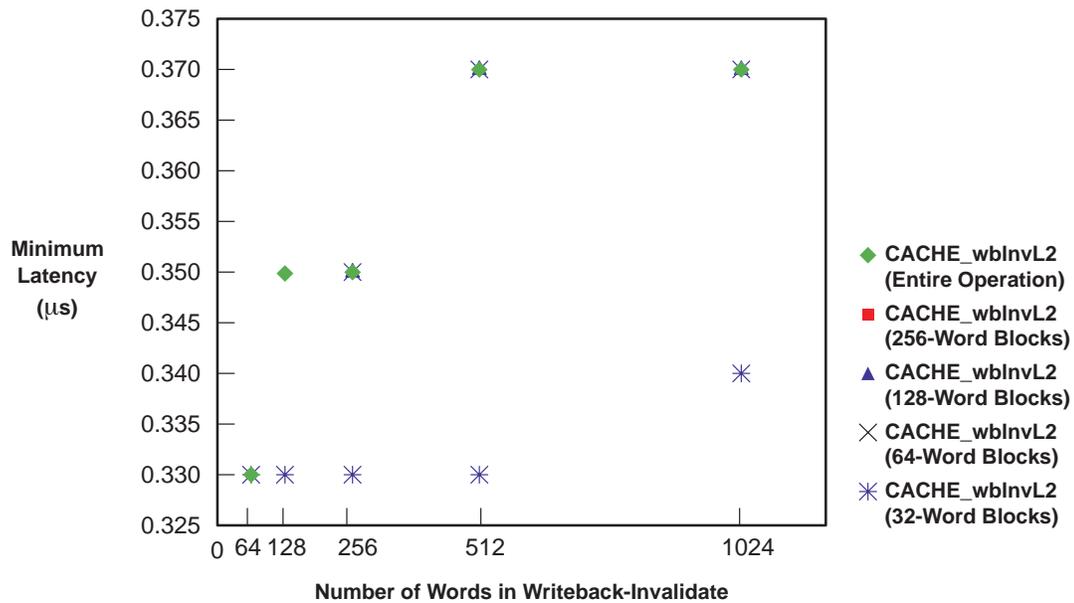
Figure 4. Minimum Required Latency Between McBSP Events for a Successful Transfer With Concurrent Writeback-Invalidates at 150-MHz CPU and 100-MHz EMIF, Using Entire Operations and Block Breakdown

When the CPU is set to 150 MHz and the EMIF is set to 100 MHz, there is virtually no benefit from breaking down the coherency cache operations. Figure 4 shows the McBSP’s performance with this frequency ratio.

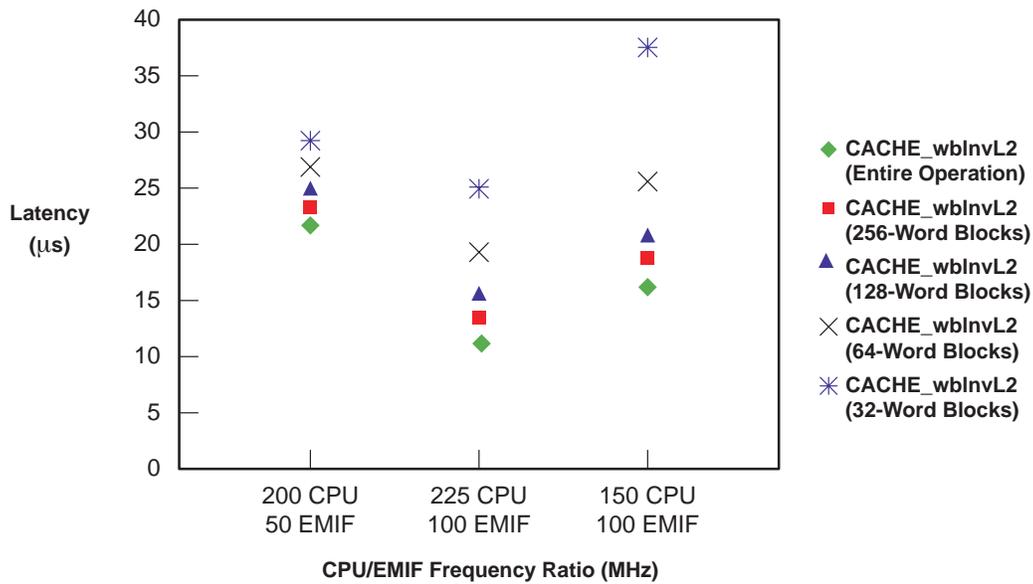
Figure 5. 1024-Word L2 Writeback-Invalidate Performance at Various Frequency Ratios With Old and New CACHE_wbInvL2()

Breaking down the cache operations into smaller blocks takes longer to complete than performing the entire cache function as one large block. Figure 5 shows how much extra overhead is incurred by breaking down an L2 writeback-invalidate operation to transfer 1024 words with different sized blocks and at various frequency ratios. Notice that for the 200-MHz CPU and the 50-MHz EMIF frequency ratio, where the new functions are most critical for peripherals such as the McBSP, the least overhead is incurred.

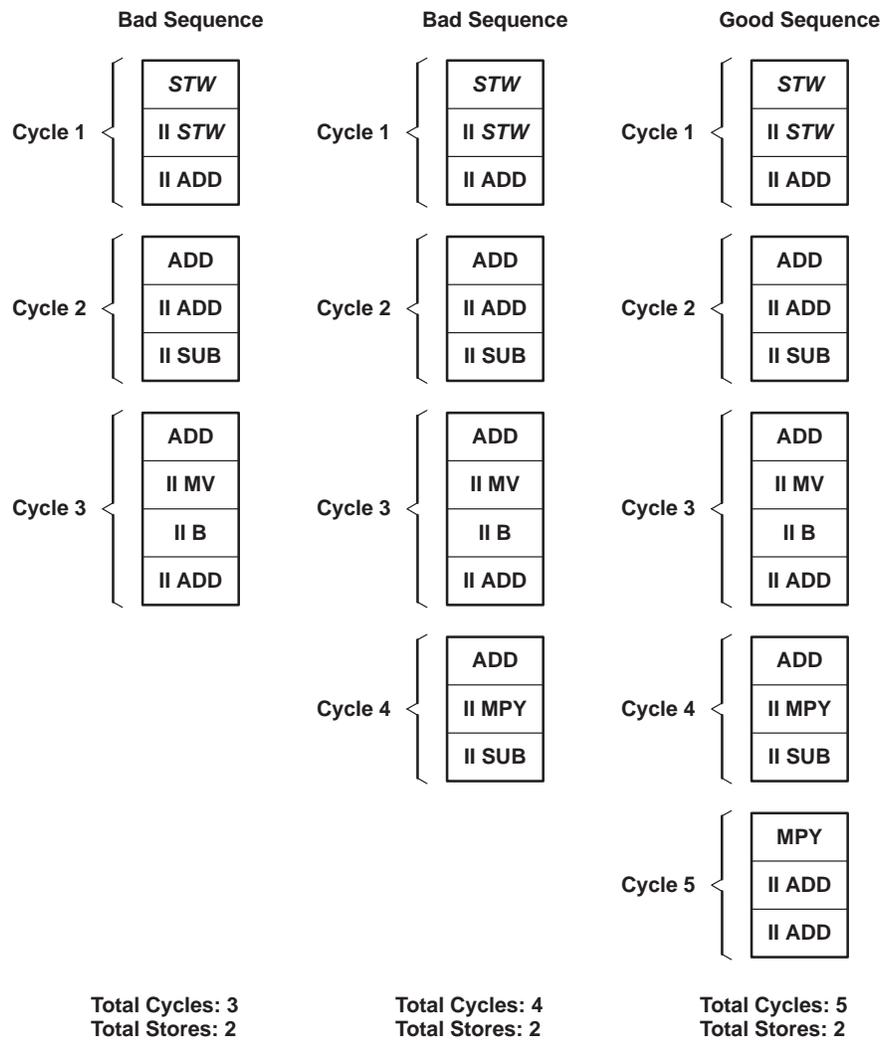
Figure 7. Pseudo Code Example With Parallel Stores (Criteria 2)

Figure 7 outlines this scenario. Note that the STW instruction represents a store of any word size (32-, 16-, or 8-bit).

In most looped code, more than one instruction would likely be executed on each cycle, i.e., instructions would be executed in parallel. In this case, as long as a store is one of the instructions being executed in parallel on a particular cycle, that cycle counts as a cycle on which a store occurs. Instructions with parallel bars (||) at the beginning of the line of assembly execute in parallel with instructions on the preceding line.

- A. Reduce the duration of the loop by breaking into smaller loops. If a particular problem loop has a length of 4 cycles (determined by looking at the software pipeline kernel in the assembly file), and the loop runs 200 times, then the total loop duration is ~800 cycles. If the deadline is 586 cycles, then loop could cause a problem (assuming the loop meets all the other criteria). The workaround is to break the loop into four smaller loops of 50 iterations each. Then any one loop will only run for 200 cycles allowing the EDMA transfer to complete between the smaller loops.

- B. Try to break criteria 2. The quickest way to do this is to turn off optimization for the file containing the problem loop (this is done in the File Specific Options for the file). Instead of using the compiler switch `-o3`, use the compiler switch `-o1` for the particular problem file. This will cause the problem loop to not be software pipelined and less likely to meet criteria 2. The downside to this fix is that all the loops in the particular file will be un-optimized, not just the problem loop.

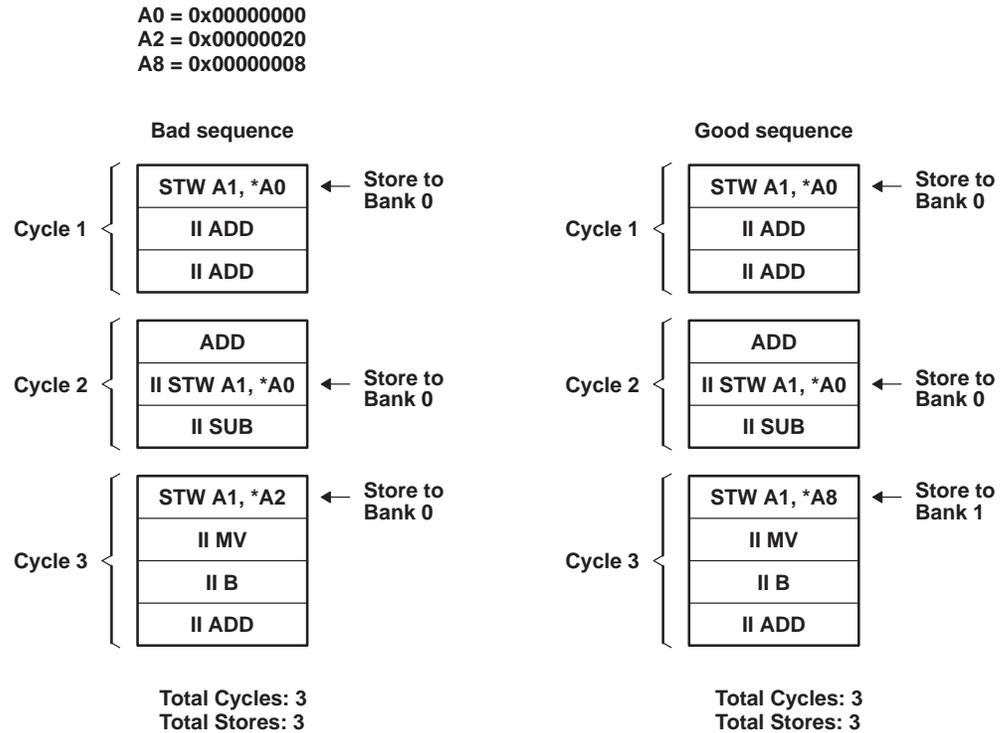
Figure 8. Pseudo Code Example Stores to Specified Banks (Criteria 3)

- All stores in the loop must be to the same bank of L2. If there are any stores to another bank, this will free the first bank long enough for the EDMA access to get in (see Figure 8).

In the case of two stores occurring on the same cycle, in parallel, the same rules apply. If both stores are to the same bank (and there are no other stores in the sequence to a different bank), then a problem may occur. If each of the parallel stores is to a different bank, then the problem cannot occur.

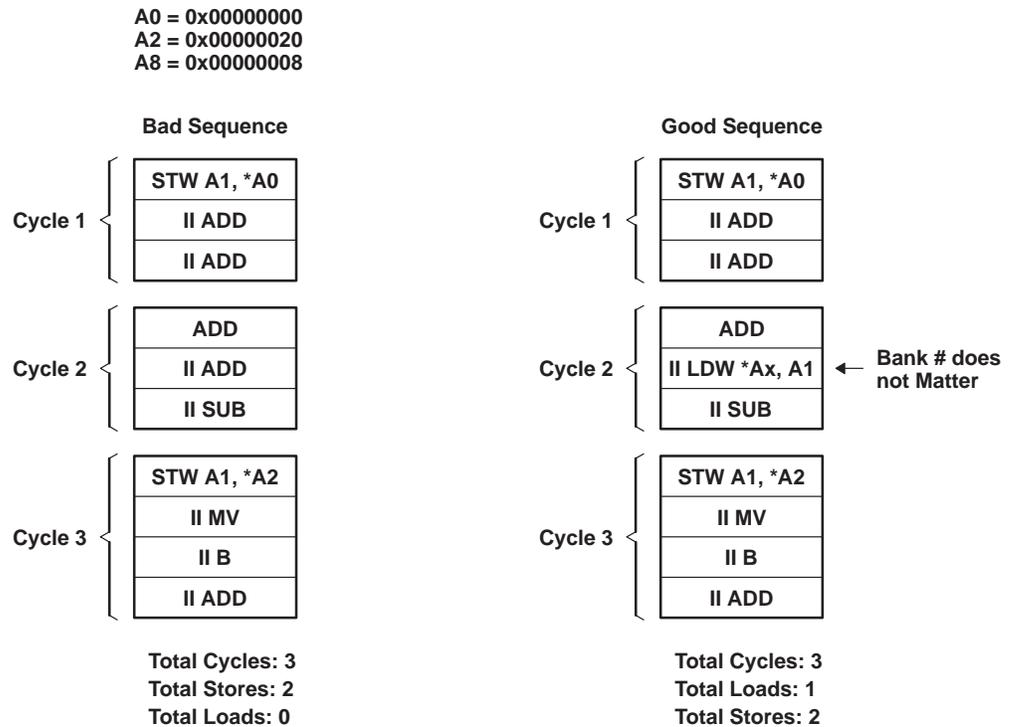
Figure 9. Pseudo Code Example Stores and Loads (Criteria 4)

A load from L2 provides enough of a gap to allow the EDMA to access L2. The good sequence would not cause a problem even if the load were executed in parallel with one of the stores, as long as the load occurred somewhere in the sequence. Notice that although the good sequence satisfies criteria 2 and 3, it would not cause a problem.
