# **TMS320DM6443**

## **Digital Media System-on-Chip**

### **Silicon Revisions 2.3, 2.1, 1.3, 1.2, and 1.1**

## **Silicon Errata**

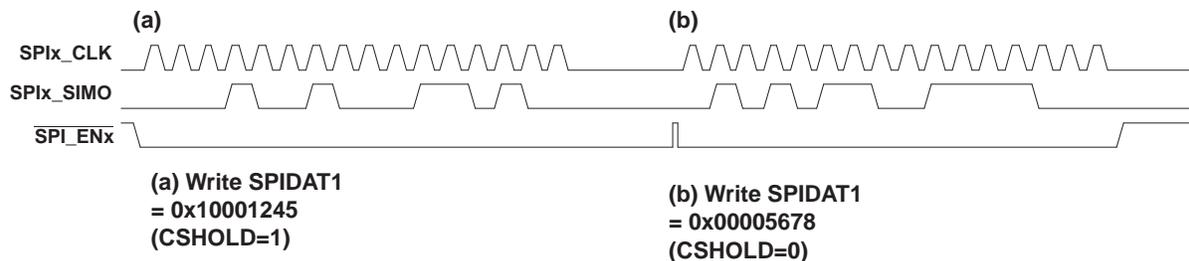
**Figure 3. Actual CSHOLD Behavior—32-Bit Writes to SPIDAT1**

Instead, what actually occurs is that SPI\_ENx is momentarily de-asserted at the beginning of the second write, as illustrated in Figure 3.

**Workaround(s):** For each word in the sequence of words during which  $\overline{\text{SPI\_ENx}}$  should be held low, write to the SPIDAT1 register with the CSHOLD bit set to '1'. Follow this by a write to only the CSHOLD field of SPIDAT1, setting CSHOLD = 0 to de-assert  $\overline{\text{SPI\_ENx}}$ . See [Figure 5](#) for an illustration.

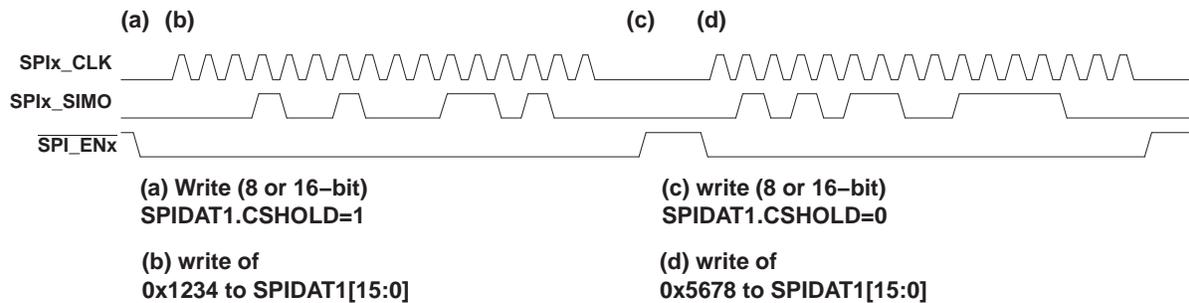
**Figure 4. Actual CSHOLD Behavior—Halfword Writes to SPIDAT1**

Both Figure 2 and Figure 3 assume that SPIDAT1 is written using a single 32-bit write instruction. If SPIDAT1 is instead written using an 8-bit or 16-bit instruction to write to the CSHOLD field, followed by a 16-bit write to the transmit shift register field of SPIDAT1, then what actually occurs is illustrated in Figure 4. This is the same case illustrated in Figure 3 except that the de-assertion of SPI\_ENx lasts for the duration between writing a '0' to the CSHOLD field and writing new data to the transmit shift register.

Alternatively, only write to the SPIDAT1 CSHOLD field before and after the transfer to toggle the  $\overline{\text{SPI\_ENx}}$  pin. During the transfer, write only to the data field of SPIDAT1[15:0] using 16-bit (halfword) write commands. For an illustration, see [Figure 6](#).

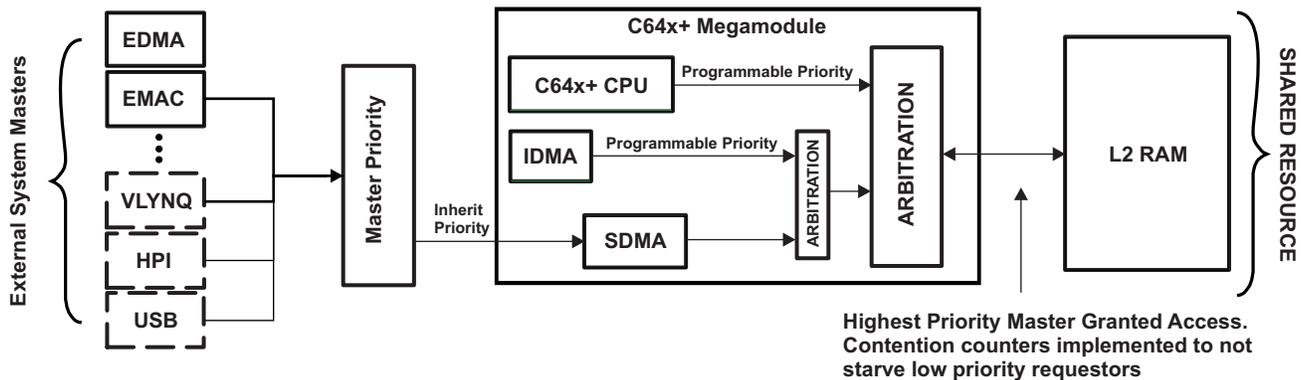
**Figure 8. Priority Arbitration Scheme for L2 RAM**

Ideally, the BWM arbitration will grant equal L2 bandwidth between equal priority DMA and CPU requests. Instead, when requests arrive at the BWM such that the CPU priority is *lower than or equal to* the DMA priority, the bandwidth is always granted in favor of the CPU over the DMA. In the case of successive CPU requests, it is possible for the CPU to block all DMA requests until the CPU traffic subsides. [Figure 8](#) shows a high-level diagram of the arbitration scheme used for L2 RAM requests.

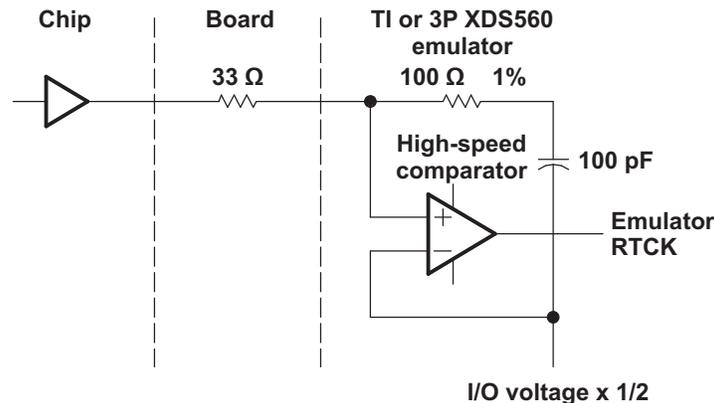
**Figure 10. Typical Emulation Interface Circuit**

Figure 10 illustrates the typical hardware interface between the TMS320DM644x DSP and the current TI or third-party debug controller pod. This combination of debug controller pod and DSP may not work reliably for two reasons:

- The RTCK and TDO buffers have approximately 100 Ω output impedance and rise and fall time of 5 ns and 4 ns respectively to minimize EMI and switching noise.
- The emulation pod is designed for a low impedance high drive output buffer with less than 3-ns rise/fall time. The debug controller pod expects the chip to drive the AC termination inside the emulation pod shown in Figure 10.

The 100 Ω chip buffer impedance, combined with 33 Ω series termination on the target board creates a voltage divider at the debug controller pod terminal with a RC time constant on the order of 10 ns. The slow 10 ns rise time causes the debug controller pod input to oscillate as the signal passes through the switching threshold. In addition, at faster debug controller pod operating frequencies (max TCK = 34 MHz), the RTCK and TDO signals are not able to swing to the full range (0 V - 1.8 V), instead these signals swing between 0.4 V and 1.45 V.

**Workaround:** Four solutions are recommended, based on the selected debug controller pod and DSP target combination.
