TMS320DM6437/35/33/31
Digital Media Processor (DMP)
Silicon Revisions 1.3, 1.2, 1.1, and 1.0

Silicon Errata

Literature Number: SPRZ250E
January 2007–Revised August 2011

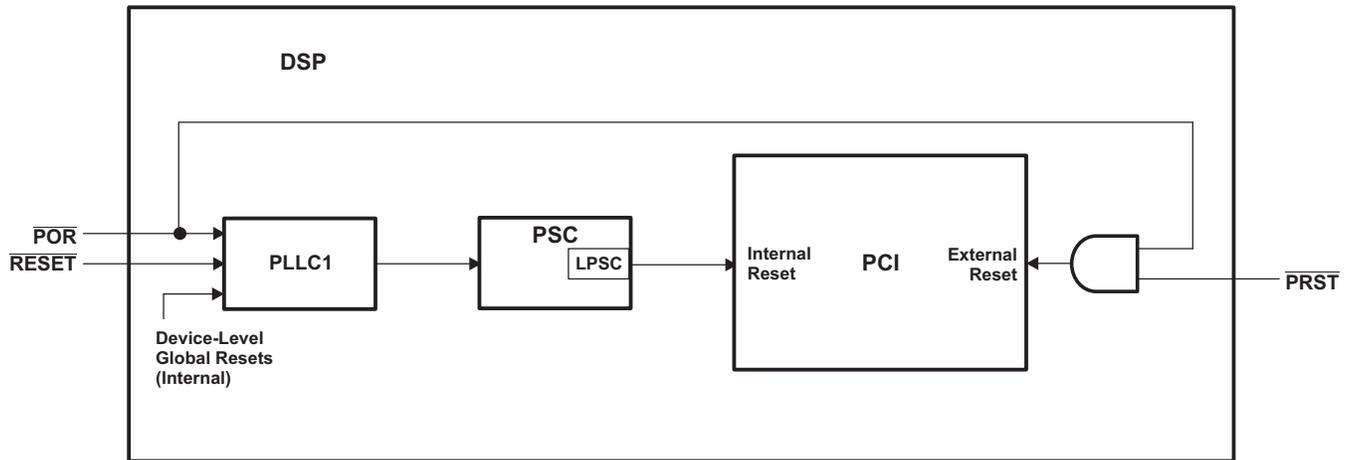
Figure 3. Internal and External Reset Inputs of the PCI Module

On all DM6437 and DM6433 silicon revisions, the PCI module has both an internal and external reset source (see Figure 3). The external reset is asserted through *either* the PCI Reset pin ($\overline{\text{PRST}}$) or the Power-On Reset pin ($\overline{\text{POR}}$). The internal reset is controlled by the Local Power and Sleep Controller (LPSC) of the PCI module. The PSC asserts the internal reset of the PCI module after a device-level global reset or when the DSP code programs the PSC to do so. A device-level global reset is generated through the Power-On-Reset pin ($\overline{\text{POR}}$) or the Warm Reset pin ($\overline{\text{RESET}}$); however, there are other methods to generate a device-level global reset. For these other methods, see Table 4.

Systems should be designed such that a device-level global reset *always* generates the PCI Reset ($\overline{\text{PRST}}$) and vice-versa. The PCI module can lock-up or go into a bad state if its internal and external resets are asserted independently—meaning one is asserted and the other is not.

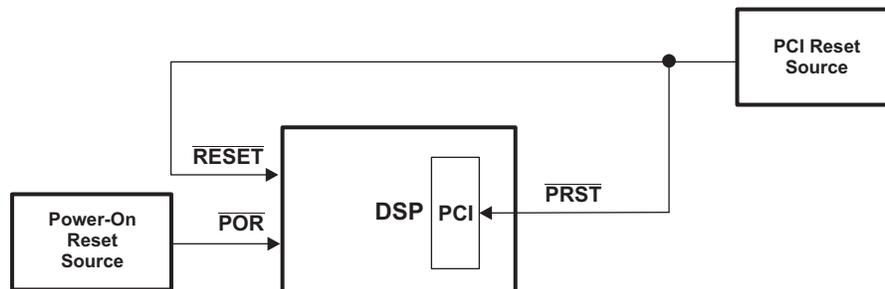
Figure 4. PCI Reset ($\overline{\text{PRST}}$) and Warm Reset ($\overline{\text{RESET}}$) Tied Together from Single External Source

Figure 4 and Figure 5 show example circuits which ensure both the device-level global reset and the PCI Reset ($\overline{\text{PRST}}$) are asserted together.

In [Figure 4](#) and [Figure 5](#) a device-level global reset resets the DSP and the PCI module only; other devices on the PCI bus *will not* be reset. To avoid interrupting any ongoing PCI transactions to/from the DSP, the DSP PCI should be "disconnected" from the PCI system.

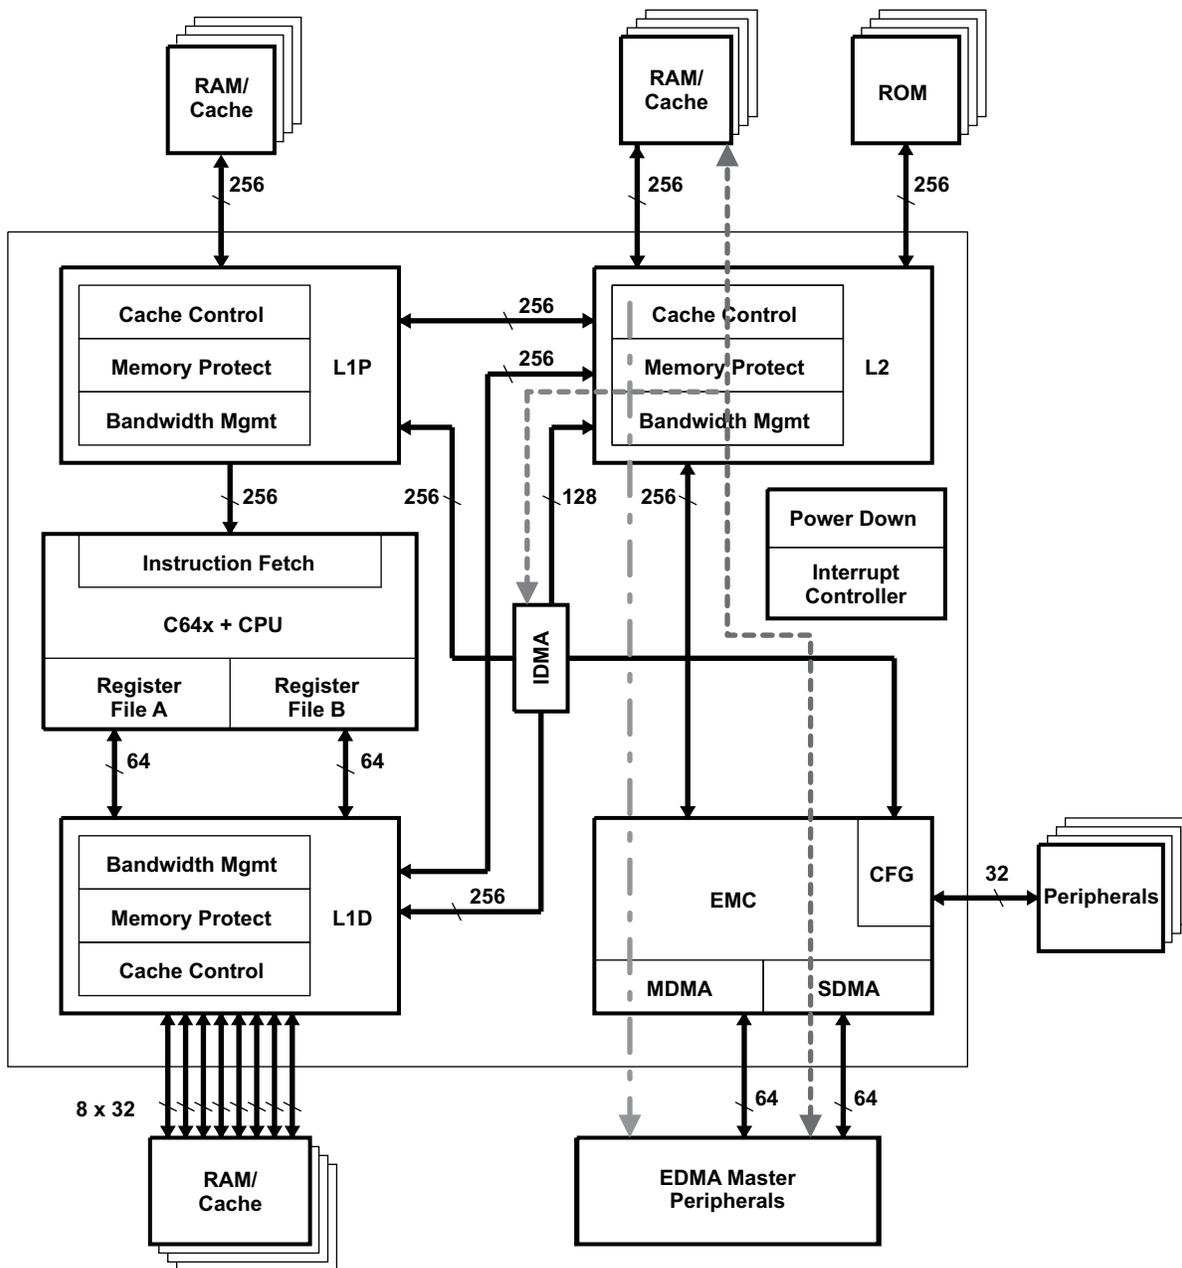
Figure 6. IDMA, SDMA, MDMA Paths

Ideally, the MDMA (dashed-dotted line in [Figure 6](#)) and SDMA/IDMA paths (dashed lines in [Figure 6](#)) operate independently with minimal interference. Normally MDMA accesses may stall for extended periods of time due to expected system level delays (e.g., bandwidth limitations, DDR2 memory refreshes). However, when using L2 as RAM, SDMA and IDMA accesses to L2/L1 may experience unexpected stalling in addition to the normal stalls seen by the MDMA interface. For latency-sensitive traffic, the SDMA stall can result in missing real-time deadlines. In a more severe case, the SDMA stall can produce a deadlock condition in the device. An IDMA stall cannot produce a deadlock condition.

[Figure 6](#) is provided for illustrative purposes and is incomplete for simplification. The IDMA/SDMA (dashed-lines) path could also go to L1D/L1P memories, and IDMA can go to DSP CFG peripherals. MDMA transactions can originate also from L1P or L1D through the L2 controller or directly from DSP.

Entirely eliminate IDMA/SDMA stalling and potential for a deadlock condition using one or both of the following methods:
