**TMS320C6745**  
**Fixed- and Floating-Point**  
**Digital Signal Processor**  
**Silicon Revisions 3.0, 2.1, 2.0, 1.1, and 1.0**

## **Silicon Errata**

Literature Number: SPRZ253G  
May 2009–Revised June 2014

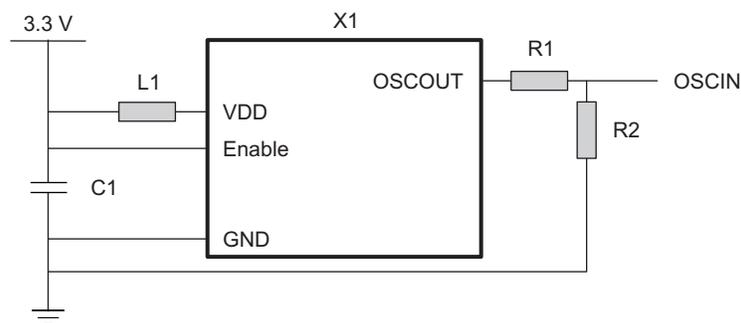
**Figure 1. External 3.3V Clock Source**

On all silicon revisions, certain design elements make this device susceptible to radiated noise during an ESD strike, as described in the standard IEC 61000-4-2. Exposure to the electrical noise caused by the ESD can cause soft device failures due to noise coupling on the system clock (OSCIN). ESD events within the IEC spec range do not cause permanent device damage and full functionality is recoverable with a device reset. The sensitivity to this noise issue is primarily due to the 1.2V oscillator/clock input implemented on this device. The low voltage range, coupled with slow rise and fall times, provides a lower noise margin than other TI devices with higher voltage internal oscillators (for example, 1.8V or 3.3V oscillators).

If ESD robustness is a concern, it is strongly recommended to avoid using the internal oscillator as a clock source. An external 3.3V clock source with a resistor voltage divider as in [Figure 1](#) can be used to externally generate the required 1.2V input clock. By using an external clock input with fast rise/fall times (less than 5 ns), the noise margin improves significantly, increasing ESD noise resistance.

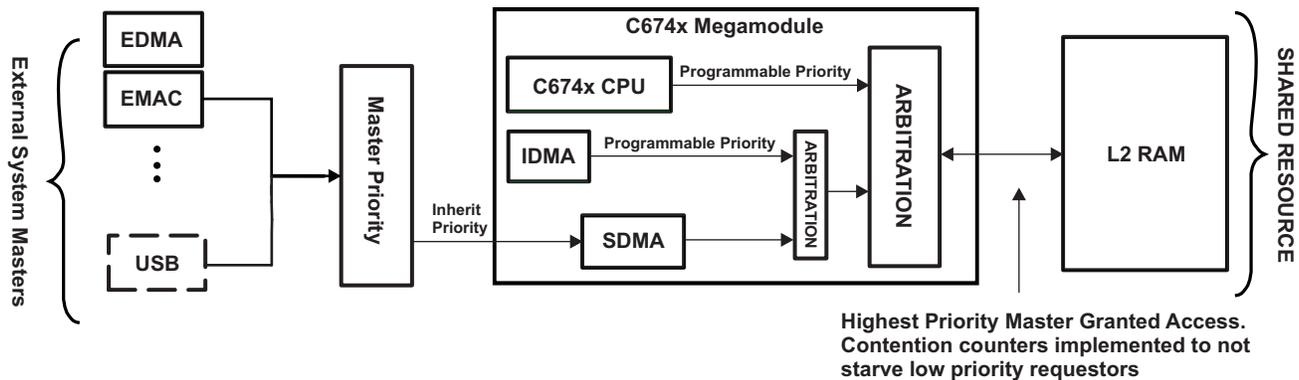
**Figure 2. Priority Arbitration Scheme for L2 RAM**

Ideally, the BWM arbitration will grant equal L2 bandwidth between equal priority DMA and CPU requests. Instead, when equal priority DMA and CPU requests arrive at the BWM, bandwidth is always granted in favor of the CPU over DMA. In the case of successive CPU requests, it is possible for the CPU to block all DMA requests until CPU traffic subsides. Additionally, some command logic in the BWM uses priority level 7, which can also result in SDMA stalls when the CPU is also programmed to priority level 7. [Figure 2](#) shows a high level diagram of the arbitration scheme used for L2 RAM requests.

**Workaround(s)** Configure DMA and CPU requests to different priority levels. The CPU should not be set to priority level 7. There is no penalty for setting the IDMA and SDMA priorities equal to each other.

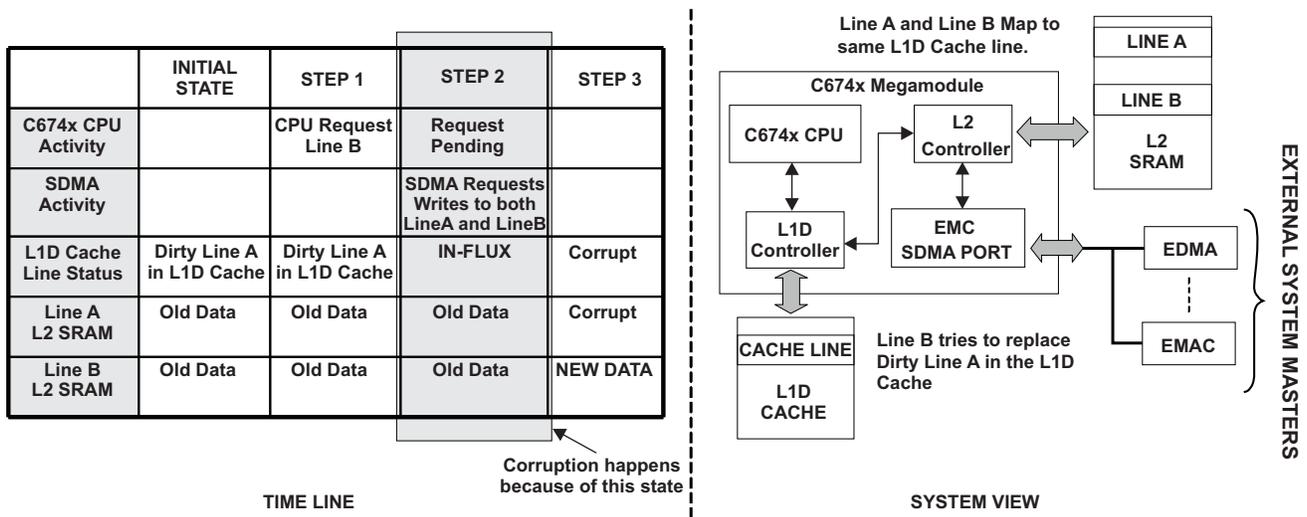
**Figure 4. Example of L1D Cache and L2 RAM Corruption**

1. L1D cache evicts a dirty line (Line A) while allocating a new line (Line B) in the same set/way (cache Lines A and B consist of 64-bytes each). In order for this to happen, the following will have taken place:
  - (a) Line A was previously read by CPU because L1D is a read-allocate cache,
  - (b) Line A is dirty because its value was modified by CPU, and
  - (c) Line B is read by CPU
2. Both Line A and Line B are associated with L2 RAM, and
3. While the original L1D victim write-back from condition (1) is in progress, the SDMA performs both:
  - (a) a read or write operation to Line A in L2 RAM and
  - (b) a write operation to Line B in L2 RAM.

If all of the above conditions are met, the L2 RAM data associated with the Line A victim writeback will become corrupt. Additionally, the Line B data originating from the SDMA write will also become corrupt in L1D cache. [Figure 4](#) shows an example scenario of L1D cache and L2 RAM corruption.

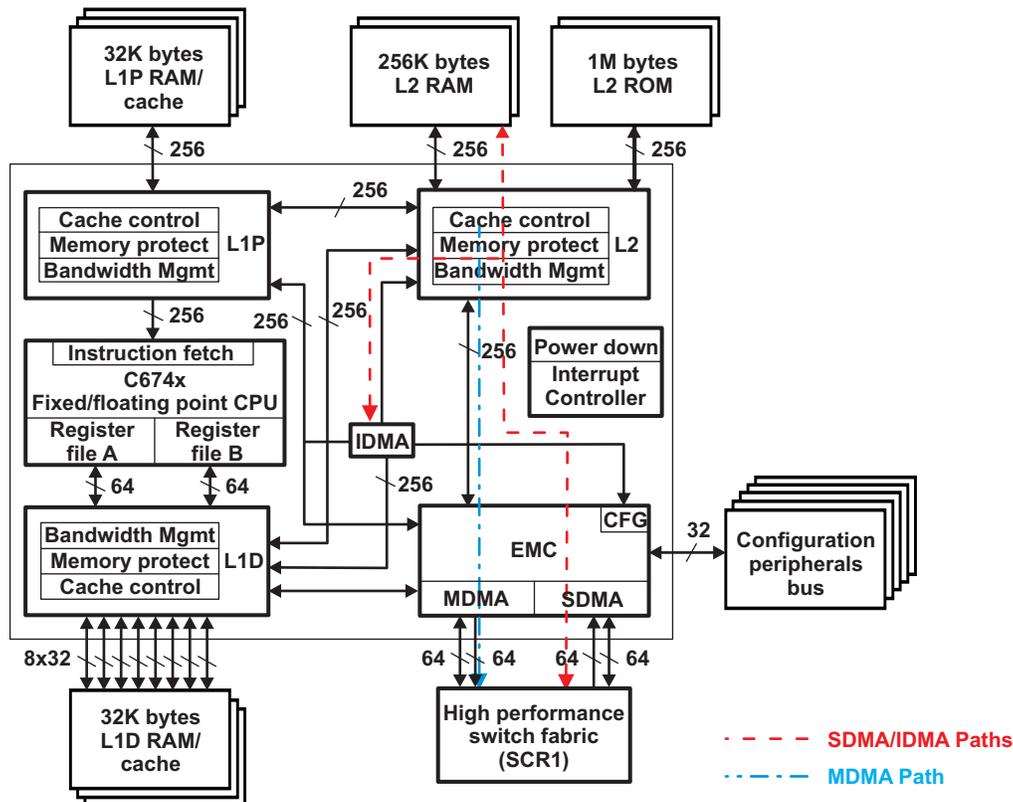
Figure 5. C674x Megamodule

Ideally, the MDMA (dashed-dotted line in [Figure 5](#)) and SDMA/IDMA paths (dashed lines in [Figure 5](#)) operate independently with minimal interference. Normally MDMA accesses may stall for extended periods of time due to expected system level delays (for example, bandwidth limitations). However, when using L2 as RAM, SDMA and IDMA accesses to L2/L1 may experience unexpected stalling in addition to the normal stalls seen by the MDMA interface. For latency-sensitive traffic, the SDMA stall can result in missing real-time deadlines. In a more severe case, the SDMA stall can produce a deadlock condition in the device. An IDMA stall cannot produce a deadlock condition.

**Note:** SDMA/IDMA accesses to L1P/D will not experience an unexpected stall if there are no SDMA/IDMA accesses to L2. Unexpected SDMA/IDMA stalls to L1 happen only when they are pipelined behind L2 accesses. Additionally, the deadlock scenario will be avoided if there are no SDMA accesses to L2.

1. Configure the entire L2 RAM as 100% cache (for example, move all data buffers from L2 to L1D or other memory). Note: Some throughput degradation is expected when the buffers are moved out to external memo
2. Eliminate all IDMA/SDMA access to L2 RAM when IDMA/SDMA stalling would have an impact by performing one of the following:
  - (a) Constrain each DMA master group to perform writes to either DSP memory space or external memory space, but not to both, or

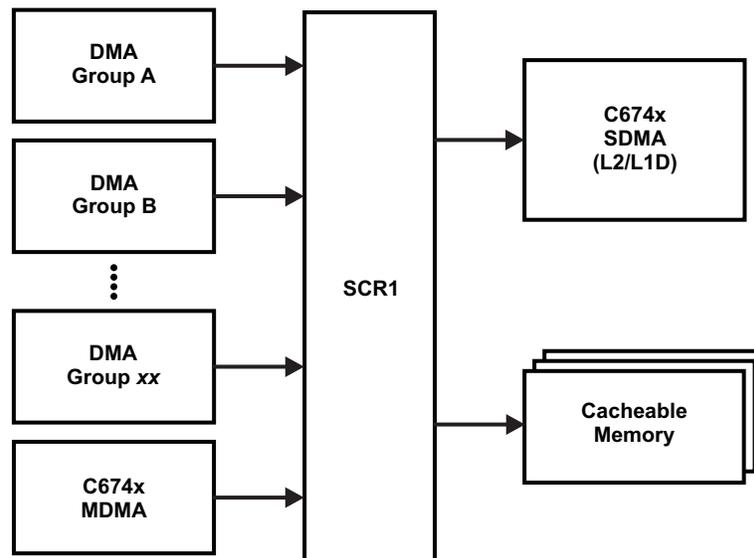
**Figure 6. SCR1 System Interconnect**

Step 2: The DSP's SDMA asserts itself as not ready and is unable to accept the write data from Step 1, and a cache line writeback is initiated from DSP memory to the same cacheable memory from Step 1. The cache line writeback command also passes through SCR1.

With the above scenario, it is possible for SCR1 to order the write commands from Step 1 in front of the write commands from Step 2. Due to the MDMA/SDMA blocking behavior, the SDMA commands from Step 2 will be waiting for the MDMA traffic from Step 1 to finish, resulting in a deadlock situation at SCR1. Figure 6 is provided for illustrative purposes and is incomplete because of simplification.
