TMS320DM355
Digital Media System-on-Chip (DMSoC)
Silicon Revision 1.1, 1.3, and 1.4

Silicon Errata

Literature Number: SPRZ264E
September 2007–Revised July 2010

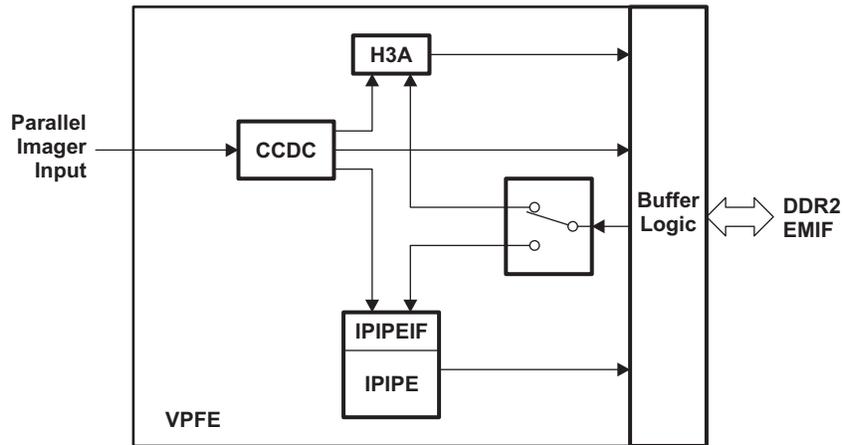
Figure 2. Video Processing Front End (VPFE) Block Diagram and Data Flows

Details This problem affects H3A auto white balance, auto exposure, and auto focus when the image sensor data is large (i.e. greater than approximately 10 mega pixels) and the data path is from imager to CCDC to H3A .

When the H3A module receives more than 4096 pixel clock cycles between consecutive HD rising edges, the H3A internal line buffer may become corrupt. The internal line buffer address is reset to zero at HD rising edge, is incremented every pixel clock cycle, and wraps back to address zero after 4096 pixel clocks. H3A calculations may not be correct when the line buffer is corrupt.

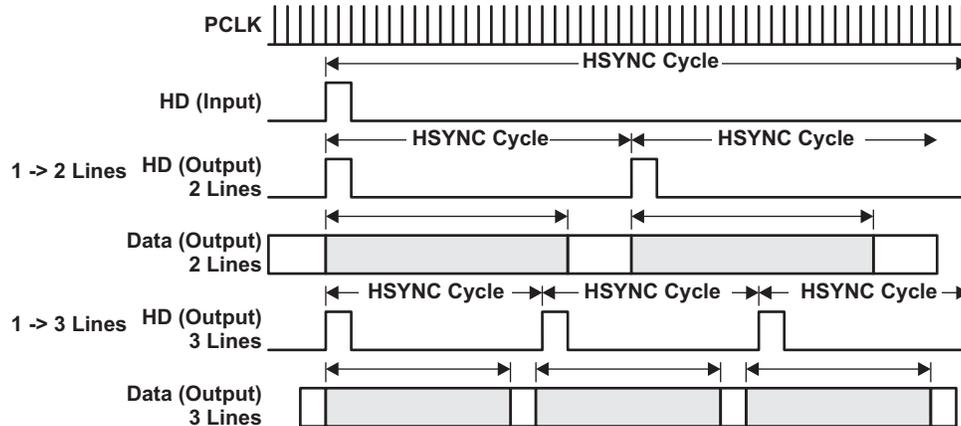
Figure 6. Readout Patterns Comparing Timing at the Output of the Reformatter

two lines of actual image data per HSYNC, then the reformatter will convert the data from one to two lines, internally. The number of pixel clock cycles between consecutive HD rising edges that the H3A modules receives corresponds to the timing at the output of the reformatter.

2. Use the imager's movie readout mode.
In the imager's movie readout mode the problem does not occur, because the number of horizontal pixels and blanking are less than 4096 pixels and the H3A module receives less than 4096 pixel clock cycles between consecutive HD rising edges.
Note that the number of pixel clock cycles between consecutive HD rising edges that the H3A module receives is determined by the external or internal timing generator and also, if used, by the reformatter inside the CCDC. The reformatter is used when imagers have special readout patterns. For example, if the readout pattern contains

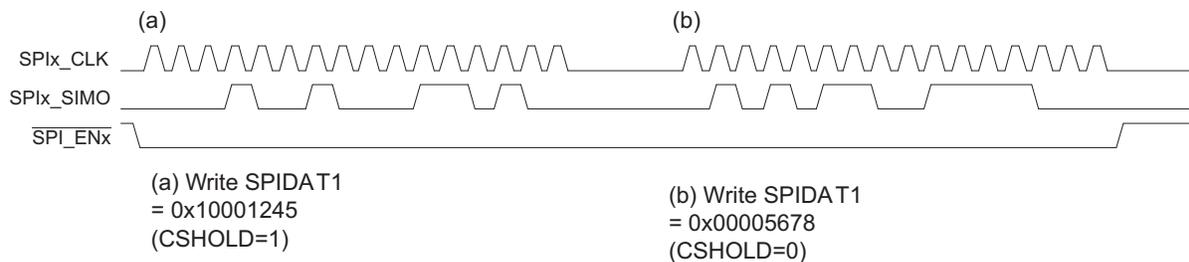
Figure 7. Expected CSHOLD Behavior

According to the SPI specification, the following sequence should produce the expected result as illustrated in [Figure 7](#):

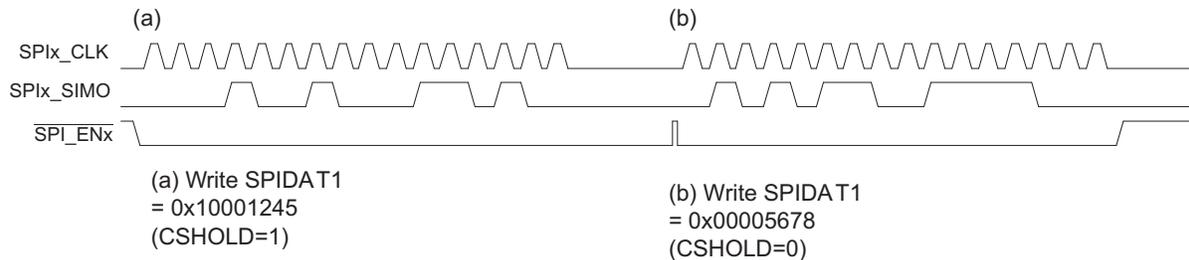
Figure 8. Actual CSHOLD Behavior—32-Bit Writes to SPIDAT1

Instead, what actually occurs is that $\overline{\text{SPI_ENx}}$ is momentarily de-asserted at the beginning of the second write, as illustrated in [Figure 8](#).

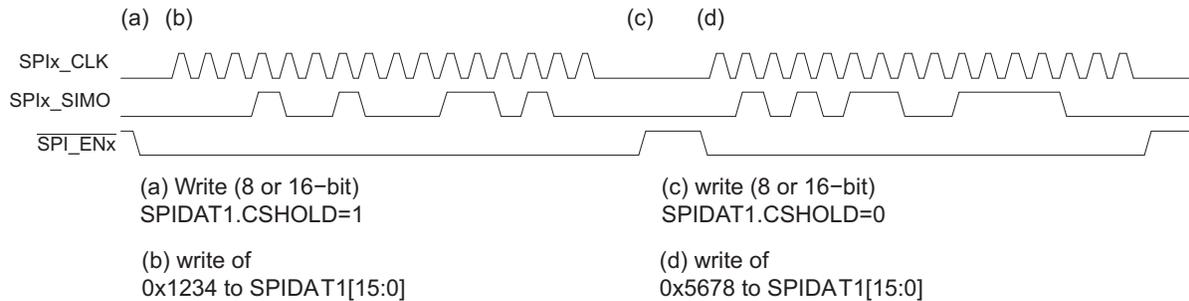
Figure 9. Actual CSHOLD Behavior—Halfword Writes to SPIDAT1

Both Figure 7 and Figure 8 assume that SPIDAT1 is written using a single 32-bit write instruction. If SPIDAT1 is instead written using an 8-bit or 16-bit instruction to write to the CSHOLD field, followed by a 16-bit write to the transmit shift register field of SPIDAT1, then what actually occurs is illustrated in Figure 9. This is the same case illustrated in Figure 8 except that the de-assertion of SPI_ENx lasts for the duration between writing a '0' to the CSHOLD field and writing new data to the transmit shift register.
