**TMS320VC5506**  
**Digital Signal Processor**  
**Silicon Errata**

SPRZ271A  
August 2008 – Revised August 2008

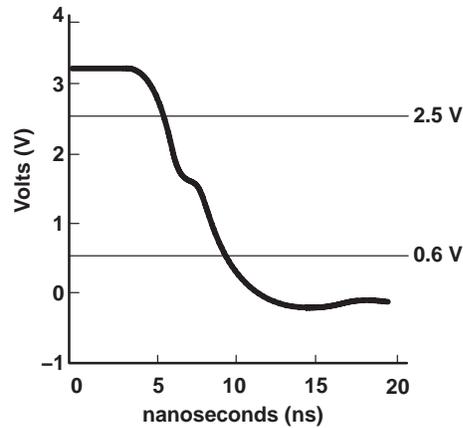
**Figure 3. Bad TCK Transition**

A TCK edge that can cause this problem might look similar to the one shown in Figure 3. A TCK edge that does not cause the problem will look similar to the one shown in Figure 4. The key difference between the two figures is that Figure 4 has a clean and sharp transition whereas Figure 3 has a “knee” in the transition zone. Problematic TCK signals may not have a knee that is as pronounced as the one in Figure 3. Due to the TCK signal amplification inside the chip, any perturbation of the signal can create erroneous clock edges.

When examining a TCK signal for this issue, either in board simulation or on an actual board, it is very important to probe the TCK line as close to the DSP input pin as possible. In simulation, it should not be difficult to probe right at the DSP input. For most physical boards, this means using the via for the TCK pad on the back side of the board. Similarly, ground for the probe should come from one of the nearby ground pad vias to minimize EMI noise picked up by the probe.

As the problem may be caused by one or more of the above factors, one or more of the steps outlined below may be necessary to fix it:
