Errata

TMS320F2833x, TMS320F2823x Real-Time MCUs Silicon Errata (Silicon Revisions A, 0)

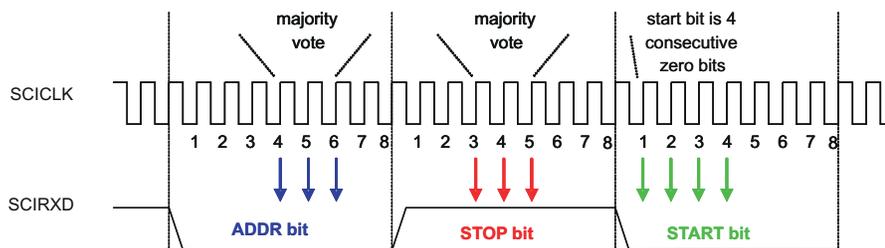
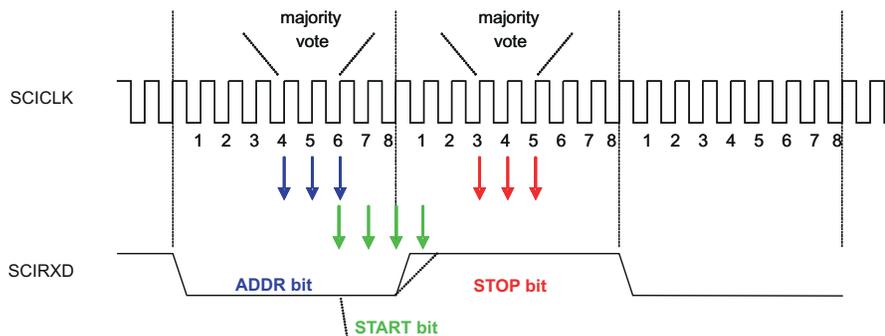
Figure 3-1. Difference Between Expected and Erroneous Operation of START Bit

SCI does not look for STOP bit after the ADDR bit. Instead, SCI starts looking for the start bit beginning on sub-sample 6 of the ADDR bit. Slow rise-time from ADDR to STOP bit can cause the false START bit to occur since the 4th sub-sample for the start bit may be sensed low.

Program the baud rate of the SCI to be slightly slower than the actual. This will cause the 4th sub-sample of the false START bit to be delayed in time, and therefore occur more towards the middle of the STOP bit (away from the signal transition region). The amount of baud slowing needed depends on the rise-time of the signal in the system. Alternatively, IDLE mode of the SCI module may be used, if applicable.

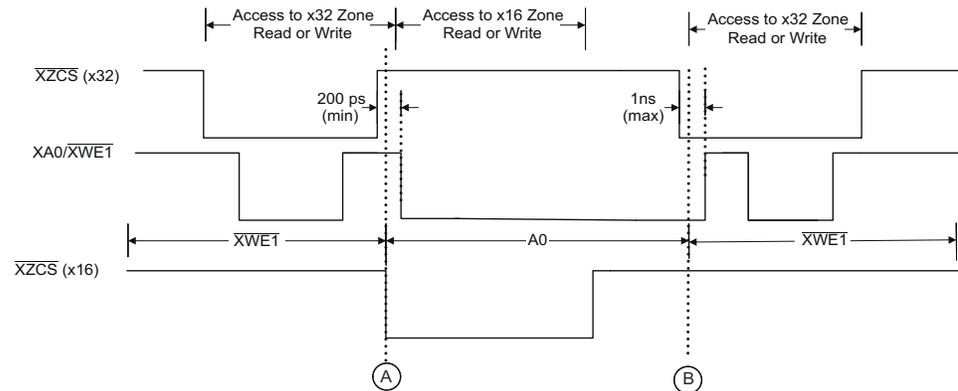
Figure 4-1. Behavior of Zone Chip Select Signals and XA0/ $\overline{\text{XWE1}}$

Figure 4-1 shows the behavior of zone chip select signals and XA0/ $\overline{\text{XWE1}}$ for back-to-back accesses between zones configured for different data bus widths.

- A. Design simulation data indicates the delta between $\overline{\text{XZCS}}$ (x32) high and XA0/ $\overline{\text{XWE1}}$ low can be as small as 200 ps.
- B. Design simulation data indicates XA0/ $\overline{\text{XWE1}}$ can stay low for as long as 1 ns after $\overline{\text{XZCS}}$ (x32) goes low.

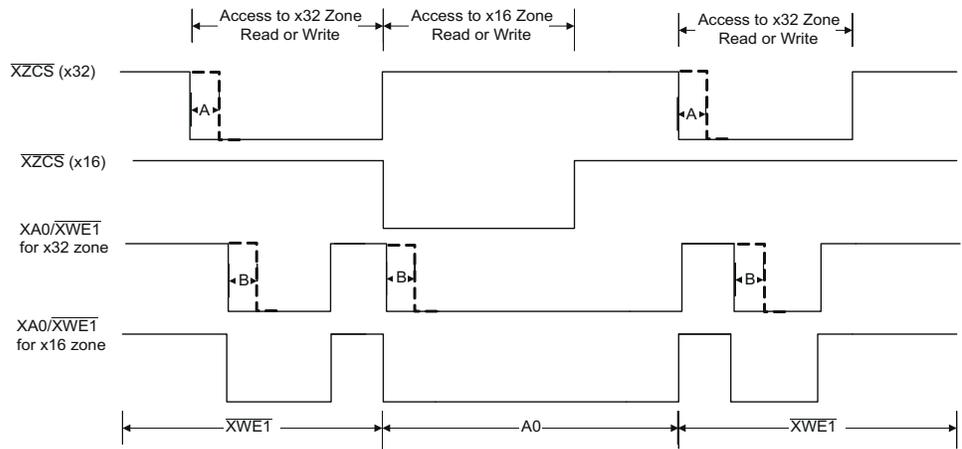
Figure 4-2. Behavior After Application of Delay

- A. Delayed falling edge of zone chip select for x32 zone.
- B. Delayed falling edge of $\overline{XWE1}$. The x16 zone will not see this delay.

The timing configuration of the x32 zone must account for the additional delay. The zone chip select delay may require additional lead time. The $\overline{XWE1}$ delay enable may require additional active write time. In addition, specify at least 1 trail cycle for writes to the x32 zone.
