# **TMS320C6652/54/55/57**

#### **Silicon Revision 1.0**

## **Silicon Errata**

Literature Number: SPRZ381C  
April 2012–Revised May 2016

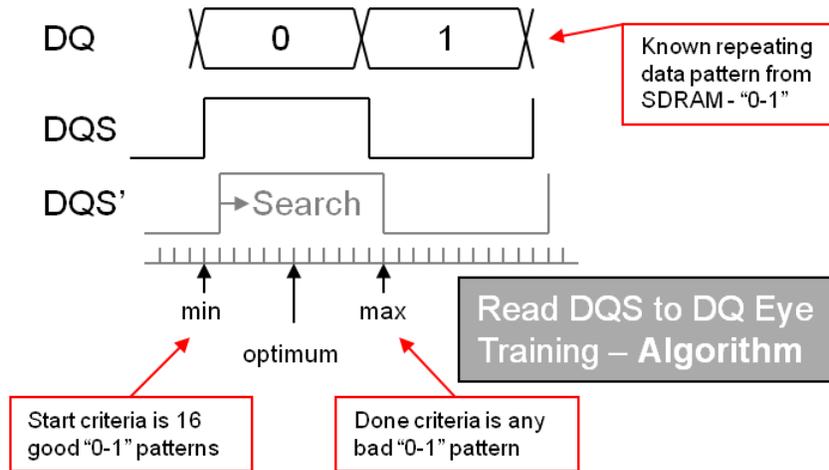
Figure 3. Read DQS to DQ Eye Training - Algorithm

As shown in Figure 3, the Read Data Eye Training algorithm should correctly detect the extents of the DQ data eye. The SDRAM are put into a DQS to DQ eye training mode and read back an alternating 0, 1 pattern.

The DDR3 PHY uses this pattern to detect good or bad data being sampled by the DQS transitions. The DDR3 PHY searches by delaying DQS relative to DQ until these constraints are found.

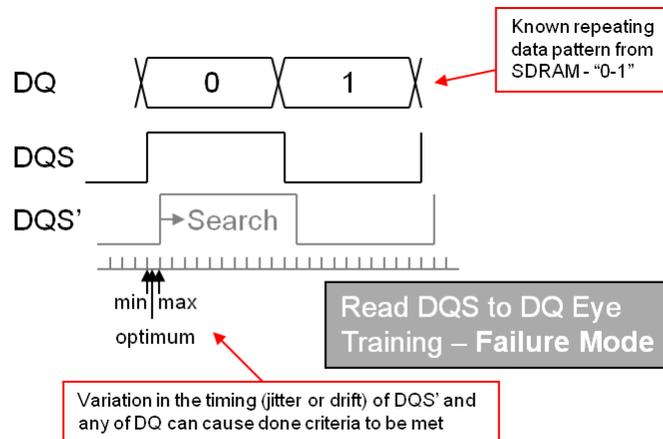
Figure 4. Read DQS to DQ Eye Training - Failure Mode

The leveling feature with the problem is the Read Data Eye Training. Depending on the jitter seen on the DQ and DQS signals, this leveling feature will fail to converge on a good data eye, resulting in corrupted DSP to DDR3 SDRAM reads.

However, if too much jitter is present on the DQ or DQS signals, the search can converge to a false edge as shown in Figure 4.

- Workaround 1:** The DDR3 PHY in the device has the ability to complete auto-leveling of the write leveling values and the read DQS gate training values separate from the read data eye training. Then a fixed value is used as the read data eye sample point. This solution is functional on standard DDR3 fly-by layouts and is referred to as Partial Automatic Leveling. It has been validated for robust operation at DDR3-1333 when connected to either a UDIMM or with a discrete SDRAM implementation.

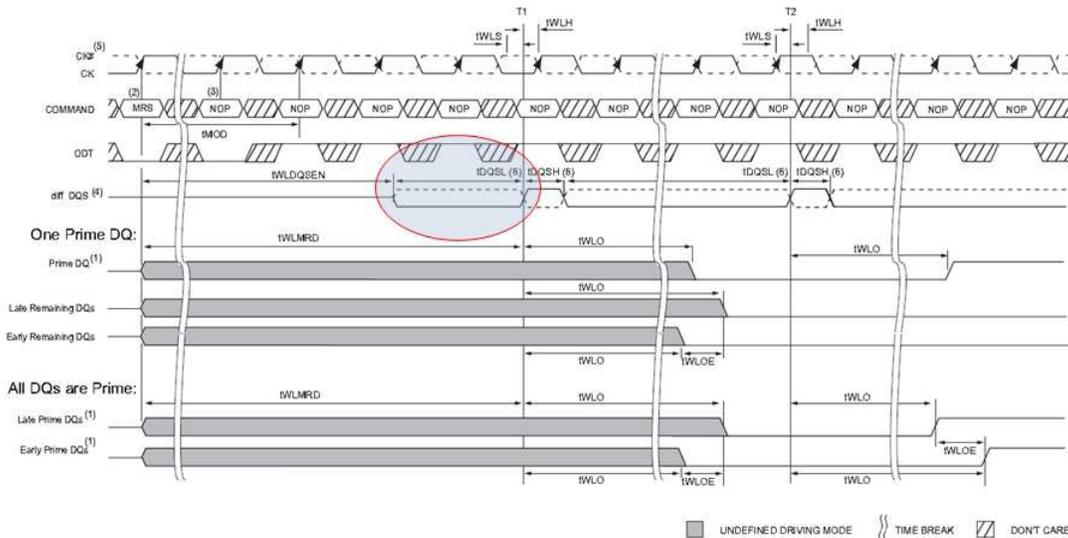
**Figure 5. Timing Details of Writing Leveling Sequence**

As shown in Figure 5, the DDR3 JEDEC standard requires that the DQS strobe be sent with a preamble (DQS=0) for at least tDQSL during write leveling, prior to the first rising edge of the DQS strobe (DQS=1). It was observed in simulations that the first DQS strobe is sent immediately following the high impedance state of the DQS line and without a preamble. This Z->1 transition on the DQS line may allow incremental write leveling to fail. Note that this issue impacts only the incremental write leveling feature of the DDR3 Memory controller. No issue is expected with automatic write leveling.

At this time, incremental write leveling is not supported on this device and we recommend that the incremental write leveling intervals in RDWR\_LVL\_CTRL and RDWR\_LVL\_RMP\_CTRL be programmed to 0 to disable this feature.

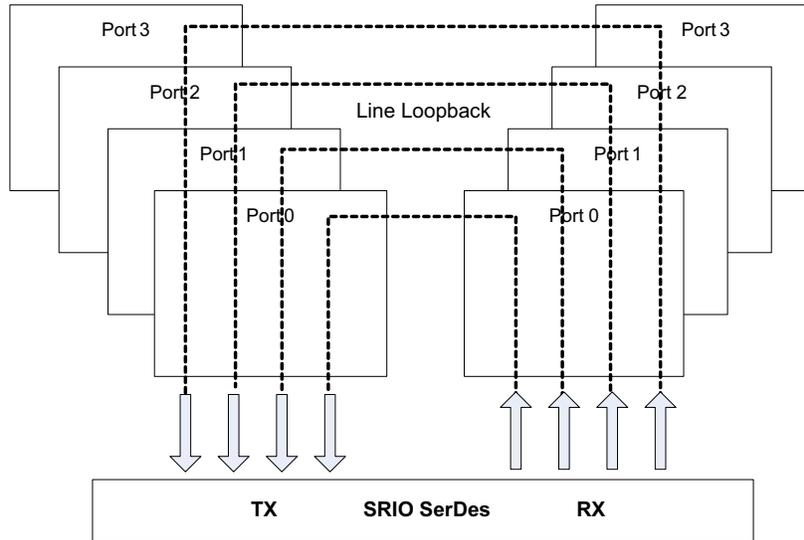
**Figure 6. SRIO SerDes in Loopback Mode**

**Details:** The SRIO physical layer is configured in line-loopback mode on a per-port basis, by setting the LLB\_EN bit in PLM\_SP(n)\_IMP\_SPEC\_CTL register. In line-loopback mode, the data from the SerDes receiver is looped back to the SerDes transmitter. [Figure 6](#) shows the line loopback from SerDes RX to SerDes TX:

The port does not provide any clock compensation when line loopback is enabled. The transmit clock must be externally synchronized with the receive clock. There is only a small FIFO that can compensate for PLL jitter or wander. Hence, correct operation of line loopback requires that the link partners use the same reference clock for the SRIO physical layer, in order to avoid overruns or underruns due to clock frequency mismatch between the link partners. As a result, line loopback mode is generally restricted to validation and qualification of board signal integrity in a lab environment.

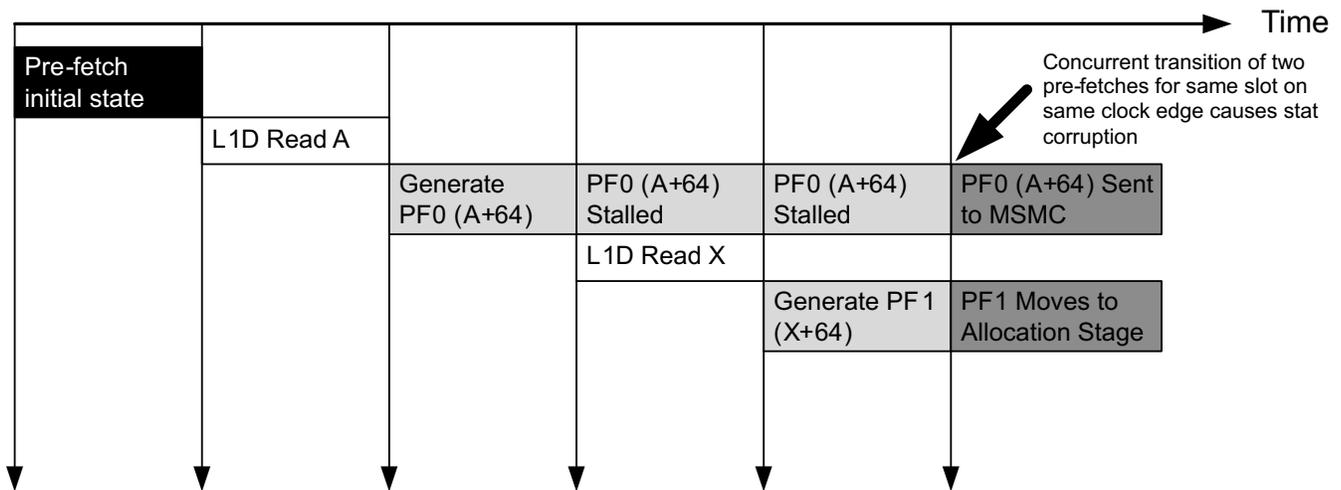
**Figure 9. Sequence diagram**

The fault lies in the 'sorting' hardware which can lead to the first pre-fetch not being marked stale under certain boundary conditions (see pathological sequence below). The subsequent fetch access when the pre-fetch access wasn't marked stale will access the stale data that has been cleared (but not yet marked as stale.) This results in the read exception and/or incorrect data being fetched. Thus, the issue occurs only when the re-fetch feature is triggered and only L1D accesses use the re-fetch feature.

8. Instead of PF0 being marked stale and thrown away when returned, both PF0 and PF1 are marked valid and outstanding.
9. This leads to two valid outstanding pre-fetches for the same data buffer slot which is an invalid state and can result in unexpected behavior for a subsequent pre-fetchable data access to address X+64.

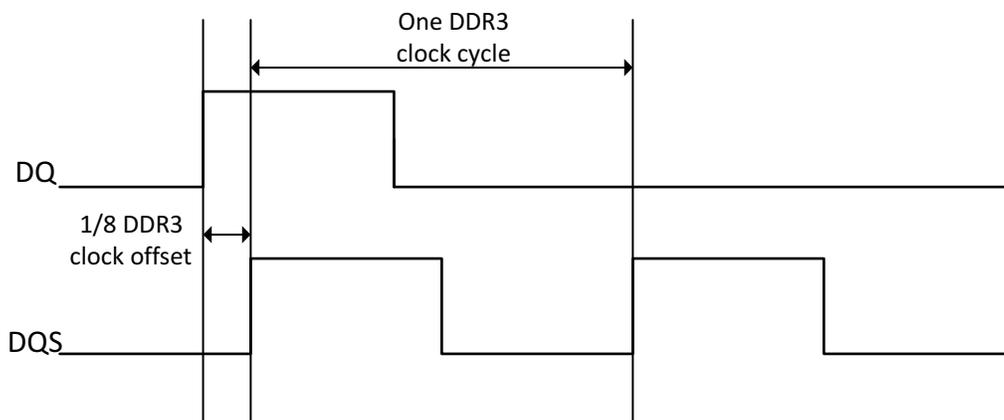
**Problem Summary:**      On C665x devices, the default value of the DATA\_REG\_PHY\_DQ\_OFFSET field in the DDR3\_CONFIG\_REG\_1 register causes DQ and DQS to be offset incorrectly during writes.

Figure 10. DQ to DQS offset with default incorrect value (0x20) for DATA\_REG\_PHY\_DQ\_OFFSET in DDR3\_CONFIG\_REG\_1

//Correct DQS-DQ write timing offset
DDR3_CONFIG_REG_1 = 0x01000000;

//Do a PHY reset. Toggle DDR_PHY_CTRL_1 bit 15 0->1->0
DDR_DDRPHYC &= ~(0x00008000);
DDR_DDRPHYC |= (0x00008000);
DDR_DDRPHYC &= ~(0x00008000);
```

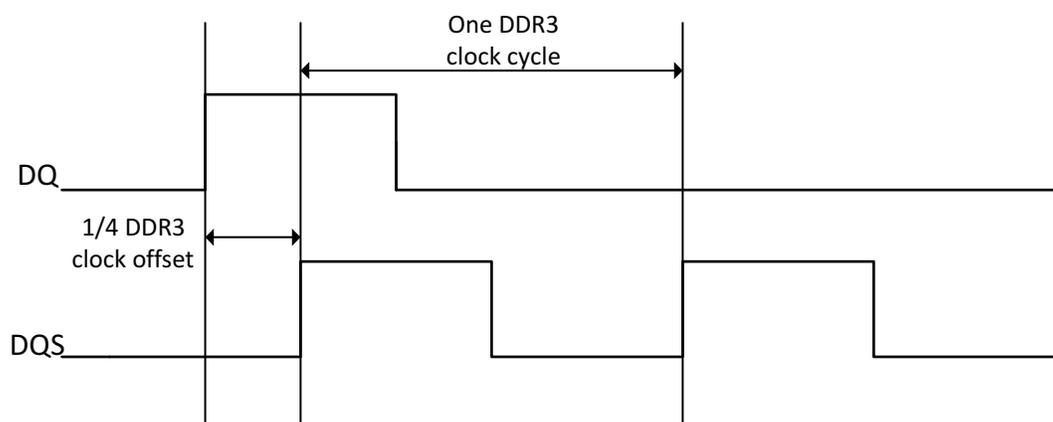
Figure 11. DQ to DQS offset with correctly programmed value (0x40) for DATA\_REG\_PHY\_DQ\_OFFSET in DDR3\_CONFIG\_REG\_1
