*TMS320C5517 Fixed-Point Digital Signal
Processor*
Silicon Revision 1.0, 2.0, and 2.1

Silicon Errata

Literature Number: SPRZ383B
April 2014–Revised September 2017

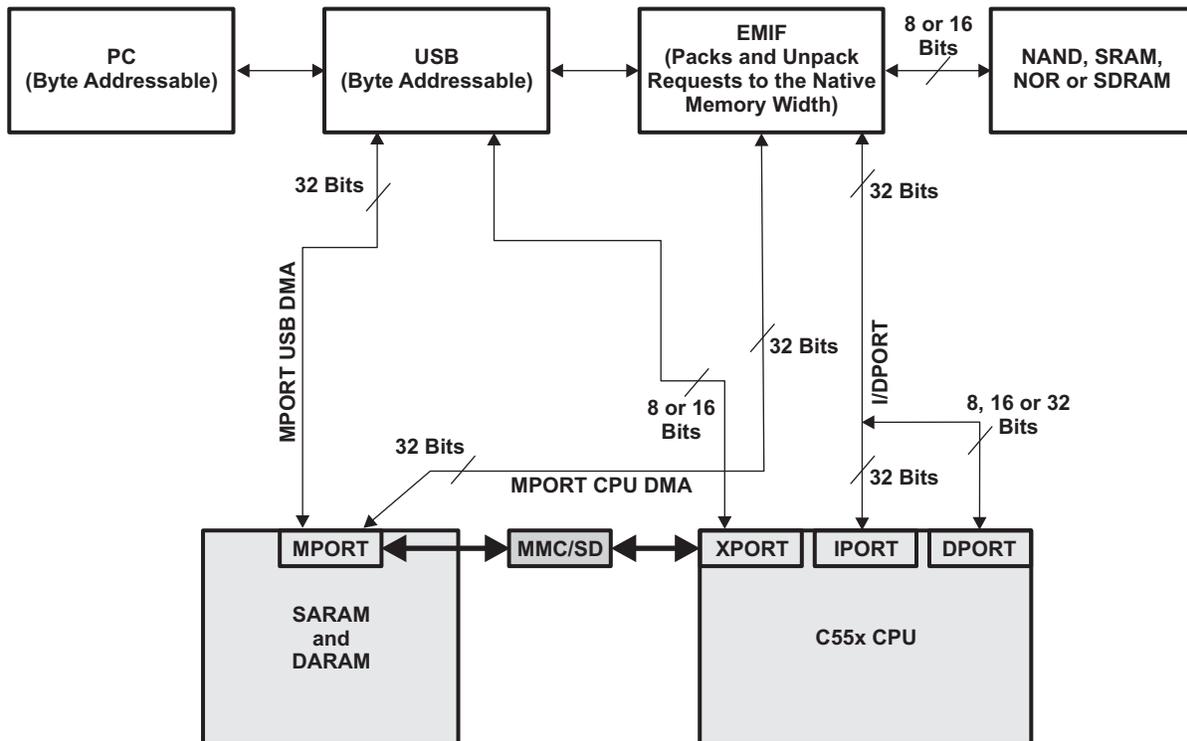
Figure 2. CPU, USB, EMIF, and MMC/SD Data Paths

Some C5517 peripherals (e.g., EMIF, USB, and MMC/SD) have sensitivity to the data endianness. EMIF: Endianness is hardcoded to big endian. MMC/SD: Endianness is controlled through software. Default is big endian. USB: DMA transfer to/from USB buffer is big endian. CPU XPORT access to USB buffer is little endian. USB endianness is not software controllable. The two endiannesses of the USB could result in inter byte swap.

Figure 2 shows data paths that could create byte/word swaps.

To correct this issue, software is required to fix the intra-word byte swap on the data prior to processing on the C5517 CPU.

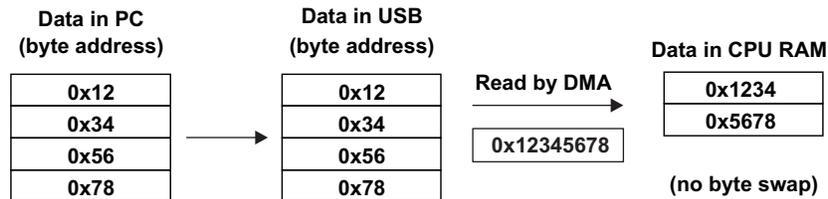
Figure 3. USB DMA Read

Data can be read from the USB by the USB DMA or CPU. The USB DMA accesses on-chip memory through the MPORT and only performs a 32-bit read while the CPU can perform a 16-bit read via the XPORT. When USB DMA transfers data from the USB buffers to on-chip memory, the data transfer is 32-bits and is handled in big endian fashion, so no data swap occurs (see [Figure 3](#)). However, when the CPU, through the XPORT, accesses the USB buffers, the data is accessed 16-bits at a time in little endian fashion resulting in an inter byte swap (see the [Figure 4](#)).

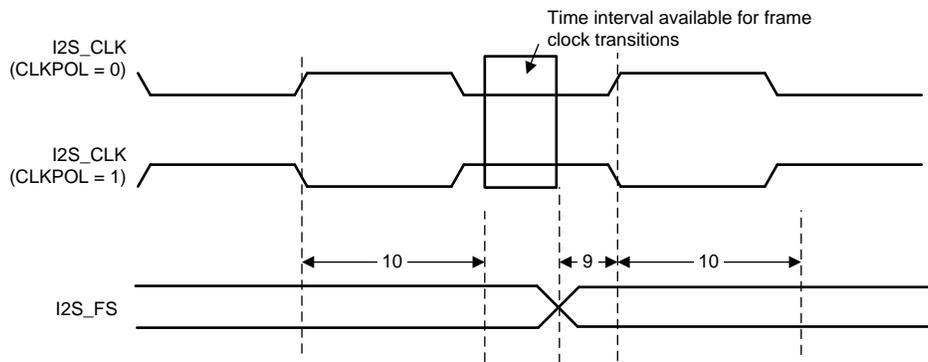
Figure 5. I2S Frame Clock Timing Constant

I2S peripherals operating in Master Mode are not capable of meeting the Frame Clock Timing Requirements. In Master Mode, the I2S peripheral sources the I2S Clock (I2S_CLK) and Frame Clock (I2S_FS). Due to potential timing violations without a workaround, support for Master Mode is descoped.

The C5517 I2S peripherals have a unique Frame Clock Timing Requirement that requires Frame Clock to be latched on both edges of the I2S Clock. This imposes an additional constraint on the timing of Frame Clock as illustrated in Figure 5. The generated Frame Clock must meet the specified setup and hold requirements with respect to the sampling edge of the generated bit clock (refer to device datasheet). To satisfy the hold time in Slave Mode, an RC delay (or equivalent) must be added to the Frame Clock trace.

However, in Master Mode, no logic can be added to delay the Frame Clock relative to the I2S Clock. Since the switching characteristics of the Frame Clock can violate the Frame Clock hold time requirement, support for Master Mode has been descoped from the I2S peripheral. Master Mode is affected in all modes of operation including all combinations of clock polarity, data delay, word lengths, data formats (I2S/Left-justified and DSP), stereo/mono, and so forth.

No explicit work-around exists to allow the use of I2S in Master Mode due to the potential for hold time violations. For using I2S, the following is recommended:
