Errata

AM437x Sitara™ Processors Silicon Revisions 1.1, 1.2

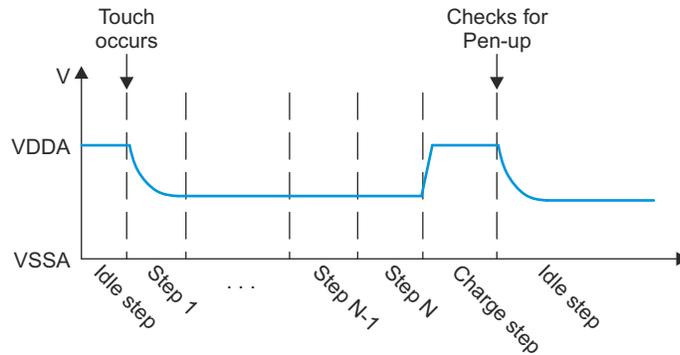
Figure 3-4. TSC Generates False Pen-up Interrupt

Details The touchscreen controller (TSC) determines the pen state (up or down) by checking the respective analog input (AIN0 for 4-wire or AIN4 for 5-wire) voltage level immediately after the Charge step. This does not provide enough time for the analog input voltage to return to the normal Pen-down voltage before testing the pen state. This will cause the TSC to generate a false Pen-up interrupt if the Charge step is enabled with the strong pull-up turned on when using hardware synchronized steps. Figure 3-4 illustrates the effect on the analog voltage when constant pen pressure is applied to the touchscreen and held through the Charge step.

- The first workaround is implemented by configuring the Charge step exactly like the Idle step, where the internal strong pull-up is not turned on. This workaround will remove the strong pull-up on the analog input during the Charge step and leave only the internal weak pull-up. The weak pull-up is not strong enough to effect the normal Pen-down voltage. Therefore, the voltage applied to the analog input will not rise and cause the TSC to generate a false Pen-up interrupt. There is a drawback to this approach; this workaround will cause the Pen-down event to remain active until the weak pull-up turned on in the Idle step charges the touchscreen capacitance, as shown in Figure 3-5.
