***TDA3x SoC for Advanced Driver Assistance Systems
 (ADAS)
 Silicon Revision 2.0A, 2.0, 1.0A, 1.0***

This document describes the known exceptions to the functional specifications for the device.

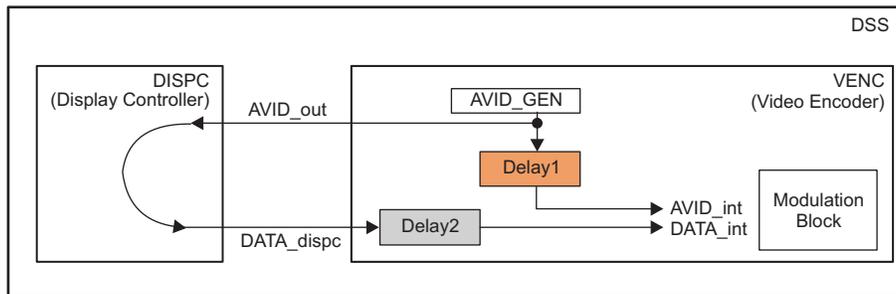
Figure 1. VENC and Display Controller

The issue is due to a two cycle difference in the expected versus actual delay between the VENC and the Display Controller (DISPC).

For the design to work, Delay1 should be equal to Delay2. In the hardware implementation it is Delay1 = Delay2 +2. This results in the first two pixels of every line being missed.

The system impact depends on the specific use-case. Most TVs have over-scan (the visible pixels on the display are less than the pixels transmitted), and in those cases the bug will not impact any functionality. In other cases, the display is missing the first two vertical columns of data which could be critical for the use-case.

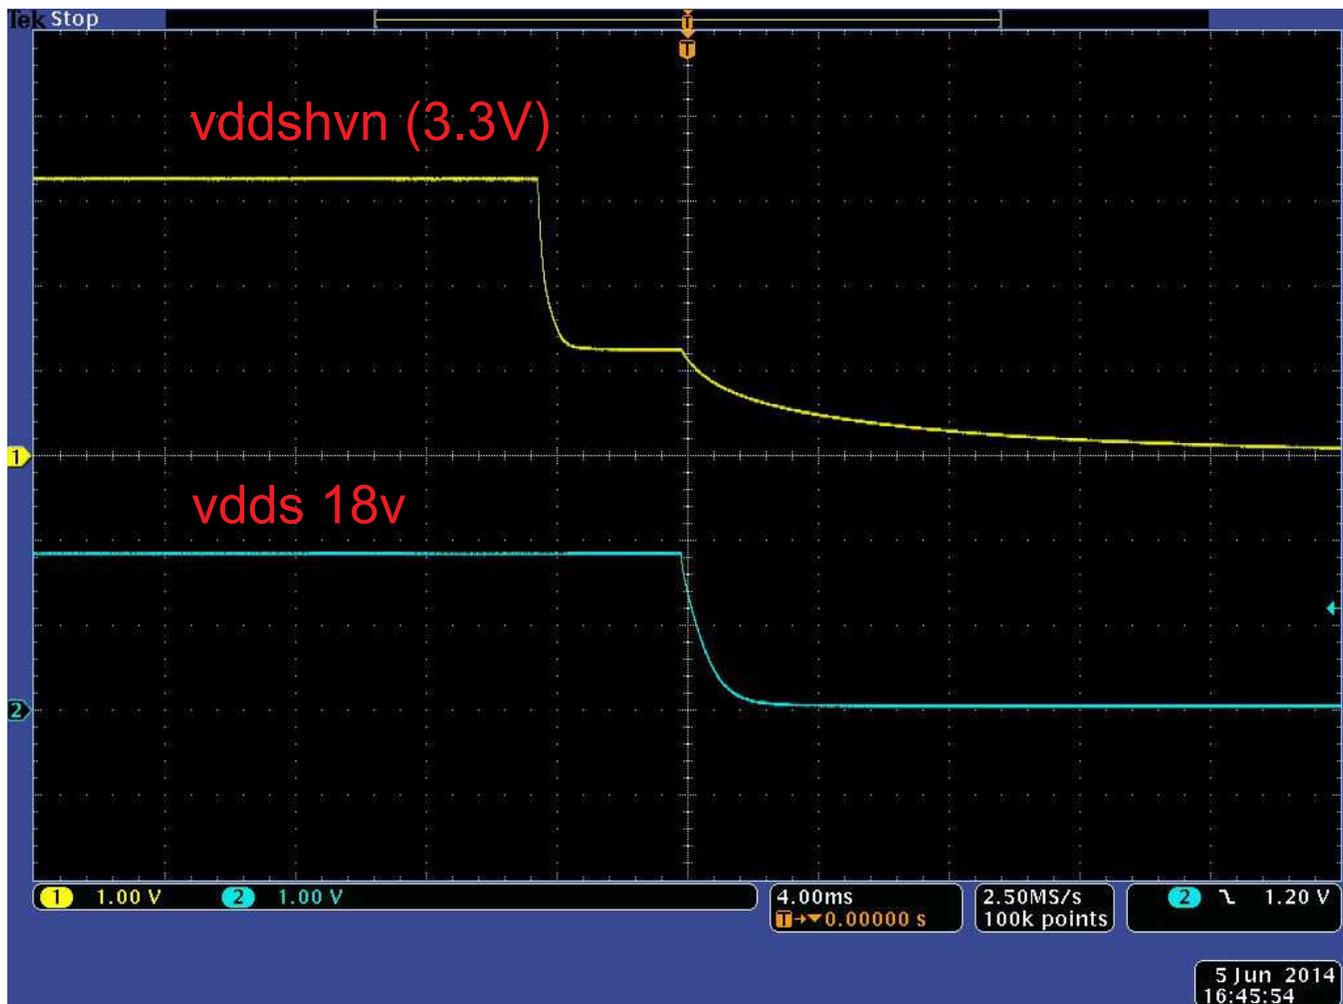
Figure 3. PAB_RevA

A subset of the SOC's LVCMOS IOs (refer to DM for details) have a pull-up resistor that is active by default, including during reset and power-down. The SOC's IOs that have internal or external pull-ups will stay at Plateau Level (<1.5V) during the power-down. If other ICs on the board that are interfaced to the SOC's LVCMOS signals use a separate supply then it's possible that the other IC's signals can be pulled to the Plateau Level while its power supply is off.

The root cause of the plateau is related to the LVCMOS IO buffer Dual Voltage detection circuitry. The LVCMOS Dual Voltage IO includes voltage comparator circuitry to determine if the IO is in 3.3V mode or 1.8V mode. During powerdown of vddshvn domains, a current path in the internal bias transistors results in the vddshvn rail being held to an intermediate voltage level (<1.5 V). This path can consume at most 500 uA per IO - worst case estimate is ~150 mA (based on 280 IOs) from the vdds18v supply

during power down. This path is not a reliability concern for the device.

In general, TI recommends using the same supply source for connected components. E.g., a single LDO should drive vddshvn and the related 3.3V external components.
