Errata

AM64x/AM243x Processor Silicon Revision 1.0, 2.0

ABSTRACT

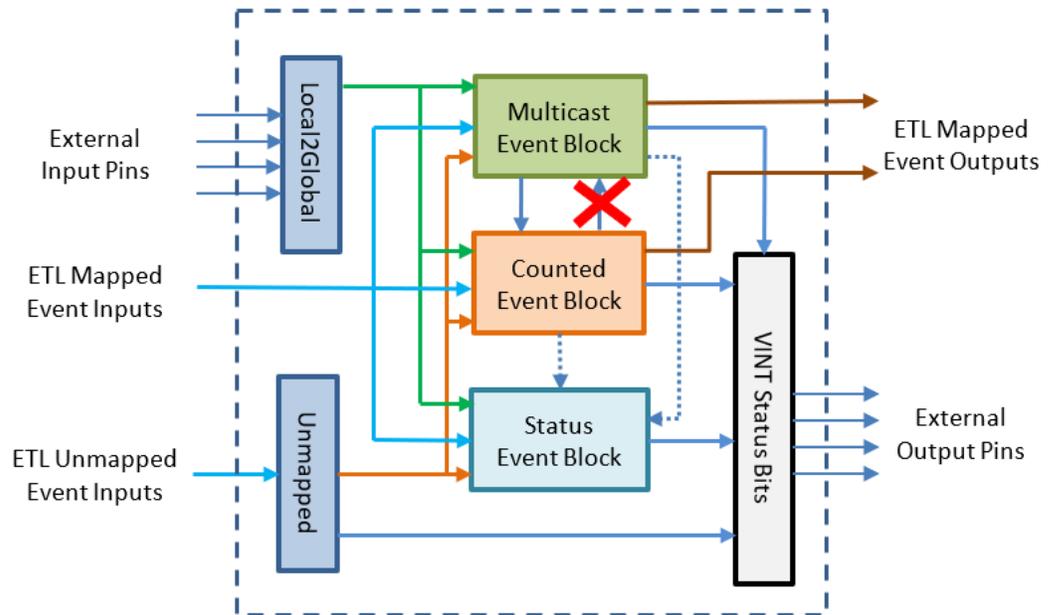
Figure 2-2. Interrupt Aggregator Version 1.1

IA version 1.1 introduced two additional changes to the architecture. First, there is a new processing block for “unmapped” events. These are events that are sent to a fixed destination (the IA) instead of being programmable at the source IP. Being fixed, they are called “unmapped”. Once in the IA, they are mapped to a traditional ETL event destination. The block that performs this mapping is called unmapped event block. The second change to the IA for 1.1 is that now, the multicast and counted event blocks (as well as the new unmapped event block) can directly set VINT status bits, and they do not need to forward output ETL events to the status event block.

Figure 2-2 shows the diagram of IA 1.1. Note that the same policy applies to avoid deadlock. In addition, the paths shown as dotted lines (sending ETL events from the multicast or counted blocks to the status event block) is now discouraged. These paths still function as before for backward compatibility, but are rendered obsolete as all blocks are now able to directly set status event bits.

By following the conventions outlined here, the system is safe from looping hazards that can create a deadlock scenario.

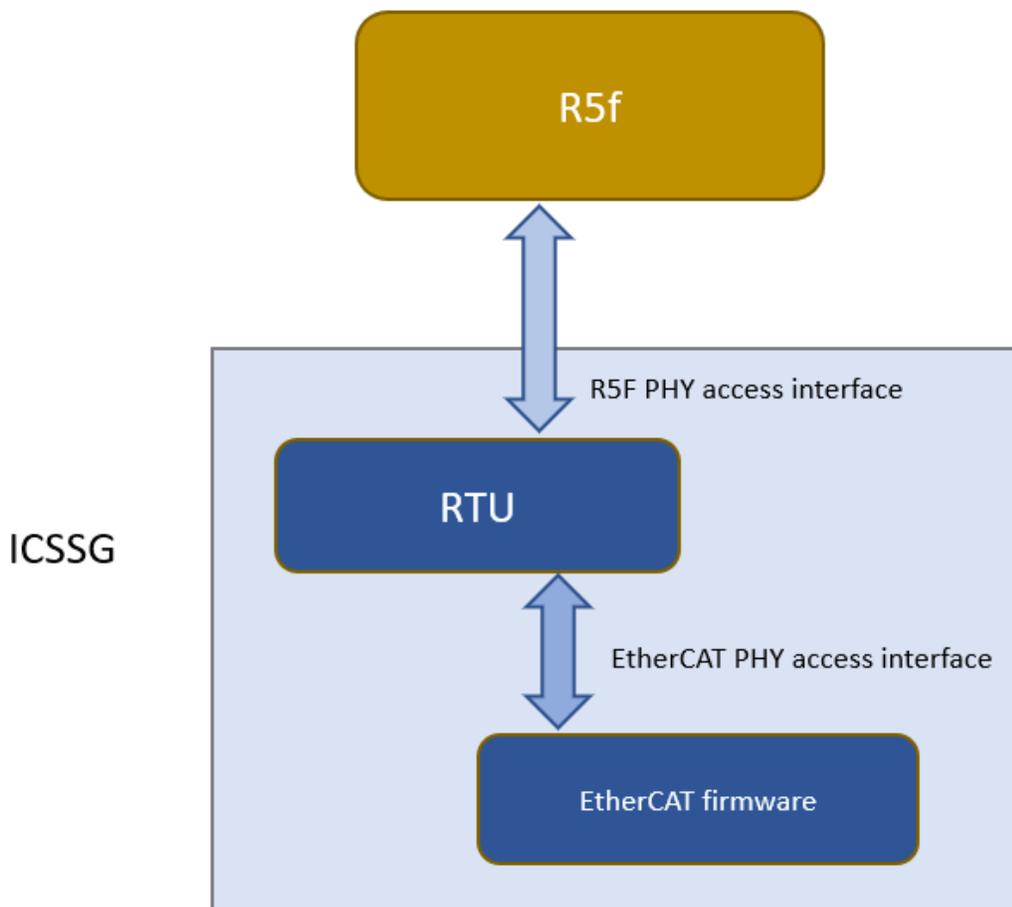
Figure 2-3. MDIO Emulation via Manual Mode using PRU Core

MDIO: MDIO interface corruption (CPSW and PRU-ICSS)
