J7200 DRA821 Processor Silicon Revision 1.0, 2.0

ABSTRACT

This document describes the known exceptions to the functional specifications (advisories). This document may also contain usage notes. Usage notes describe situations where the device's behavior may not match presumed or documented behavior. This may include behaviors that affect device performance or functional correctness.

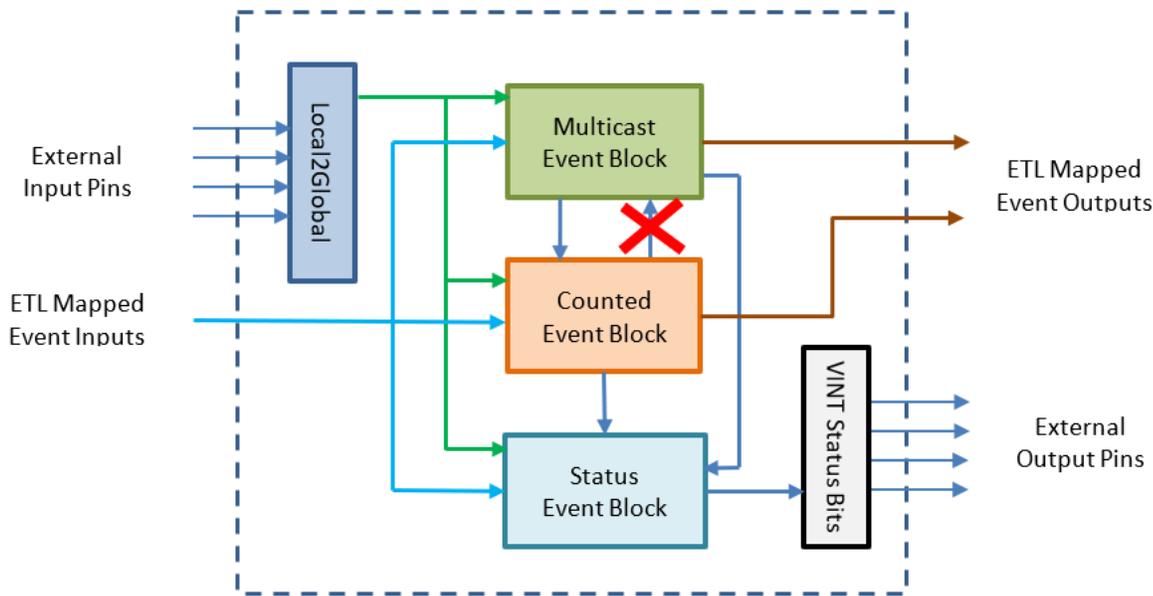
Figure 3-1. Interrupt Aggregator Version 1.0

An issue was found after design that could cause the IA to deadlock. The issue occurs when event “loops” occur between these three processing blocks. It is possible to create a situation where a processing block can not output an event because the path is blocked, and since it can not output an event, it can not take any new input events. This inability to take input events prevents the output path from being able to unwind, and thus both paths remain blocked.

Figure 3-1 shows the conceptual block diagram of IA 1.0. Potential loops are avoided by adopting the policy of not allowing the counted event block to send events to the multicast block. This method was chosen because it is more common to split an event first, and then count one while sending the other elsewhere. With this path blocked by convention, it is not possible for a single event to visit any block more than once and thus not possible for paths to become blocked so long as the outputs remain unblocked.

By following the conventions outlined here, the system is safe from looping hazards that can create a deadlock scenario.
