# TMS320F28003x Real-Time MCUs Silicon Errata

## Silicon Revision 0

### ABSTRACT

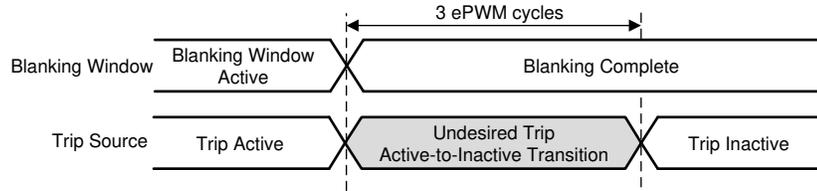
**Figure 3-2. Undesired Trip Event and Blanking Window Expiration**

The blanking window is typically used to mask any PWM trip events during transitions which would be false trips to the system. If an ePWM trip event remains active for less than three ePWM clocks after the end of the blanking window cycles, there can be an undesired glitch at the ePWM output.

Figure 3-2 illustrates the time period which could result in an undesired ePWM output.

Extend or reduce the blanking window to avoid any undesired trip action.
