# TMS320F280013x Real-Time MCUs Silicon Errata

## Silicon Revisions C, B, A, 0

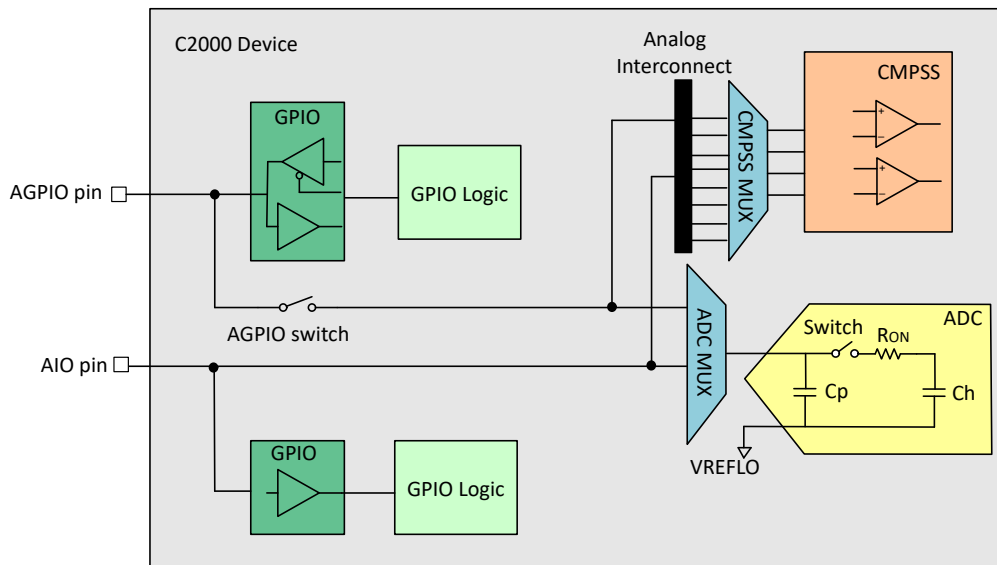
**Figure 3-1. Analog Subsystem Diagram with AGPIO and AIO Analog Pin Types**

### **CMPSS: A CMPSS Glitch can Occur if Comparator Input Pin has AGPIO Functionality and ADC is Sampling the Input Pin**

The AGPIO analog pin path contains an extra series switch of 53Ω. This creates a low-capacitance isolated node shared by the ADC and CMPSS comparator, as shown in Figure 3-1. This node can be disturbed when the ADC samples the channel (depending on the prior voltage stored on the ADC sample-and-hold capacitor), and this disturbance can cause a false CMPSS event of up to 50ns. To accommodate this potential disturbance, the workarounds below can be implemented.

1. Use a different pin (that is AIO pin type) for analog channels that need both ADC and CMPSS together.
2. Use the CMPSS Digital Filter with a setting of 50ns or greater, which will filter the temporary disturbance.
3. Precondition the sample-and-hold capacitor of the ADC so that the disturbance will not cause a false trip. For example, perform a dummy read of a 3.3V connection from a different channel on the ADC immediately before the impacted channel is read,
