TMS320F280015x Real-Time MCUs Silicon Errata

Silicon Revisions B, A, 0

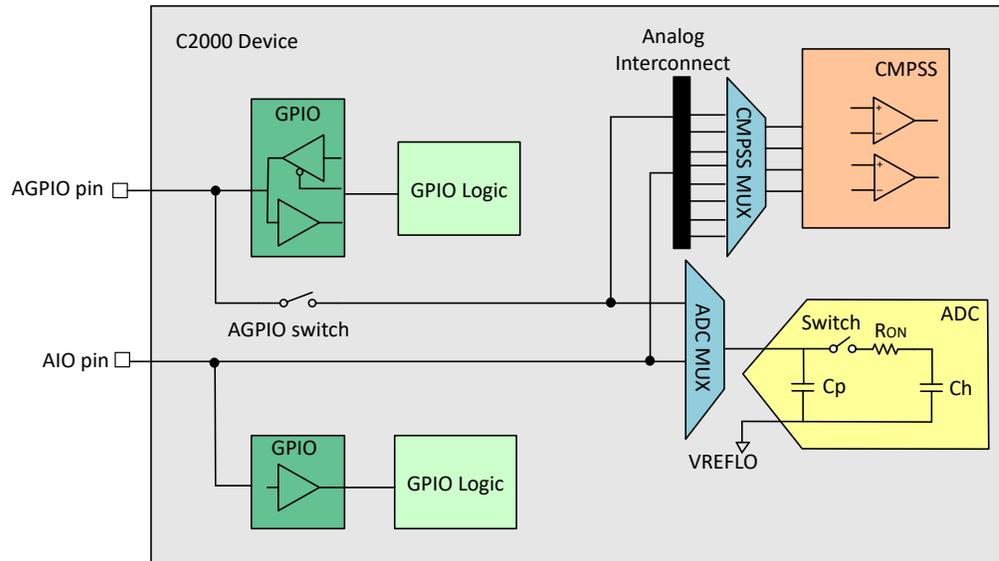
Figure 3-1. Analog Subsystem Diagram with AGPIO and AIO Analog Pin Types
Workarounds

Advisory
CMPSS: A CMPSS Glitch can Occur if Comparator Input Pin has AGPIO Functionality and ADC is Sampling the Input Pin
Revisions Affected

The AGPIO analog pin path contains an extra series switch of 53Ω. This creates a low-capacitance isolated node shared by the ADC and CMPSS comparator, as shown in [Figure 3-1](#). This node can be disturbed when the ADC samples the channel (depending on the prior voltage stored on the ADC sample-and-hold capacitor), and this disturbance can cause a false CMPSS event of up to 50ns. To accommodate this potential disturbance, the workarounds below can be implemented.

1. Use a different pin (that is AIO pin type) for analog channels that need both ADC and CMPSS together.
2. Use the CMPSS Digital Filter with a setting of 50ns or greater, which will filter the temporary disturbance.
3. Precondition the sample-and-hold capacitor of the ADC so that the disturbance will not cause a false trip. For example, perform a dummy read of a 3.3V connection from a different channel on the ADC immediately before the impacted channel is read, so the disturbance is in the positive direction, away from the false trip. The opposite dummy read of a 0V signal would be used if the false trip is inverted in polarity.

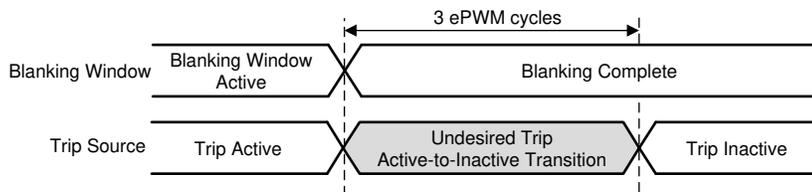
Figure 3-2. Undesired Trip Event and Blanking Window Expiration

Advisory *ePWM: An ePWM Glitch can Occur if a Trip Remains Active at the End of the Blanking Window*

Details The blanking window is typically used to mask any PWM trip events during transitions which would be false trips to the system. If an ePWM trip event remains active for less than three ePWM clocks after the end of the blanking window cycles, there can be an undesired glitch at the ePWM output.

Figure 3-2 illustrates the time period which could result in an undesired ePWM output.

Workaround Extend or reduce the blanking window to avoid any undesired trip action.
