Errata

AM62Ax Sitara™ Processors Silicon Errata, Silicon Revision 1.0

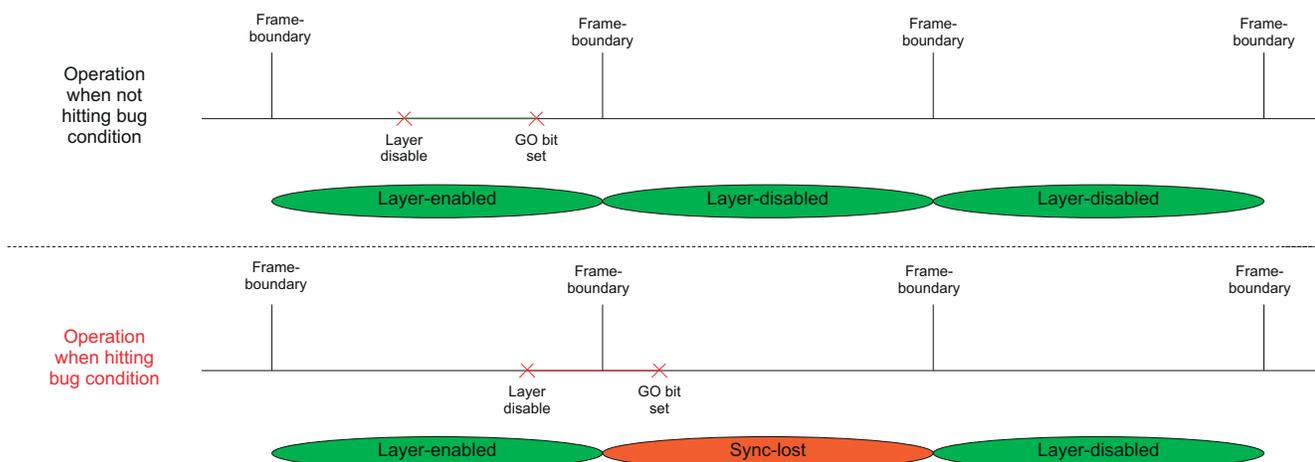
Figure 2-1. Bug Condition

Disabling a layer (for example VID1) connected to an OVR (that is toggling DSS_VID_ATTRIBUTESx[0] ENABLE from 1 to 0) may result in synclost during the next frame. The synclost may result in a corrupted or blank frame (all pixel data sent out of DSS during the frame is 0x0). The occurrence of synclost is dependent on the timing of setting the GO bit (that is DSS_VP_CONTROL[5] GOBIT to 1) vis-à-vis the disabling of the layer. If the “disable layer” MMR write operation and “set GO bit” MMR write operation happens within the same frame boundary, no synclost occurs. If the operations happen across the frame boundary, then synclost occurs (for one frame). The design automatically recovers and returns to normal operation from the next frame after GO bit is set, see [Figure 2-1](#).

A simple software workaround exists. In the workaround, prior to disabling a layer on the OVR, it is moved to the “non-visible” area of the OVR (for example: DSS_OVR_ATTRIBUTES_x[17-6] POSX = max_value_of_posx or DSS_OVR_ATTRIBUTES_x[30-19] POSY = max_value_of_posy). This avoids the synclost when the layer is disabled.

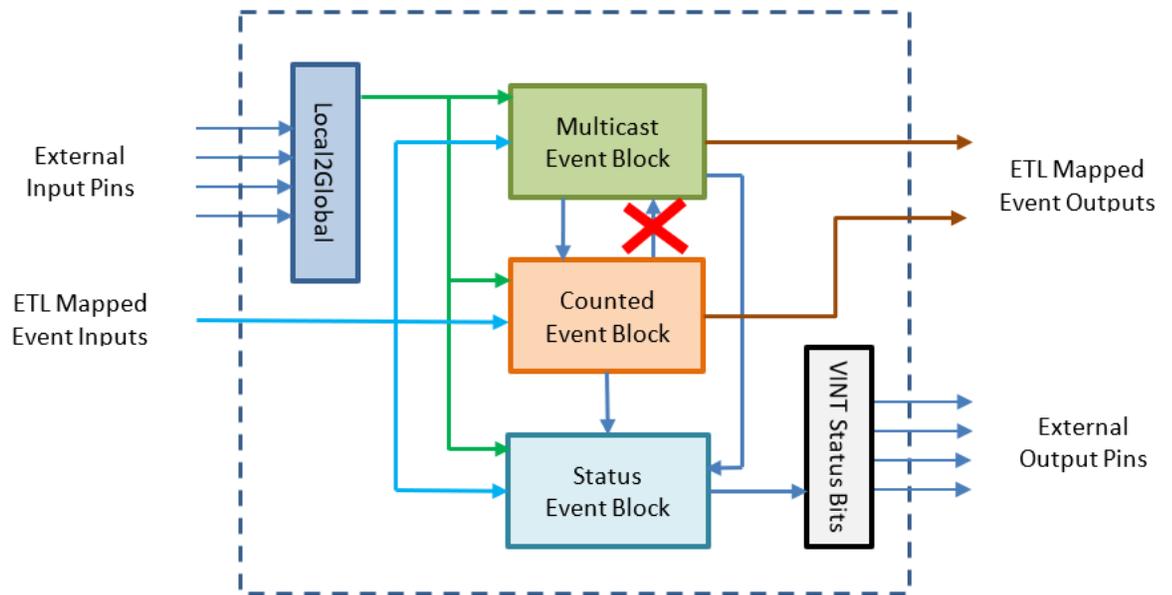
Figure 2-3. Interrupt Aggregator Version 1.0

An issue was found after design that could cause the IA to deadlock. The issue occurs when event "loops" occur between these three processing blocks. It is possible to create a situation where a processing block can not output an event because the path is blocked, and since it can not output an event, it can not take any new input events. This inability to

take input events prevents the output path from being able to unwind, and thus both paths remain blocked.

Figure 2-3 shows the conceptual block diagram of IA 1.0. Potential loops are avoided by adopting the policy of not allowing the counted event block to send events to the multicast block. This method was chosen because it is more common to split an event first, and then count one while sending the other elsewhere. With this path blocked by convention, it is not possible for a single event to visit any block more than once and thus not possible for paths to become blocked so long as the outputs remain unblocked.

By following the conventions outlined here, the system is safe from looping hazards that can create a deadlock scenario.
