Errata

AM62Px Sitara™ Processors Silicon Errata, Silicon Revision 1.0, 1.1

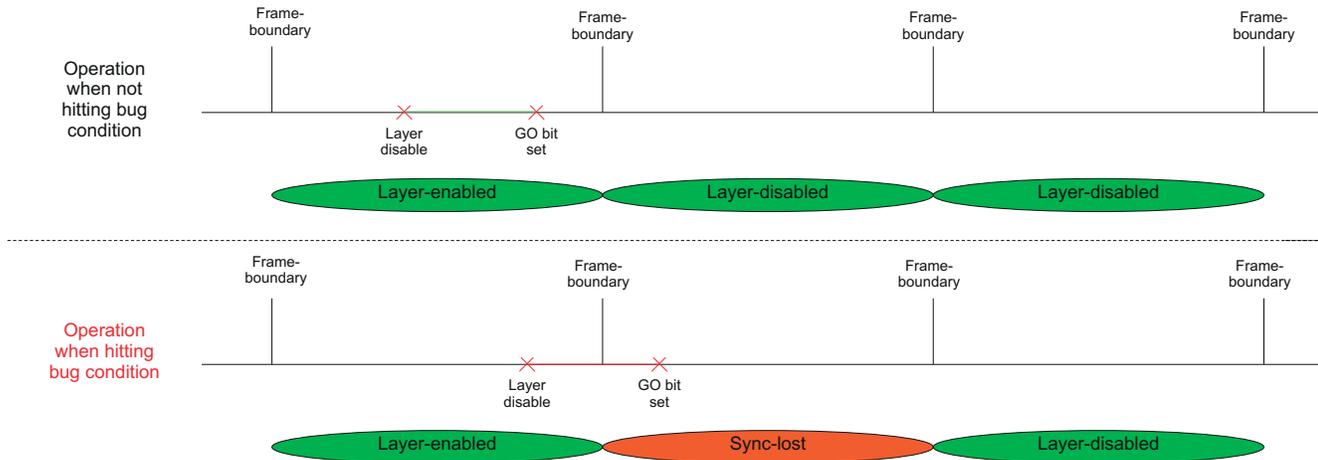
Figure 2-1. Bug Condition

DSS: Disabling a Layer Connected to Overlay May Result in Synclost During the Next Frame

Disabling a layer (for example VID1) connected to an OVR (that is toggling DSS_VID_ATTRIBUTESx[0] ENABLE from 1 to 0) may result in synclost during the next frame. The synclost may result in a corrupted or blank frame (all pixel data sent out of DSS during the frame is 0x0). The occurrence of synclost is dependent on the timing of setting the GO bit (that is DSS_VP_CONTROL[5] GOBIT to 1) vis-à-vis the disabling of the layer. If the “disable layer” MMR write operation and “set GO bit” MMR write operation happens within the same frame boundary, no synclost occurs. If the operations happen across the frame boundary, then synclost occurs (for one frame). The design automatically recovers and returns to normal operation from the next frame after GO bit is set, see [Figure 2-1](#).

A simple software workaround exists. In the workaround, prior to disabling a layer on the OVR, it is moved to the “non-visible” area of the OVR (for example: DSS_OVR_ATTRIBUTES_x[17-6] POSX = max_value_of_posx or DSS_OVR_ATTRIBUTES_x[30-19] POSY = max_value_of_posy). This avoids the synclost when the layer is disabled.

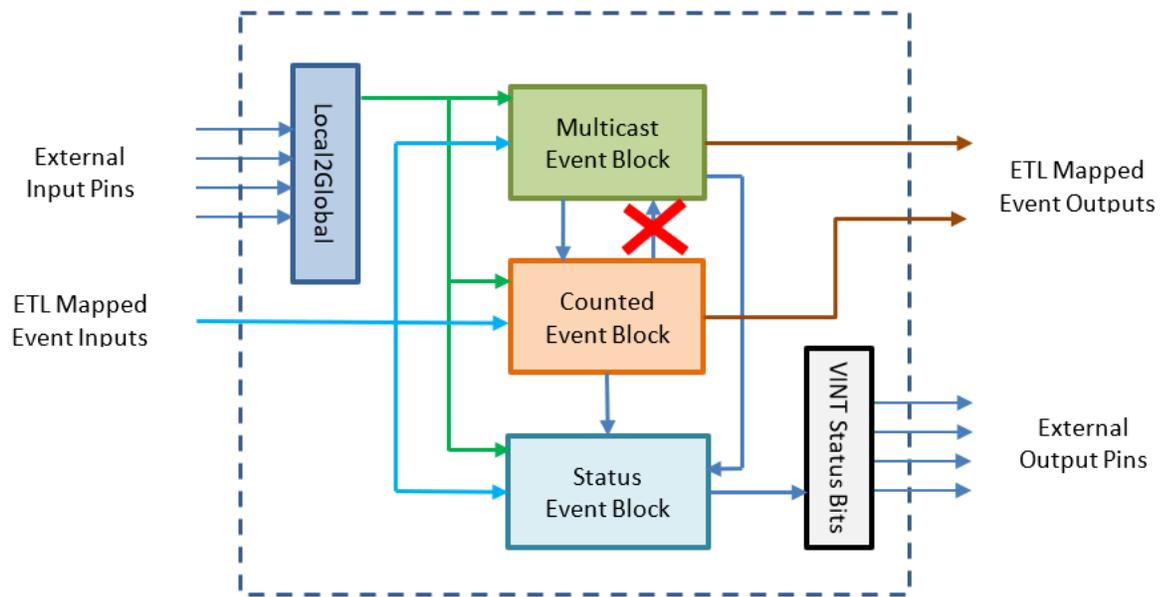
Figure 2-3. Interrupt Aggregator Version 1.0

An issue was found after design that could cause the IA to deadlock. The issue occurs when event “loops” occur between these three processing blocks. It is possible to create a situation where a processing block can not output an event because the path is blocked, and since it can not output an event, it can not take any new input events. This inability to take input events prevents the output path from being able to unwind, and thus both paths remain blocked.

[Figure 2-3](#) shows the conceptual block diagram of IA 1.0. Potential loops are avoided by adopting the policy of not allowing the counted event block to send events to the multicast block. This method was chosen because it is more common to split an event first, and then count one while sending the other elsewhere. With this path blocked by convention, it is not possible for a single event to visit any block more than once and thus not possible for paths to become blocked so long as the outputs remain unblocked.

By following the conventions outlined here, the system is safe from looping hazards that can create a deadlock scenario.
