Errata AM261 Sitara™ Microcontroller Silicon Revision 1.0

This document describes the known exceptions to the functional specifications (advisories). This document may also contain usage notes. Usage notes describe situations where the device's behavior may not match presumed or documented behavior. This may include behaviors that affect device performance or functional correctness.

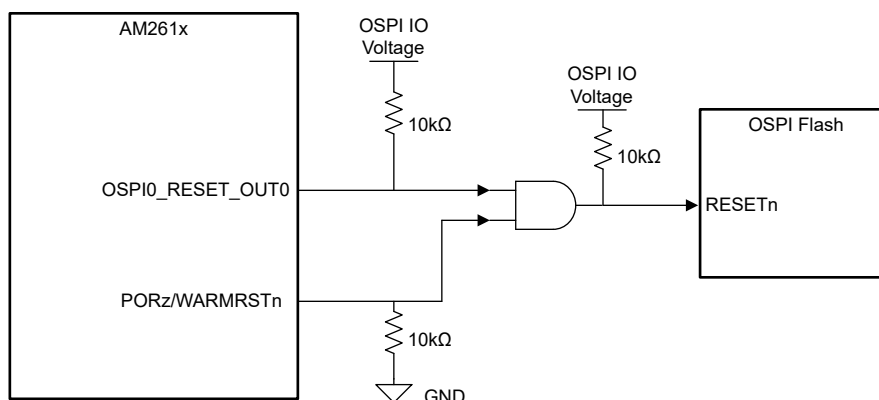
Figure 2-2. AM261x OSPI Reset using any OSPI0_RESET_OUT0 pin AND PORz/WARMRSTn

During OSPI boot mode, including fallback modes that would result in OSPI boot mode, ROM configures pin GPIO61 as OSPI0_RESET_OUT0. If this pin is connected to the Reset pin of the OSPI Flash Memory, boot failures may occur due to a reset signal management issue in the OSPI controller.

1. Configures GPIO61 in OSPI0_RESET_OUT0 mux mode
2. Correctly asserts the reset signal (drives low)
3. Fails to de-assert the reset signal due to incorrect OSPI controller configuration (GPIO61 pin remains driven low)

Option 1: Do not use GPIO61 pin to reset the flash. Use PORz/WARMRSTn to reset the flash device on a power cycle and use another GPIO for OSPI0_RESET_OUT0 and pass that signal through an AND gate with PORz/WARMRSTn. See [AM261x OSPI Reset using any OSPI0_RESET_OUT0 pin AND PORz/WARMRSTn](#) for an example.
