# Errata

# AM62Dx Sitara™ Processors Silicon Errata, Silicon Revision 1.0

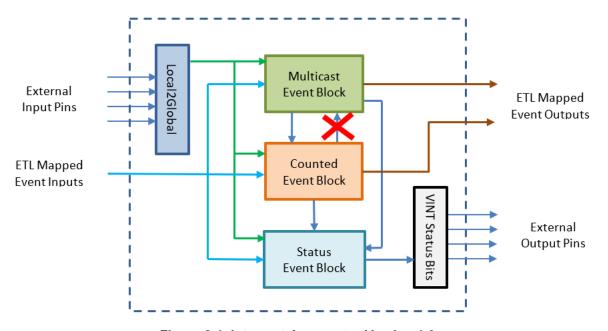
Figure 2-1. Interrupt Aggregator Version 1.0

An issue was found after design that could cause the IA to deadlock. The issue occurs when event "loops" occur between these three processing blocks. It is possible to create a situation where a processing block can not output an event because the path is blocked, and since it can not output an event, it can not take any new input events. This inability to

take input events prevents the output path from being able to unwind, and thus both paths remain blocked.

Figure 2-1 shows the conceptual block diagram of IA 1.0. Potential loops are avoided by adopting the policy of not allowing the counted event block to send events to the multicast block. This method was chosen because it is more common to split an event first, and then count one while sending the other elsewhere. With this path blocked by convention, it is not possible for a single event to visit any block more than once and thus not possible for paths to become blocked so long as the outputs remain unblocked.

By following the conventions outlined here, the system is safe from looping hazards that can create a deadlock scenario.
