Errata

TMS320F28P551, TMS320F28P552, and TMS320F28P558 Real-Time MCUs Silicon Errata Silicon Revision 0

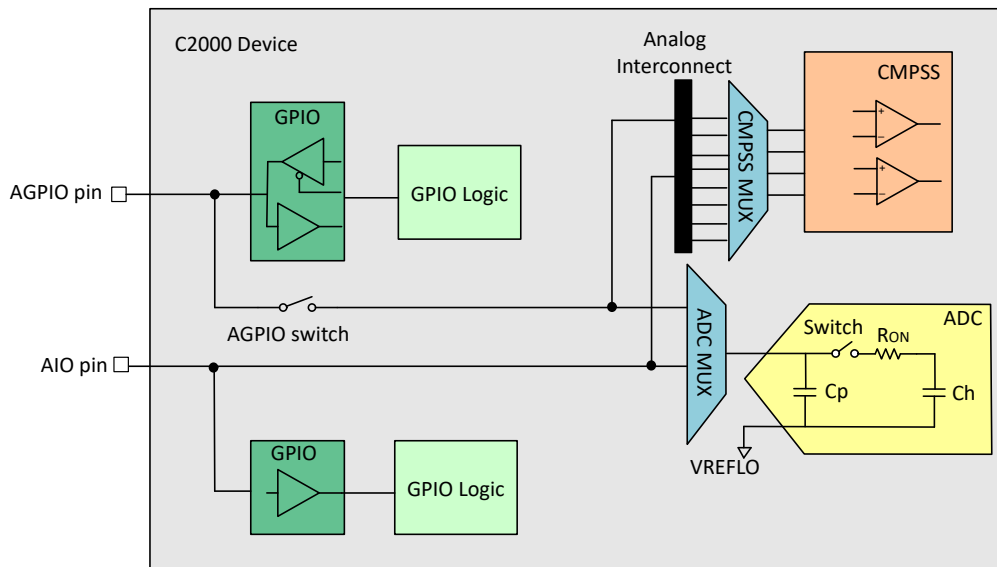
Figure 3-1. Analog Subsystem Diagram with AGPIO and AIO Analog Pin Types

The AGPIO analog pin path contains an extra series switch of 53Ω. This creates a low-capacitance isolated node shared by the ADC and CMPSS comparator, as shown in Figure 3-1. This node can be disturbed when the ADC samples the channel (depending on the prior voltage stored on the ADC sample-and-hold capacitor), and this disturbance can cause a false CMPSS event of up to 50ns. To accommodate this potential disturbance, the workarounds below can be implemented.

1. Use a different pin (that is AIO pin type) for analog channels that need both ADC and CMPSS together.
2. Use the CMPSS Digital Filter with a setting of 50ns or greater, which will filter the temporary disturbance.
3. Precondition the sample-and-hold capacitor of the ADC so that the disturbance will not cause a false trip. For example, perform a dummy read of a 3.3V connection from a different channel on the ADC immediately before the impacted channel is read,

so the disturbance is in the positive direction, away from the false trip. The opposite dummy read of a 0V signal would be used if the false trip is inverted in polarity.
