# AWRL6432 Device Silicon Errata

## Silicon Revisions 1.0 and 2.0

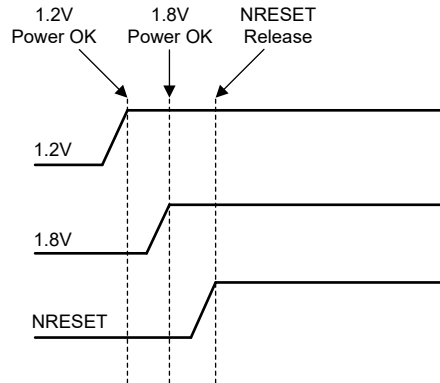
Figure 4-1. Recommended power up sequence

When the device is in power optimized topology and 1.8V powers up before 1.2V, a momentary large current can be seen at 1.2V rail before NRESET release only during the device power up. To avoid that, power up 1.2V (VDDIN, VDD\_SRAM and VNWA) before 1.8V .

1. This usage note is ONLY applicable for 1.2V rail. For signals other than 1.2V power supply, refer the "Device Wake-up Sequence" diagram in the data sheet.
2. The power distribution network in TI EVM/Reference designs follows "Device Wake-up Sequence" in the data sheet and supports the additional current without powering up 1.2V first.

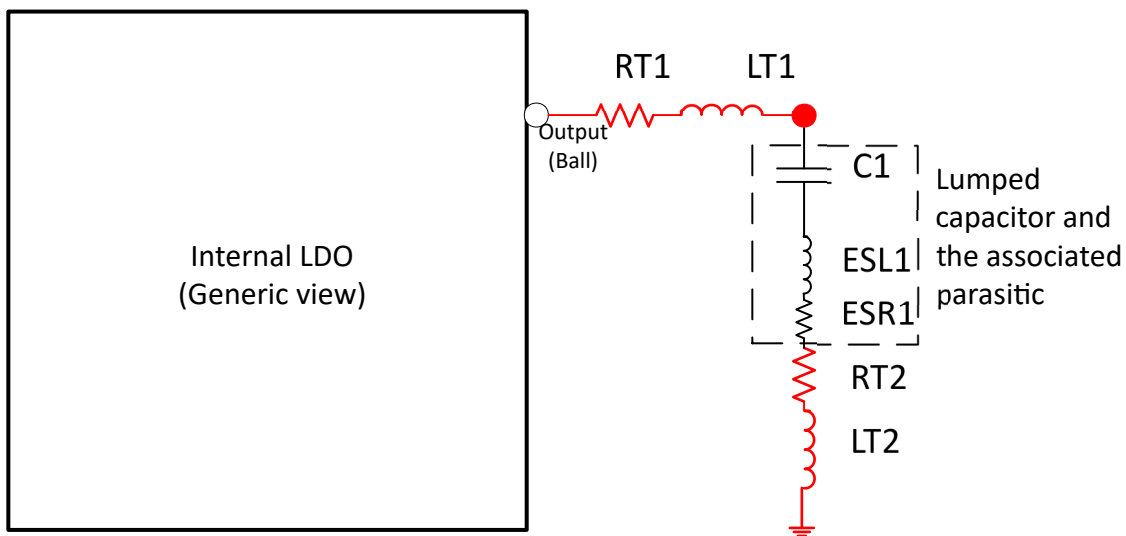
Figure 4-2. Single decoupling capacitor associated PCB parasitic

As indicated in the device data sheet, 1.2V Digital LDO requires one decoupling capacitor with a typical value of 4.7uF. The parasitic offered by different portion of the output path is illustrated in Figure 4-2. "RT1" and "RT2" are parasitic resistances offered by the ball to capacitor lead trace and the ground trace, respectively. Similarly, "LT1" and "LT2" are parasitic inductances offered by the ball to capacitor lead trace and the ground trace, respectively. "ESL1" and "ESR1" are the effective series inductance and resistance of the decoupling capacitor. Table 4-1 gives the minimum, maximum and typical values of the capacitance and the parasitic.

Min	Typ	Max	Unit
Recommended value of C	3.6	4.7	5.2	uF
Allowed output parasitic inductance $L_p$	1	1.5	2	nH
<b>Allowed output parasitic resistance <math>R_p</math></b>	<b>15</b>	<b>20</b>	<b>35</b>	<b>mOhm</b>

If the  $R_p$  is not achievable in PCB design, below workarounds can be considered:

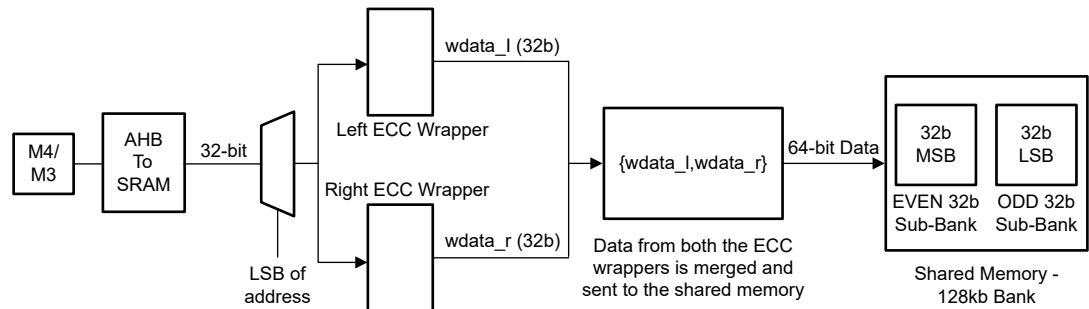
**Figure 6-1. Shared Memory Logic Diagram When Shared with M4/M3**

Internal shared memory has ODD and EVEN banking structure. For a particular address range, partial write (less than 32 bit) to EVEN bank corrupts same address of ODD bank with next data on the bus. When shared memory is allocated to M4/M3, back to back full word write access to location A followed by sub-word write access to location B corrupts data in location A.

When shared with M3/M4, the incoming data bit width is 32 bit as shown in the diagram. So, depending on LSB of address, signals are sent to either left or right ECC wrapper.

1. Use shared memories as code memory when shared with processor.
2. Disable ECC for non functional safety devices – ECC is disabled for shared memories in RBL for non functional safety devices.
