**TMS320C6727, TMS320C6727B,
TMS320C6726, TMS320C6726B,
TMS320C6722, TMS320C6722B,
TMS320C6720
Digital Signal Processors
Silicon Errata**

Silicon Revisions 1.2, 1.1, 1.0

SPRZ232F
July 2005
Revised October 2008

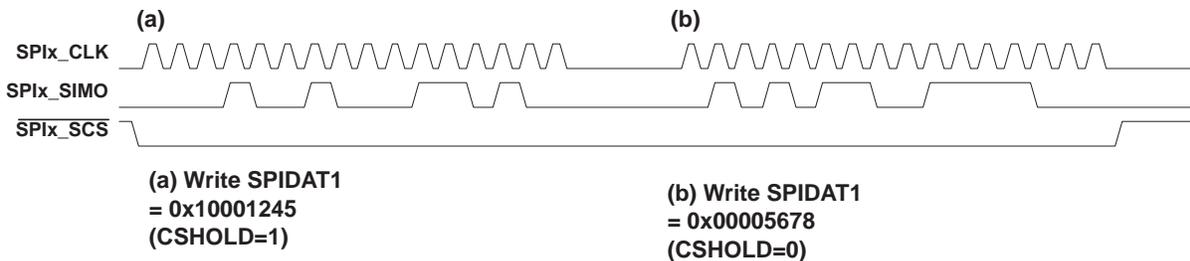
Figure 2. Expected CSHOLD Behavior

Instead, what actually occurs is that $\overline{\text{SPIx_SCS}}$ is momentarily de-asserted at the beginning of the second write, as illustrated in Figure 3.

Both Figure 2 and Figure 3 assume that SPIDAT1 is written using a single 32-bit write instruction. If SPIDAT1 is instead written using an 8-bit or 16-bit instruction to write to the CSHOLD field, followed by a 16-bit write to the transmit shift register field of SPIDAT1, then what actually occurs is illustrated in Figure 4. This is the same case as illustrated in Figure 3 except that the de-assertion of $\overline{\text{SPIx_SCS}}$ lasts for the duration between writing to a '0' to the CSHOLD field and writing new data to the transmit shift register.
