66AK2Hxx
Multicore DSP+ARM KeyStone II SOC
Silicon Revisions 1.0, 1.1, 2.0, 3.0, 3.1

Silicon Errata

Literature Number: SPRZ402F
June 2013–Revised June 2018

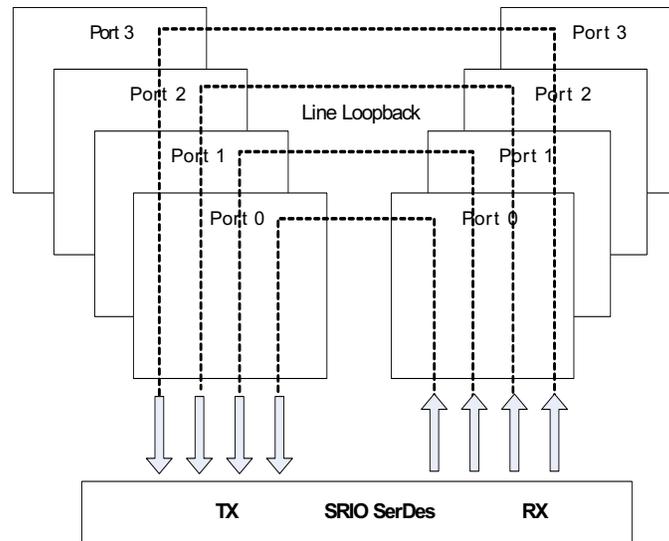
Figure 2. SRIO SerDes in Loopback Mode

The SRIO physical layer is configured in line-loopback mode on a per-port basis, by setting the LLB_EN bit in PLM_SP(n)_IMP_SPEC_CTL register. In line-loopback mode, the data from the SerDes receiver is looped back to the SerDes transmitter. [Figure 2](#) shows the line loopback from SerDes RX to SerDes TX.

The port does not provide any clock compensation when line loopback is enabled. The transmit clock must be externally synchronized with the receive clock. There is only a small FIFO that can compensate for PLL jitter or wander. Hence, correct operation of line loopback requires that the link partners use the same reference clock for the SRIO physical layer, in order to avoid overruns or underruns due to clock frequency mismatch between the link partners. As a result, line loopback mode is generally restricted to validation and qualification of board signal integrity in a lab environment.
