# **TMS320DM6443**

## **Digital Media System-on-Chip**

### **Silicon Revisions 2.3, 2.1, 1.3, 1.2, and 1.1**

## **Silicon Errata**

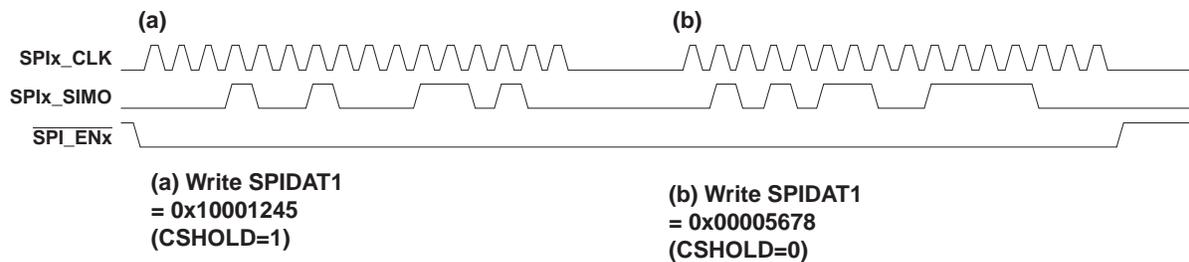
**Figure 2. Expected CSHOLD Behavior**

According to the SPI specification, the following sequence should produce the expected result as illustrated in Figure 2:

- Write 0x10001234 to SPIDAT1 for transmission of 0x1234 (CSHOLD = 1)
- Write 0x00005678 to SPIDAT1 for transmission of 0x5678 (CSHOLD = 0)

Instead, what actually occurs is that SPI\_ENx is momentarily de-asserted at the beginning of the second write, as illustrated in Figure 3.
