TMS320DM355
Digital Media System-on-Chip (DMSoC)
Silicon Revision 1.1, 1.3, and 1.4

Silicon Errata

Literature Number: SPRZ264E
September 2007–Revised July 2010

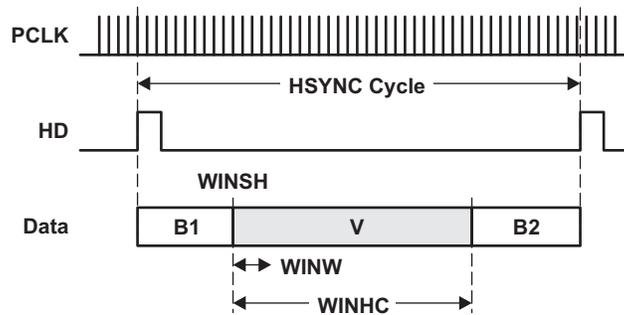
- $B1$ = Data area from HD rising edge to start of valid AEW/AF data.
- V = Valid AEW/AF data area. This is the data area for AEW/AF calculations. This area is specified using registers in the H3A module. Note that the registers are different for AEW and for AF. For AEW, bits WINSH specify the horizontal start position of the AEW windows, bits WINW specify the horizontal width of the windows, and bits WINHC specify the total number of windows. The total number of pixels in the valid AEW data area is equal to $V = WINW * WINHC$. For AF, bits IIRSH specify the horizontal start position of the IIR filter, bits PAXSH specify the horizontal start position of the AF paxels, bits PAXW specify the horizontal width of the paxels, and bits PAXHC specify the total number of paxels. The total number of pixels in the valid AF data area is equal to $V = [(PAXSH - IIRSH) + PAXW * PAXHC]$. See the VPFE PRG for complete bit descriptions.

- $B2$ = Data area from end of valid AEW/AF data to next HD rising edge.

Figure 4. Valid Window Width and Horizontal Window Count Data Area

2. Use the imager's movie readout mode.
In the imager's movie readout mode the problem does not occur, because the number of horizontal pixels and blanking are less than 4096 pixels and the H3A module receives less than 4096 pixel clock cycles between consecutive HD rising edges.
Note that the number of pixel clock cycles between consecutive HD rising edges that the H3A module receives is determined by the external or internal timing generator and also, if used, by the reformatter inside the CCDC. The reformatter is used when imagers have special readout patterns. For example, if the readout pattern contains

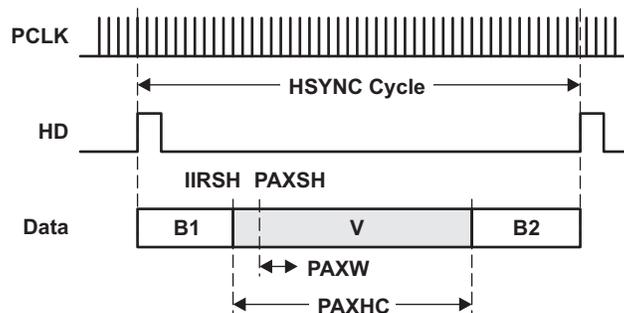
Figure 5. Paxel Width and Horizontal Paxel Count
