# **TMS320C6652/54/55/57**

#### **Silicon Revision 1.0**

## **Silicon Errata**

Literature Number: SPRZ381C  
April 2012–Revised May 2016

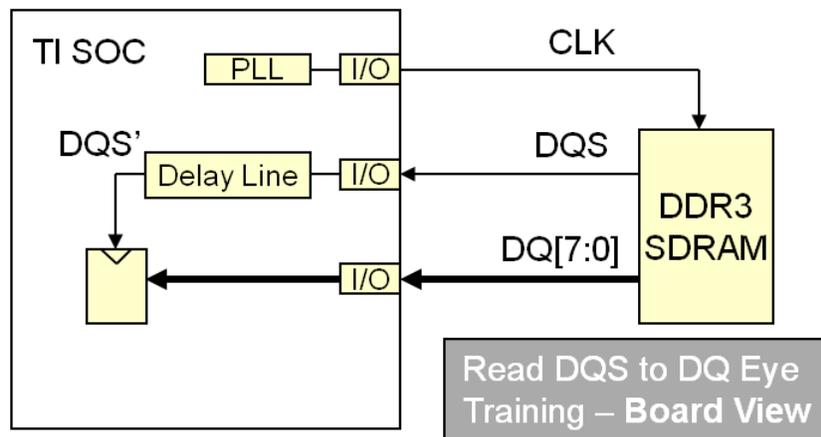
**Figure 2. Read DQS to DQ Eye Training - Board View**

The leveling feature with the problem is the Read Data Eye Training. Depending on the jitter seen on the DQ and DQS signals, this leveling feature will fail to converge on a good data eye, resulting in corrupted DSP to DDR3 SDRAM reads.

The intended purpose of the Read Data Eye Training feature is to align the DQS sampling transitions in the middle of the DQ data eye within individual byte lanes of the DDR3 memory interface. As seen in [Figure 2](#), the DQS signal can be delayed relative to the DQ signal within the DDR3 PHY.
