ABSTRACT

This document describes the known exceptions to the functional specifications (advisories).

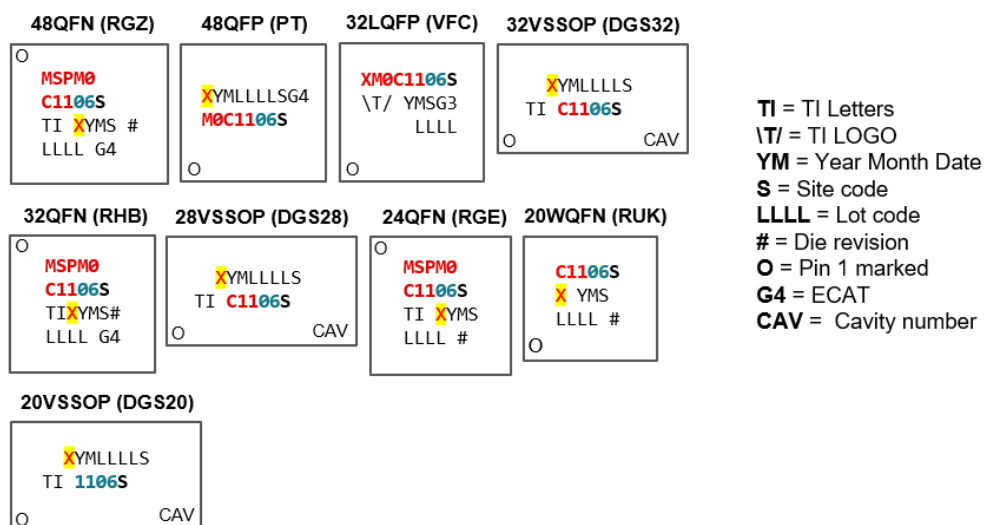
Figure 5-1. Package Symbolization

The package diagrams below indicate the package symbolization scheme, which is the pre-prod version. After release, RTM version will be added here. And [Table 5-1](#) defines the device revision to version ID mapping.
