TMS320C6701
Digital Signal Processor
Silicon Errata

SPRZ179A
January 2001

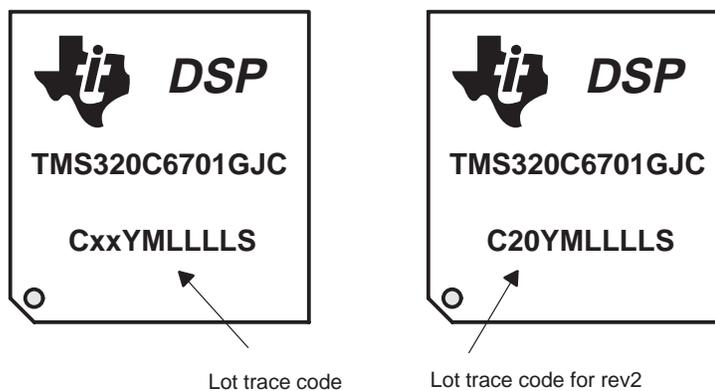
Figure 1. Example, Lot Trace Code for TMS3206701

The device revision can be determined by the lot trace code marked on the top of the package. The location for the lot trace codes for the GJC package are shown in Figure 1 and Table 1.

Lot Trace Code	Silicon Revision	Comments
20	2.0	
1x	1.x	Functionally the same as revision 2.0
00	0.0
